# Aviation Short Investigation Bulletin

Issue 11

**Report No.** AB-2012-088

**Publication date** 3 August 2012

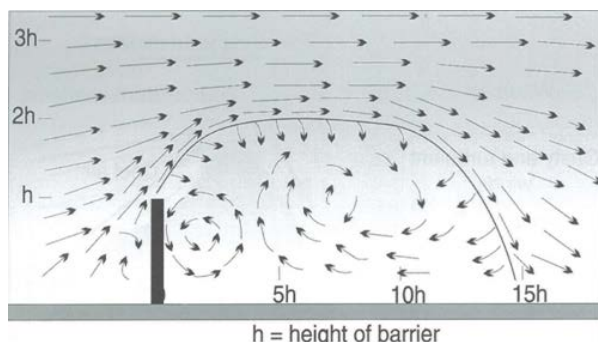
**Figure 2: Airflow near a solid (impermeable) cross wind barrier**

The BOM estimates that for smaller impermeable barriers, such as trees and buildings, turbulence occurs up to about twice the height of the barrier vertically, and an equivalent distance downwind of up to 15 times the height of the barrier (Figure 2)
