# Collision between the Liberian bulk carrier *Grand Rodosi* and the Australian fishing vessel *Apollo S*

Port Lincoln, South Australia | 8 October 2010

**ATSB Transport Safety Report**  
Marine Occurrence Investigation  
279-MO-2010-008  
Final

MO-2010-008

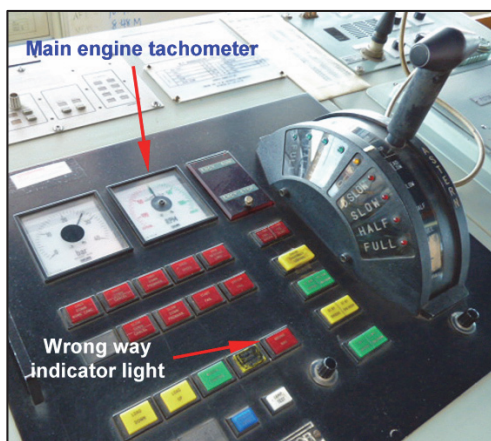
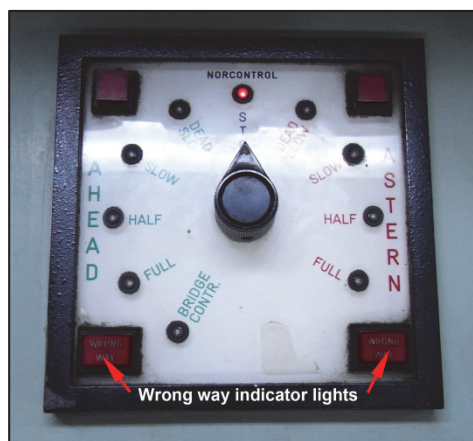
**Figures 2a & b: Bridge and ERC telegraphs**

In order to obtain the required engine movement, the bridge telegraph lever (Figure 2a) was moved to the desired position. An alarm then sounded on the bridge and in the engine room control room and continued to sound until the engine room control (ERC) telegraph (Figure 2b) was turned (ahead or astern) to match that bridge order. When that happened, the alarm stopped and the appropriate light on the bridge and ERC telegraphs remained lit to indicate that the requested movement had been acknowledged.

Should this occur, the alarm and monitoring system is designed to detect the discrepancy between the telegraph order and the actual direction of rotation and a flashing visual 'wrong way' alarm on the ERC and bridge telegraph consoles is activated (Figures 2 a & b). However, when the main engine is operated from the engine room control room, the Norcontrol AutoChief III bridge control system's 'wrong way' running interlock and audible alarm protections are by-passed.

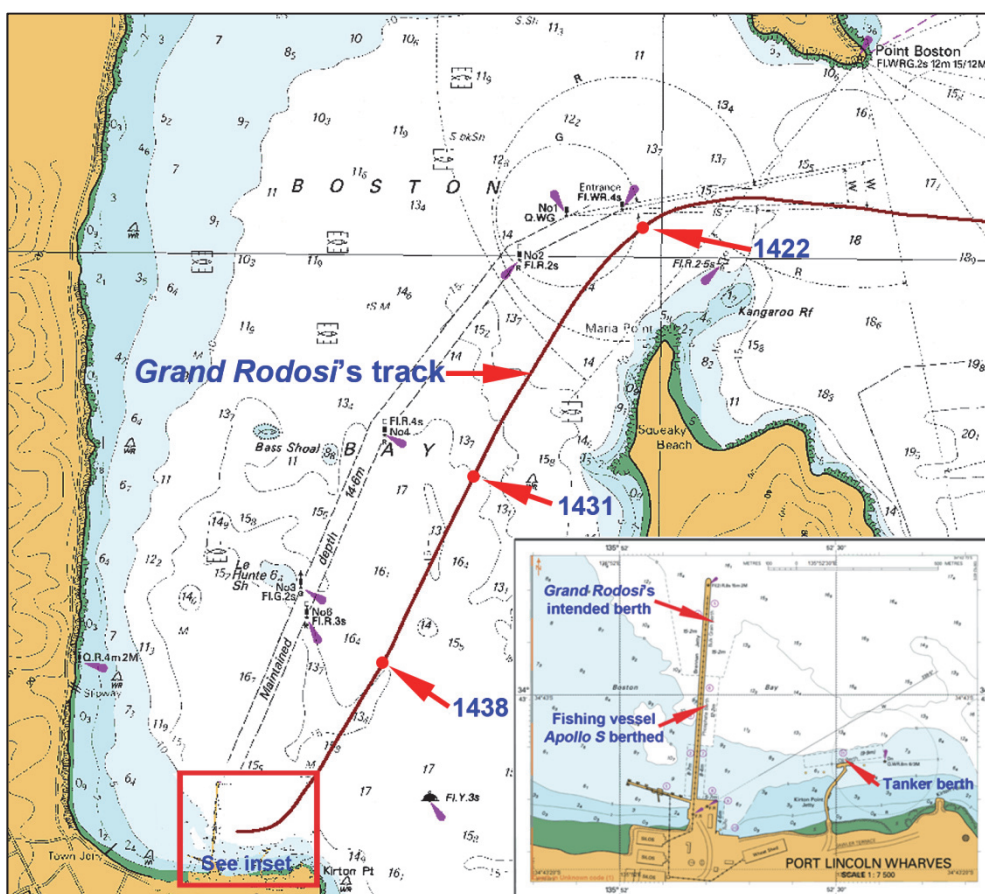
**Figure 7: Section of navigational chart Aus 134 showing the actual passage through Boston Bay and the Port Lincoln wharves.**

With an after draught of less than 11 m, the pilot decided to take the ship outside the channel, keeping the channel beacons on the ship's starboard side. After passing the channel's entrance beacon, his plan was to steer the ship towards the Kirton Point tanker berth (Figure 7), and then, as the ship approached the tanker berth, turn it to starboard before berthing it port side to the number 5 berth on Brennan Jetty.

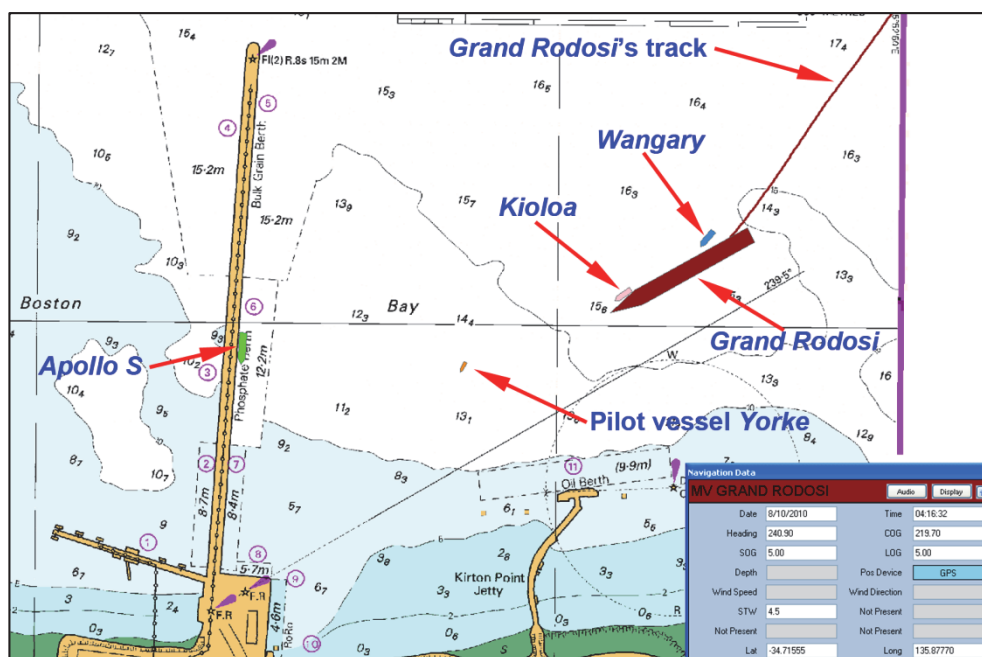
Figure 8: *Grand Rodosi* S-VDR replay at 1446

At about 1446½, the pilot ordered the engine stopped. Again, the third mate moved the telegraph to the stop position and this was acknowledged in the engine room. The ship's heading was 241° (T), its speed was 5 knots and it was 2.9 cables from the tanker berth (Figure 8).

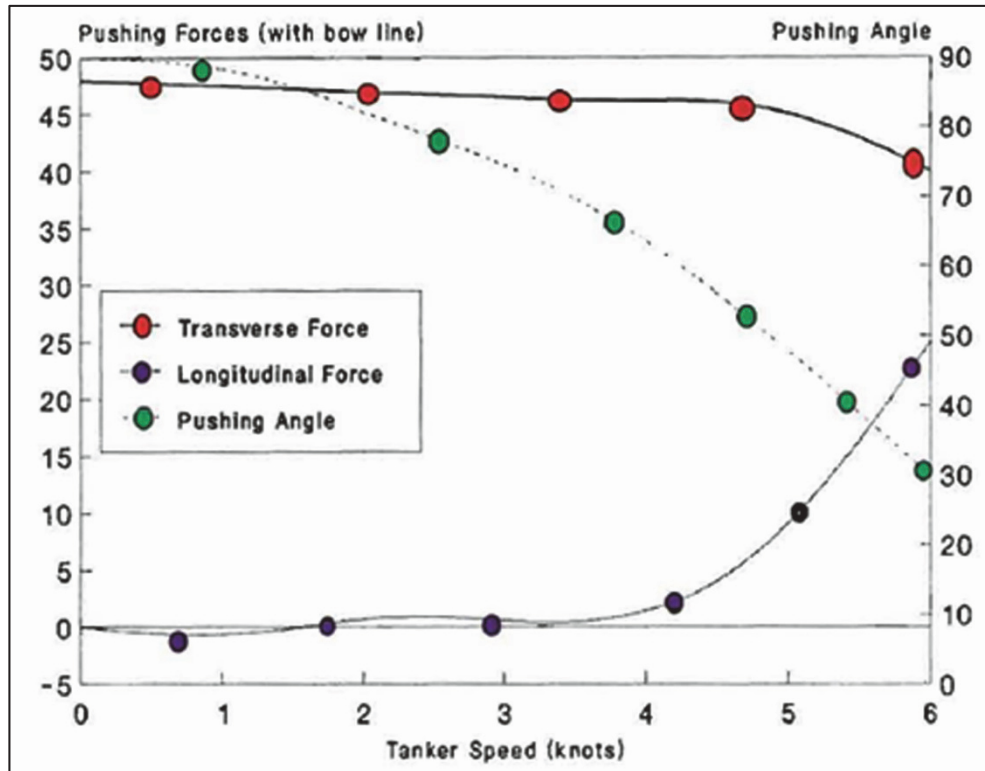
**Figure 16: Performance and behaviour of a 40 m conventional tug**

As indicated in the graph (Figure 16), the pushing angle becomes smaller as soon as the ship gathers speed. The transverse pushing forces exerted by this tug decrease with ship's speed higher than five knots, but longitudinal forces increase very quickly at speeds above four knots. These longitudinal forces increase ship speed.

account. Naturally, differences in performance exist between various types of conventional tugs. In general, however, the upper limit at which effective sideways pushing forces can be exerted is found to be about three knots.

At ship speeds higher than around four knots, and for less manoeuvrable tugs three knots, the performance of conventional tugs is very poor. At these higher speeds transverse pushing forces are minimal, but longitudinal forces increase very quickly, thus increasing ship's speed, which is not desirable.
