Aircraft proximity event – two Cessna 172S, VH-EWE and VH-EOP

Moorabbin Airport, Victoria – 19 July 2012

ATSB Transport Safety Report
Aviation Occurrence Investigation
AO-2012-099
Final

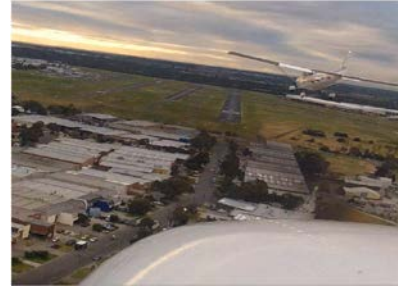
Figure 2: Aircraft positions at 1629

A subsequent review of Airservices Australia surveillance data showed that, at about 1629, EOP and EWE were on converging tracks (Figure 2). Shortly after, the instructor and student of EWE again looked for traffic. With no traffic sighted, they commenced the turn onto final. The turn was conducted lower and later than normal. At about the same time, EOP received an ATC clearance to land.
