Fuel contamination – Cessna 182P, VH-WTS

near Cunnamulla Aerodrome, Queensland, 19 June 2012

ATSB Transport Safety Report
Aviation Occurrence Investigation
AO-2012-083
Final

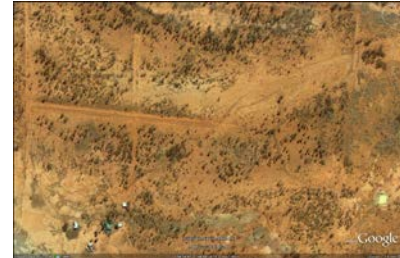
Mayvale Station airstrip

On 19 June 2012, at about 0815 Eastern Standard Time¹, the pilot of a Cessna Aircraft Company 182P aircraft, registered VH-WTS (WTS), departed Mayvale Station, about 53 km east-north-east of Cunnamulla, Queensland, for an aerial inspection of the property. Shortly after becoming airborne, at about 80 to 100 ft, the pilot recalled the aircraft losing airspeed and then clipping a tree during the subsequent forced landing. The pilot's next recollection was being on the ground, out of the aircraft and unable to stand. The aircraft had collided with the ground and came to rest inverted (Figure 1).
