Aviation Short Investigation Bulletin

Issue 14

ATSB Transport Safety Report
Aviation Short Investigations
AB-2012-157
Final

Report No. AB-2012-157

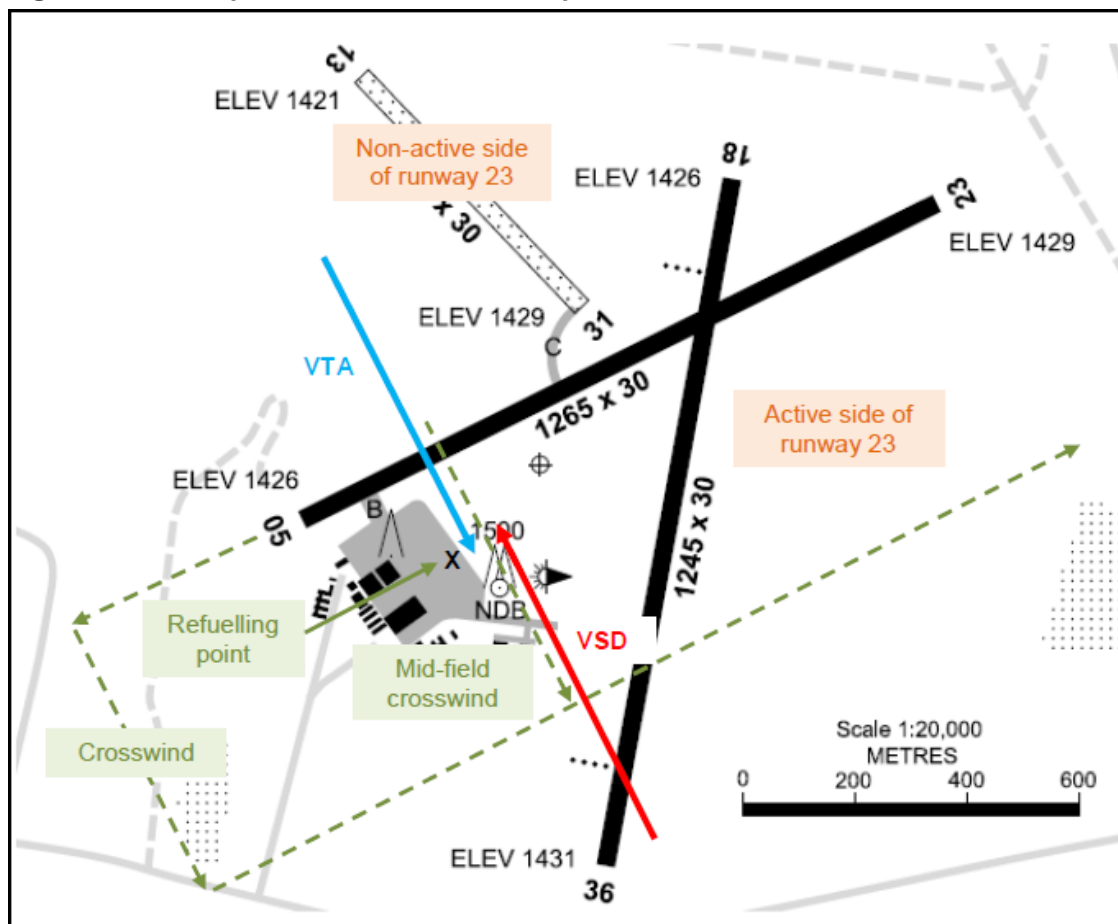
Figure 1: Aircraft positions overhead the airport

A review of Airservices Australia radar surveillance data did not identify VSD or VTA. However, at 1212 Eastern Standard Time⁴, the data showed two aircraft overhead the airport on converging headings. The aircraft passed in close proximity, with about 0.2 NM lateral separation and 300 ft vertical separation.

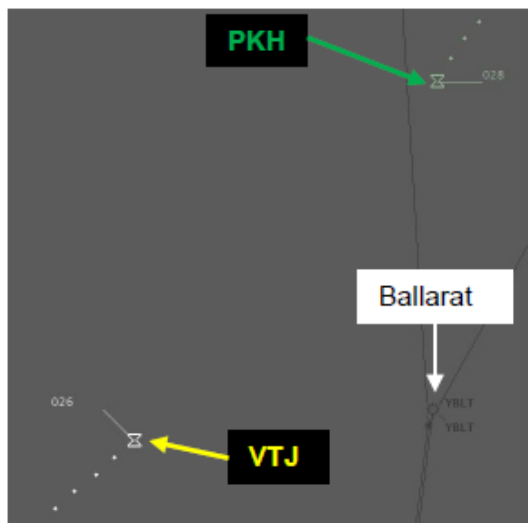
Figure 2: Aircraft positions at 1241

The pilot of a Cessna 172S aircraft, registered VH-VTJ (VTJ), broadcast on the CTAF advising that he was 10 NM to the west, inbound. Shortly after, he heard a broadcast from the pilot of a Cessna 172RG aircraft, registered VH-PKH (PKH), advising he was also inbound (Figure 2⁵).

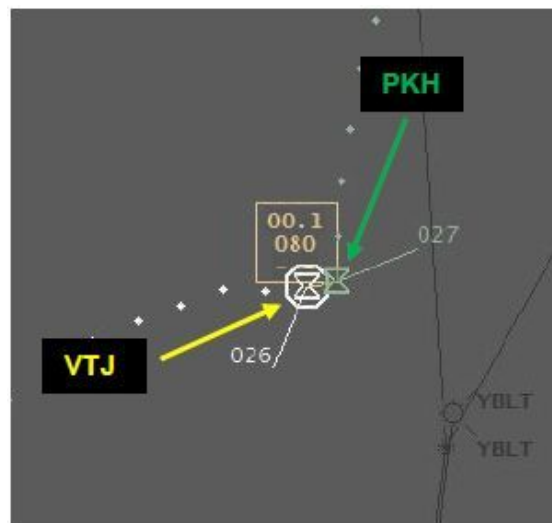
Figure 3: Aircraft positions at 1242

At about 1242, the pilot of VTJ stated that he broadcast another call advising he was joining the circuit, mid-field crosswind. He then observed PKH to his left, about 200-300 ft below and overtaking (Figure 3). The pilot of VTJ did not take any avoiding action, however, continued to monitor PKH. He further stated that he could not recall hearing a joining mid-field crosswind call from PKH.

A review of Airservices Australia surveillance data indicated that the distance between VTJ (at 2,600 ft AMSL) and PKH (at 2,700 ft AMSL) reduced to 0.1 NM laterally and 100 ft vertically.

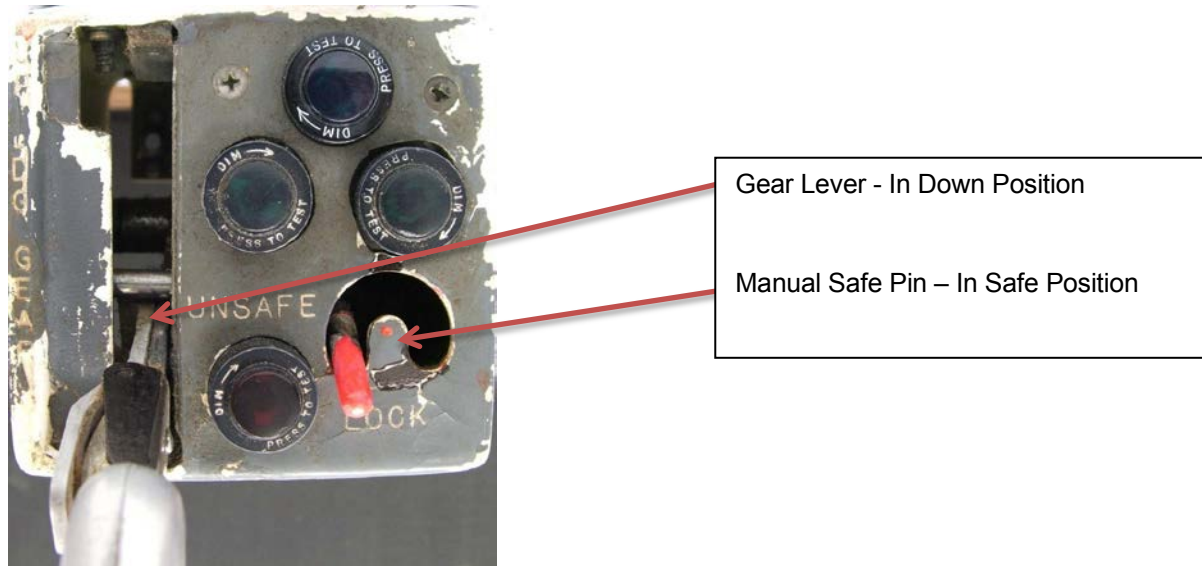
Figure 1: Gear Selector

The day after the incident, the aircraft was inspected by engineers and a number of landing gear extensions and retractions were performed without fault.

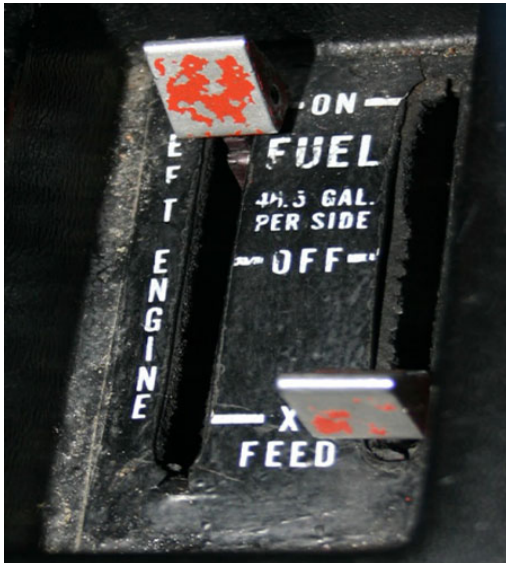
Figure 1: Fuel Selector

According to the pilot's checklist, the fuel selector operation was to be checked while the aircraft was taxiing. The pilot was to set one of the selectors to OFF. When the corresponding engine started to sputter, the selector was to be set to XFEED. When the engine resumed operation the selector was to be set to ON. The selector for the other engine was then to be checked in the same manner. The checklist provided four additional opportunities to ensure that both fuel selectors were set to ON: during the engine run up, during the pre-takeoff check, when the aircraft was lined up on the runway, and when the aircraft was established at cruising altitude.

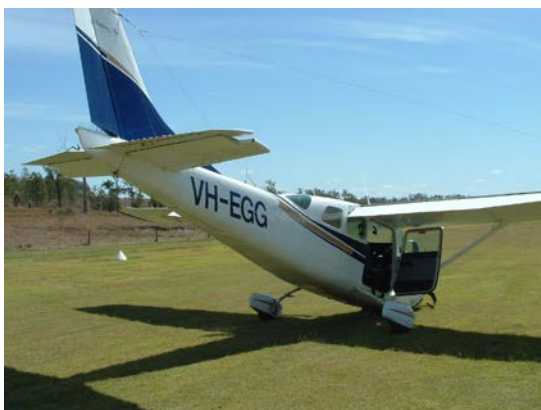
Figure 1: VH-EGG and windsock indication

The pilot reported that, at the time, he was confident that he could conduct the approach and landing under the given wind conditions. However, in hindsight, he stated that he should have conducted a go-around.
