Aviation Short Investigation Bulletin

Issue 15

Aviation Short Investigations AB-2013-018 Final – 27 February 2013 Released in accordance with section 25 of the Transport Safety Investigation Act 2003

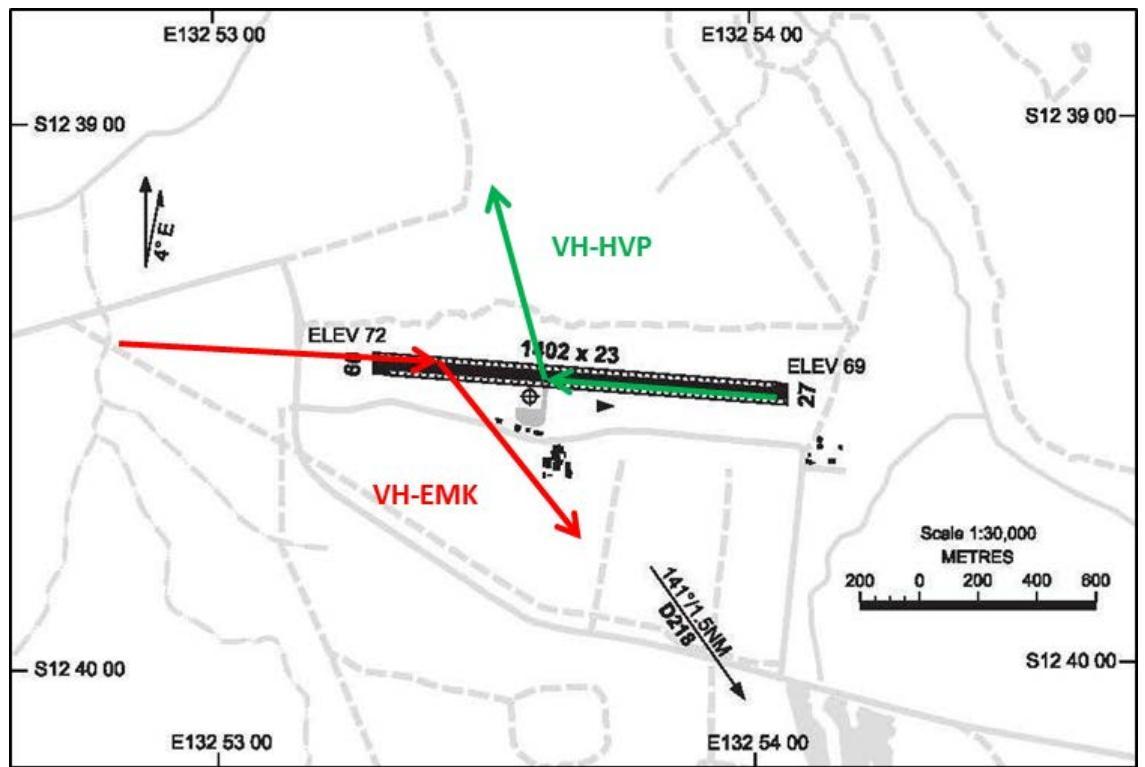
Figure 1: Approximate aircraft positions

When at about 1 NM inbound, the crew of EMK observed HVP taking-off on runway 27, directly opposite to their approach path. The Captain immediately called for a go-around, which the FO initiated. The FO took avoiding action by manoeuvring the aircraft to the right.

At the same time, the pilot of HVP observed EMK on final for runway 09, at about 500 ft. The pilot decided to continue the take-off as he did not want to remain on the runway if the crew of EMK had not sighted HVP.

After take-off, at about 50 ft, the pilot of HVP turned the aircraft to the right to maintain separation with EMK. Immediately after, the pilot observed EMK in a climbing right turn.

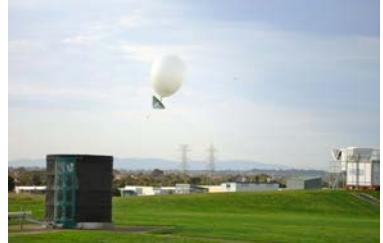
Weather balloon

Shortly after takeoff, at about 700 ft, the captain observed a weather balloon above, in his 1 o'clock² position. The captain advised the FO, who immediately initiated a slight left turn.

The balloon was observed to pass about 10-20 m laterally from the right wingtip and the captain advised air traffic control (ATC).

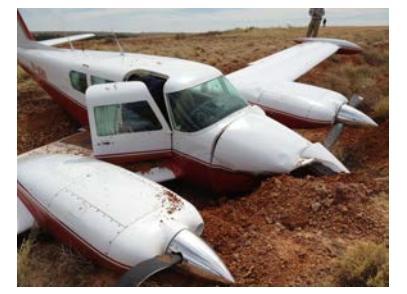
VH-MMN

When the aircraft was about half way along the runway, the pilot realised that the aircraft's speed was too fast and he applied full braking. The pilot determined that it was too late to commence a go-around. He reported that the braking appeared to be ineffective due to the surface of the runway and the aircraft continued beyond the runway end. The left landing gear struck a depression, and then the aircraft spun to the left and came to rest in a 1 m deep gully. The pilot and passenger exited the aircraft and the aircraft sustained serious damage (Figure 1).

The Innamincka Township ALA had one gravel runway aligned 100°/280°, about 1,000 m (980 m usable) in length. The pilot reported that the surface of the runway, particularly towards the end of runway 28, contained a lot of small loose stones, which may have affected the braking capacity of the aircraft during the landing roll. The pilot also stated that there were markings on the runway indicating that the aircraft's brakes had intermittingly locked up during the landing. The pilot contacted the airport operator several days after the accident and was advised that the runway surface had since been rolled.

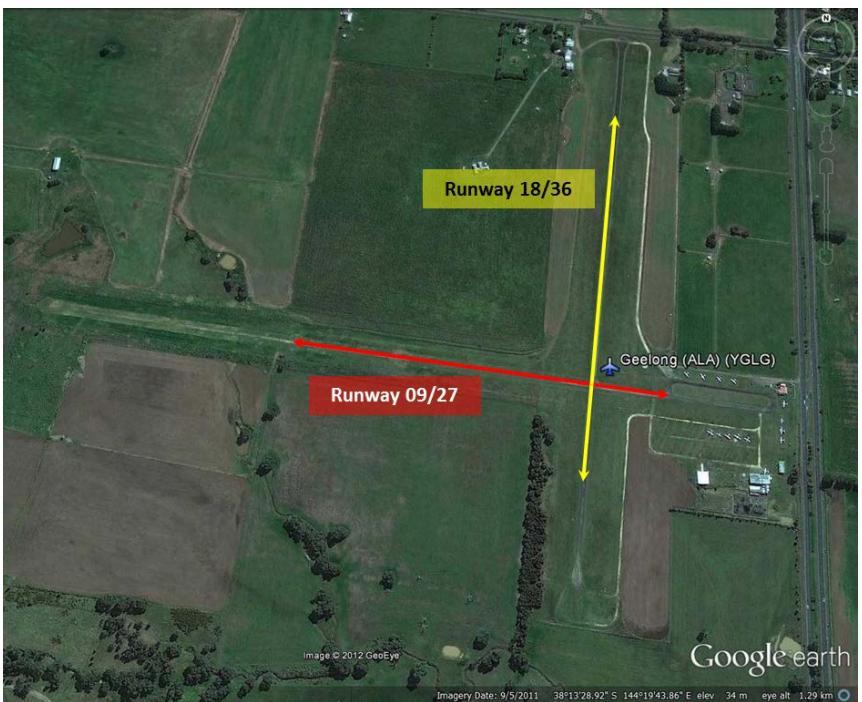
Figure 1: Geelong (Grovedale) airstrip

The pilot reported that neither he nor the passenger observed any markings on the runway to indicate the airstrip was closed. The pilot did, however, observe a marking at the northern end of runway 18/36. Prior to departing Geelong, the pilot visually inspected the runway and noted that the marking was a large square or rectangle covering the width of the runway, and was of a powder-like substance. The pilot could not recall sighting the windsock.

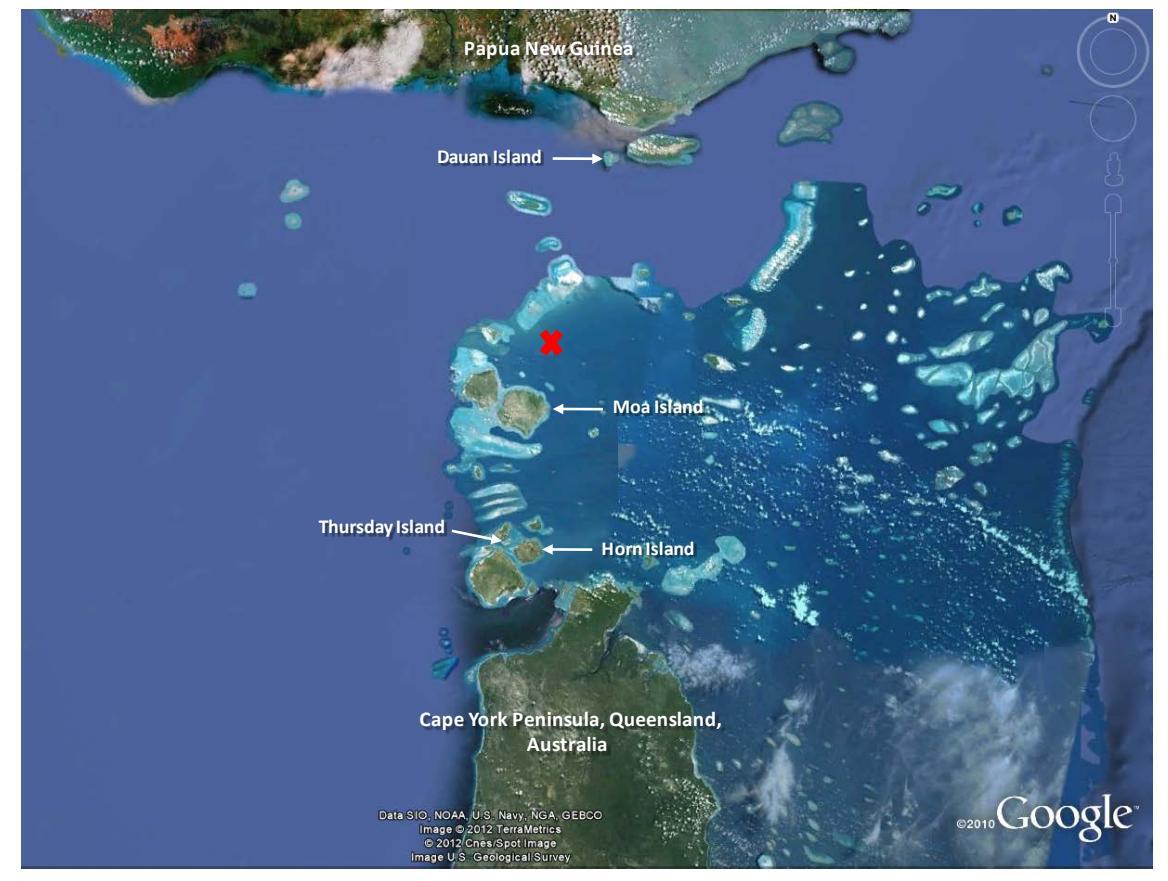
Figure 1: Horn Island area showing the approximate location of ditching (red cross)

At about 1845, a search and rescue helicopter arrived and transported the pilot to Horn Island. The pilot was uninjured, however the helicopter sustained substantial damage as a result of exposure to the salt water. The helicopter was recovered the next day.

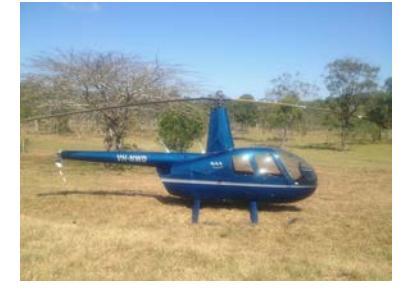
VH-NWD

helicopter passed through 250 ft and 60 knots indicated airspeed, the pilot heard a loud grinding noise from the rear of the helicopter. This noise was immediately followed by the illumination of the clutch light² and an uncommanded left yaw.
