Engine failure involving Gippsland Aeronautics GA-8, VH-AJZ

135 km NNE of Marree, South Australia | 29 September 2011

AO-2011-125 Final – 18 March 2013

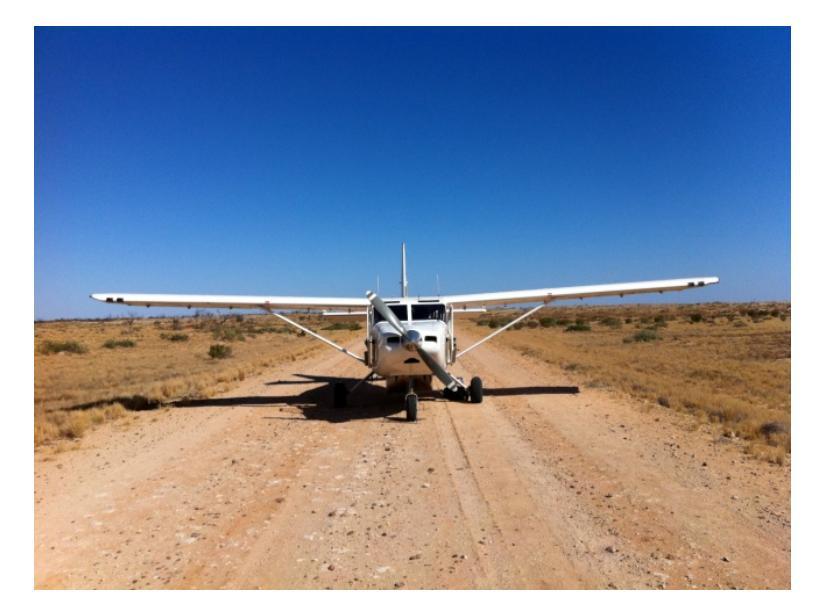
About 45 minutes after takeoff and at a height of about 500 ft AGL, the pilot felt a shudder through the airframe, heard a loud pop and the propeller stopped suddenly. The pilot carried out a forced landing on the Birdsville Track (Figure 1), approximately 135 km north-north-east of Marree.

Figure 1: VH-AJZ on the Birdsville Track
