Runway excursion involving Cessna T210, VH-DQI

Cape Leveque Western Australia, 30 December 2012

ATSB Transport Safety Report
Aviation Occurrence Investigation
AO-2013-001
Final – 21 March 2013

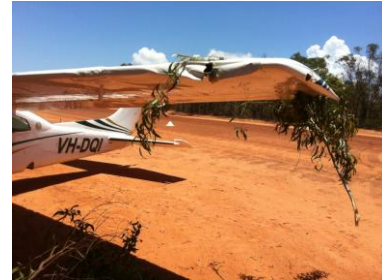
Figure 1: Right wing and nose gear damage

The pilot ensured the aircraft was safely shut down, and then assisted the passengers. One passenger received minor injuries and the aircraft sustained substantial damage.
