# Loss of control involving Robinson R44 helicopter, VH-COK

Jaspers Brush Aerodrome, New South Wales | 4 February 2012

**ATSB Transport Safety Report**  
Aviation Occurrence Investigation  
AO-2012-021  
Final – 3 May 2013

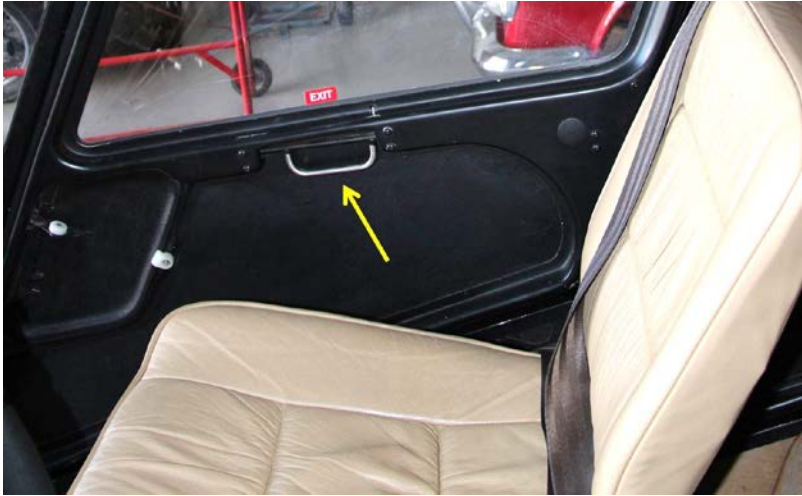
To securely latch the door from inside the helicopter, the pilot performs a dual action. First, the horizontal rod is moved to its fullest extent rearward using the looped handle (Figure 6). That movement engages the pointed end of the rod into a hole in the door frame. Once fully rearward, subsequent rotation of the looped handle in a downward direction (arc) moves the vertically-oriented rod upward about the sliding joint and engages into the upper door frame.

**Figure 6: Exemplar R44 pilot's door from the inside showing the looped operating handle fully to the rear and rotated to the down and latched position**

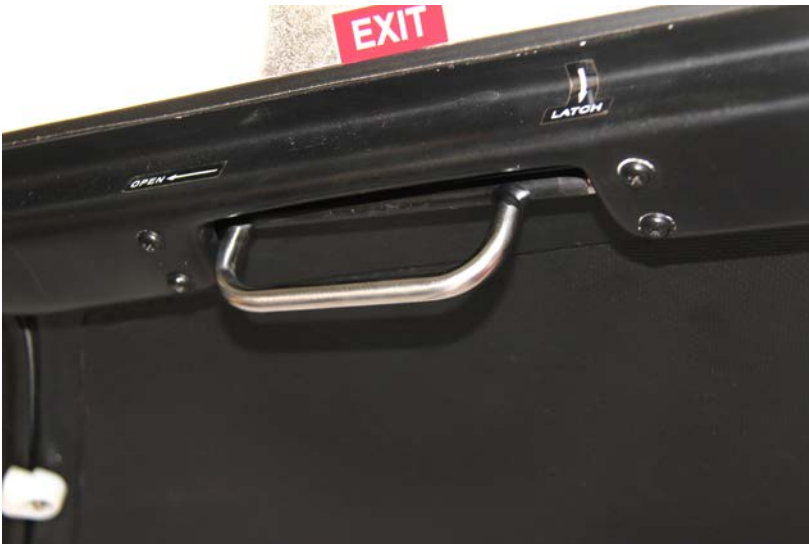
Figure 7 shows the looped door handle in the unlatched position.

**Figure 7: Exemplar R44 pilot's door from the inside showing the looped handle in the unlatched (fully forward) position**

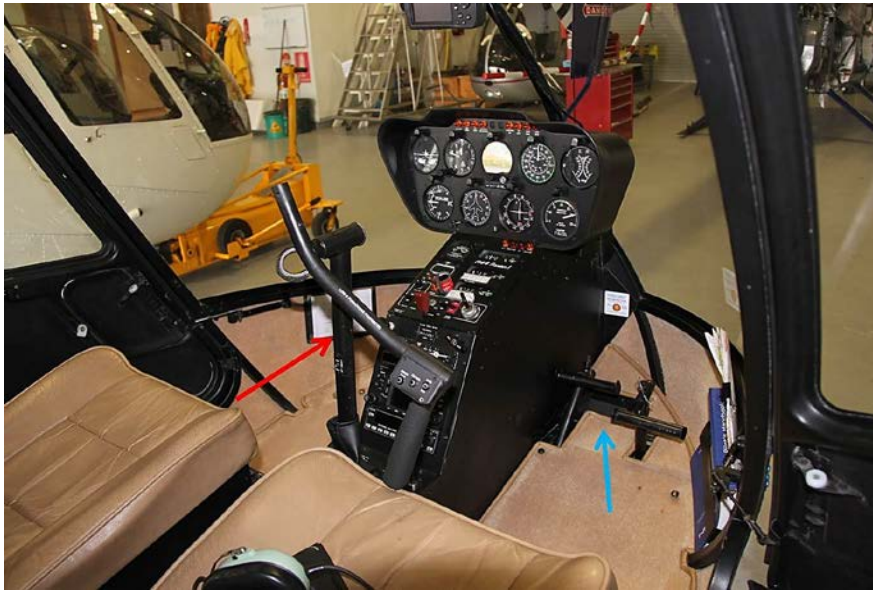
The flight controls in an R44 Raven II helicopter control the pitch angle of the main rotor and tail rotor blades through mechanical linkages. The cyclic control, typically operated by the pilot's right hand, varies the angle of each main rotor blade individually to tilt the main rotor disc and control the attitude of the helicopter. Pilot movement of the hand grip on the cyclic control is transferred via an arm to a centrally-mounted control column (Figure 8).

**Figure 8: Exemplar R44 cockpit flight controls showing the cyclic column (red arrow) and right grip and the tail rotor pedals (blue arrow)**

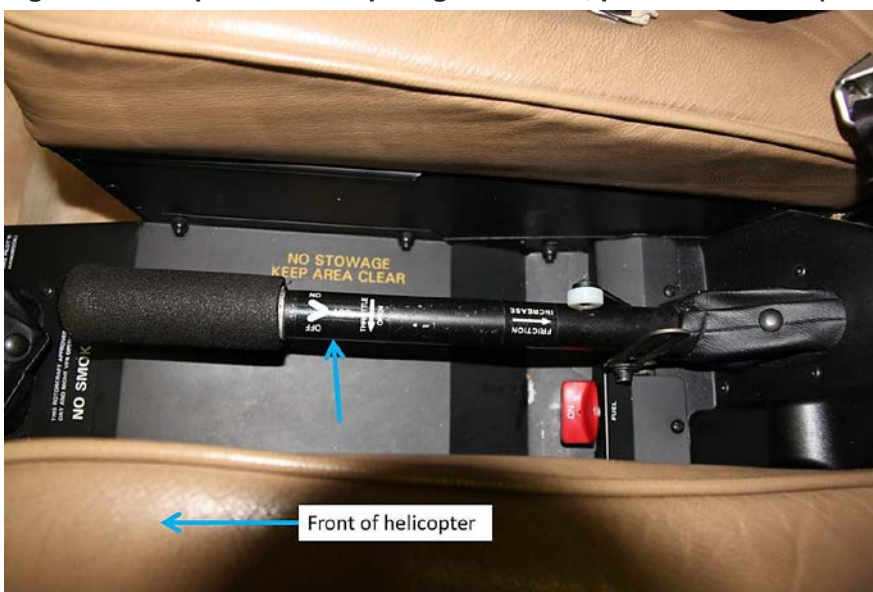
The collective control, raised or lowered by the pilot's left hand, varies the angle of both main rotor blades together to produce more or less rotor thrust for climb or descent. The collective is positioned to the left of each front seat and incorporates a twist-grip engine throttle (Figure 9). The main rotor controls on the Raven II helicopter also incorporate hydraulic assistance.

**Figure 9: Exemplar R44 cockpit flight controls, pilot's collective (blue arrow)**

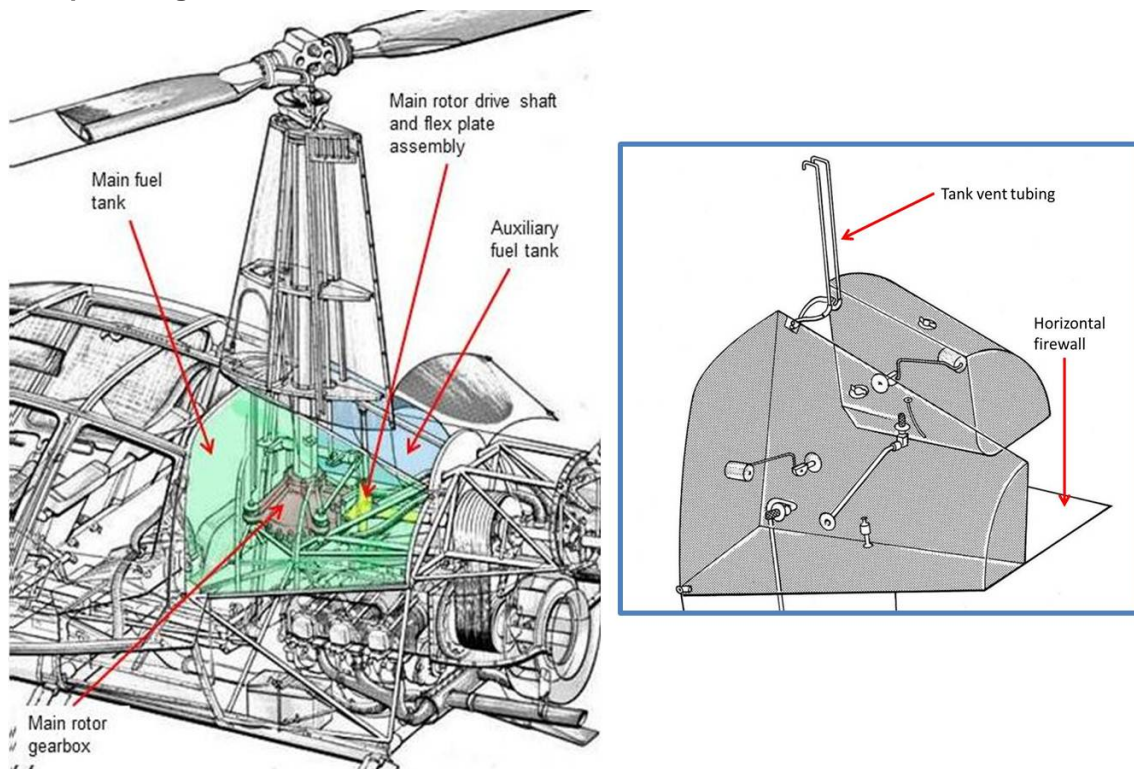
Two all-aluminium fuel tanks were installed above the engine to either side of the main rotor gearbox (Figure 10). Both tanks were originally interconnected by rigid-tubing fuel lines,<sup>4</sup> with the right-side-mounted auxiliary tank draining into the left-side-mounted main tank. The main tank had a maximum capacity of 120 L and the auxiliary tank a maximum of 70 L. Both tanks vented to atmosphere in the enclosed area inside the main rotor mast fairing, above the tanks (Figure 10).

**Figure 10: R44 helicopter<sup>5</sup> fuel tanks surrounding the lower main rotor gearbox assembly and main rotor driveshaft. Inset - fuel tank system diagram showing the original inter-tank plumbing and vent tubes**

The main rotor gearbox, which was situated in the space between the two fuel tanks and relatively close to their inner walls (Figure 10), was displaced from three of its four mounting points. Only the front right gearbox mount remained intact.
