Helicopter winching accident involving an Agusta Westland AW139 helicopter, VH-SYZ

16 km WSW of Wollongong Airport, New South Wales | 24 December 2011

ATSB Transport Safety Report

AO-2011-166

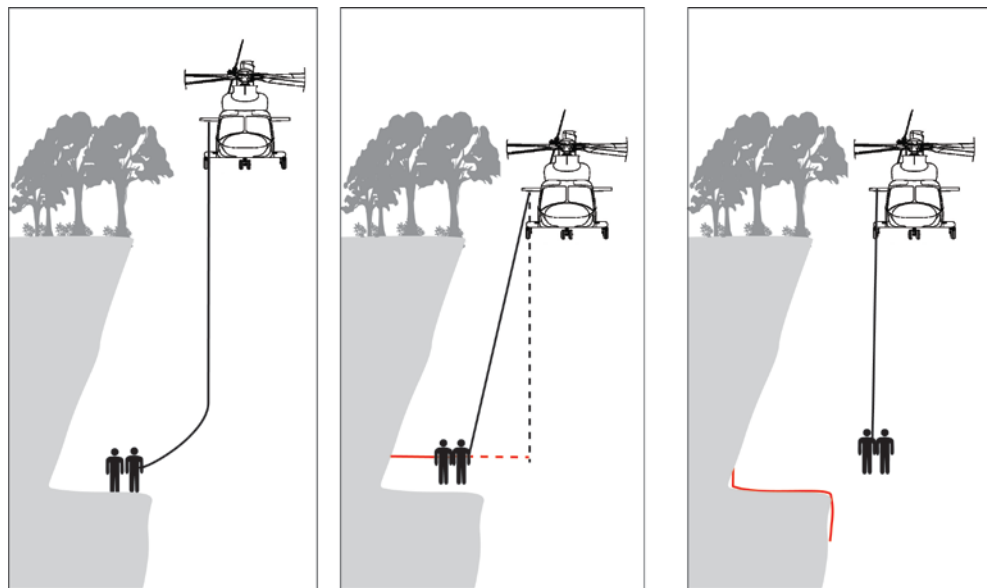
Figure 4: Stabilising rope system (coloured red in this graphic, which is sequenced left to right)

The specific construction of the stabilising rope system, including the manner in which it would be secured to the rock ledge, was not discussed by the crew during the planning stage. The support paramedic and ACM recalled that the duty paramedic advised that he intended to establish the stabilising rope system using a different rope to the tag line. Specifically, the support paramedic recalled intending to use a red safety line that was part of the roping equipment carried by SCAT personnel. In contrast, the pilot reported that he understood the duty paramedic intended to use the yellow tag line as a stabilising system.

During the planning stage, the ACM advised the crew that he was unfamiliar with the intended stabilising technique and enquired how the stabilising rope would be detached once the patient and paramedic were directly under the winch. The ACM reported that the duty paramedic advised that once he and the patient were in that position, he would disconnect from and discard the stabilising rope prior to the ACM winching them up and into the helicopter (Figure 4).

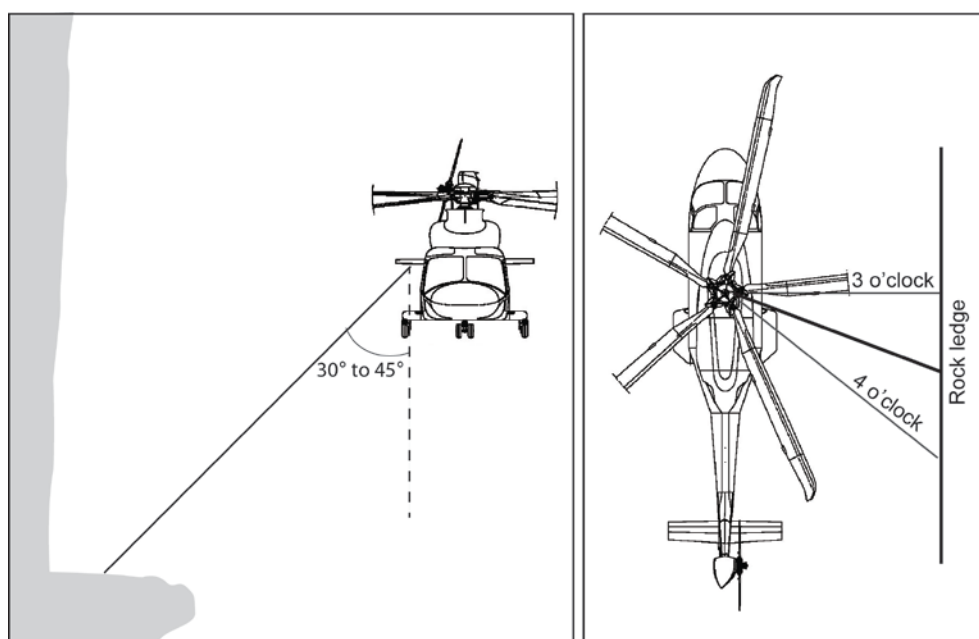
Figure 6: Position of the helicopter relative to the ledge¹³

From his position at the top of the waterfall, the support paramedic assessed that the helicopter terminated to a hover such that the winch cable was running to the rock ledge at about the 4 o'clock position with reference to the front of the helicopter when viewed from above (Figure 6). He further assessed that the helicopter was about 1.5 to 2 main rotor diameters (21 to 28 m) horizontally from his position and about two thirds of the way down the waterfall.

The ACM recalled that, once the helicopter was established in a hover, the winch cable was running to the ledge at between the 3 and 4 o'clock position and at an angle away from vertical of between 30 and 45 degrees (Figure 6). Although the ACM could not recall the amount of winch cable deployed as displayed on the winch control pendant, based on the relative position between the helicopter and the rock ledge, he estimated that about 150 ft (46 m) of cable was deployed once the helicopter was established in the hover. The injured canyoner recalled that, from his vantage point on the rock ledge, the cable ran up to the helicopter at about 45 degrees.

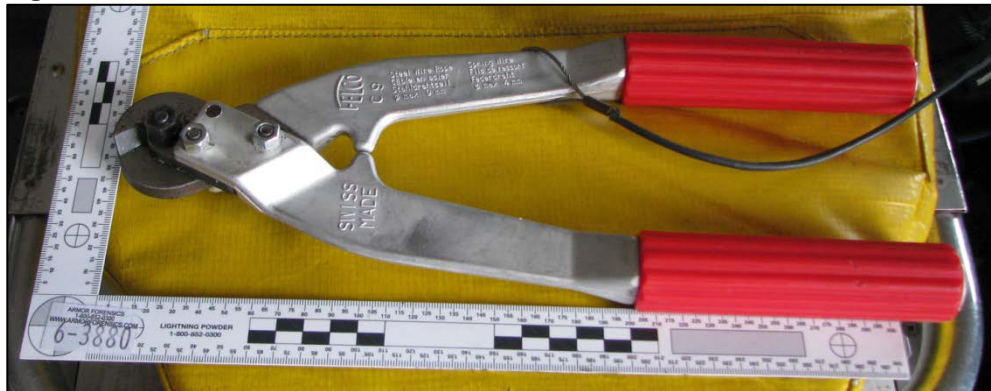
Figure 11: Manual winch cable cutters

The ACM guided the pilot to reposition the helicopter in an attempt to visually assess the patient and paramedic and facilitate the use of hand signals. However, the movement of the helicopter was limited by the generation of water spray from the main rotor downwash that obscured the pilot's hover reference. Due to the water spray and concern that winching the duty paramedic and patient from their obscured position may result in further injury, the pilot instructed the ACM to sever the winch cable using the manual cable cutters (Figure 11) so that the helicopter could depart.

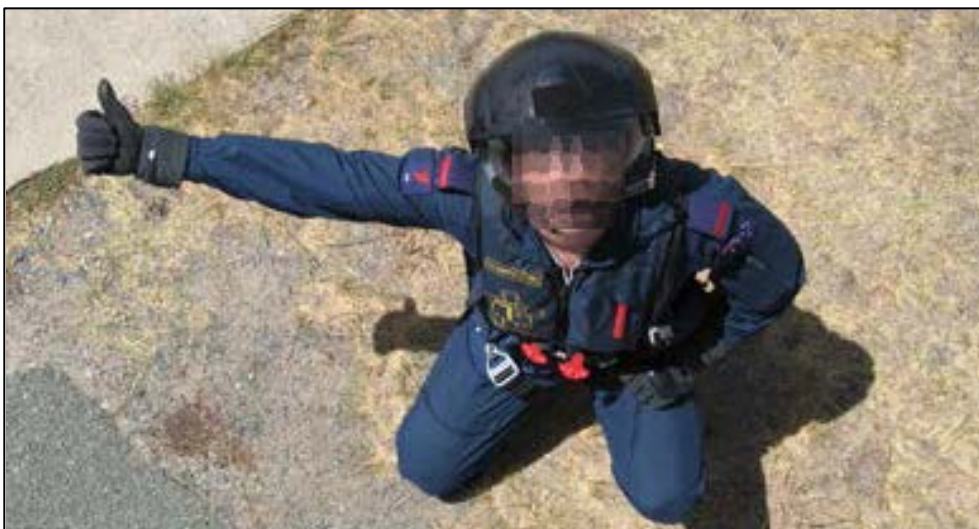
Figure 20: ‘Ready to be winched’ hand signal

In addition to the use of radio communication, a system of hand signals was available for use between the ACM and the ARC. In particular, the signal that indicated that the ARC was ready to be winched was one arm extended horizontally from the body with the thumb up (Figure 20). The operations manual modified the use of hand signals for night winching operations as follows:

The MPFR-recorded communication between the pilot and ACM did not indicate that the winch lights were extinguished after the pilot instructed the ACM to use hand signals. This action was suggested by the pilot once radio contact could not be established with the duty paramedic (see the earlier section titled *History of the flight*).
