Partial power loss (both engines) involving Piper PA-39, VH-RMA

52 km NW of West Wyalong, New South Wales, 9 December 2012

ATSB Transport Safety Report
Aviation Occurrence Investigation
AO-2012-166
Final – 17 May 2013

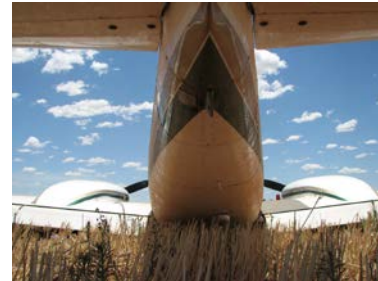
VH-RMA

The pilot secured the aircraft, broadcast his situation and exited the aircraft. The pilot was uninjured and the aircraft sustained serious damage.

An insurance representative attended the accident site (Figures 2 and 3) and noted that there was sufficient fuel remaining in the main fuel tanks to complete the flight. An assessment for contaminants such as water could not be undertaken at the accident site. The reason for the reported performance loss on either engine could not be definitively determined.
