Engine failure involving a Cessna 182R, VH-OWZ

Kununurra Airport, Western Australia, 22 January 2013

ATSB Transport Safety Report
Aviation Occurrence Investigation
AO-2013-023
Final – 17 May 2013

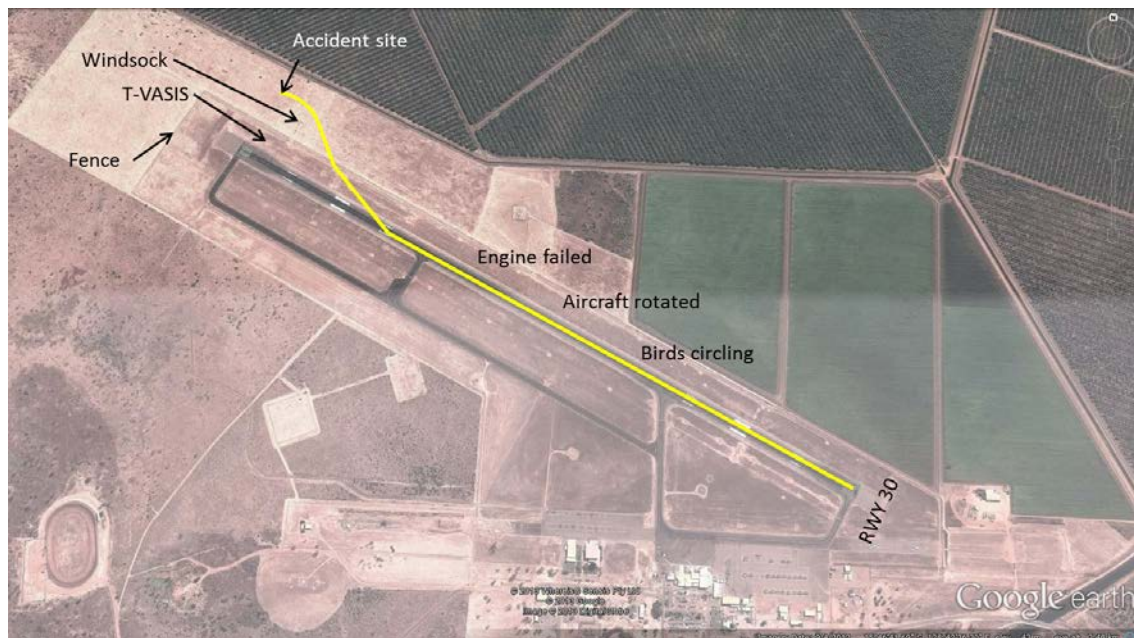
Figure 1: Aircraft track

Due to the low altitude, the pilot confirmed that the engine controls were in the full forward position and that the fuel tank selector was on 'both'. The pilot then looked for a suitable place to land. The pilot observed obstructions at the end of the runway; a drainage ditch, a fence, the T-VASIS,² and the windsock, but saw a suitable field to the north (Figure1).

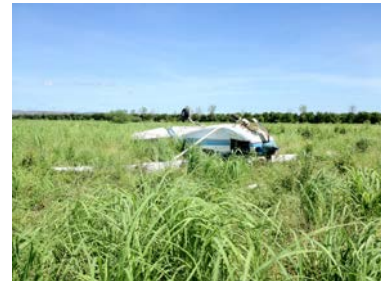
Accident site

The pilot then selected the auxiliary fuel pump on, but the engine did not respond. He lowered the landing gear and extended full flaps. The main landing gear touched down in long grass and the aircraft decelerated rapidly. When the nose gear touched down, it dug into boggy ground and the aircraft flipped over, coming to rest inverted (Figure 2). The pilot and passenger received minor injuries and the aircraft sustained substantial damage.
