Wheels up landing involving a Cessna 337F, VH-JUP

Exmouth (ALA), Western Australia, 25 February 2013

ATSB Transport Safety Report
Aviation Occurrence Investigation
AO-2013-040
Final – 17 May 2013

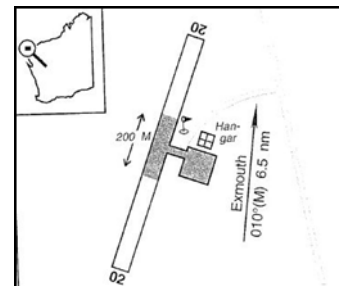
Exmouth (ALA)

The passengers and pilot exited the aircraft without injury. The fiberglass cargo pod (Figure 1) fitted to the aircraft was damaged. The aircraft hull was undamaged; however, the rear propeller contacted the ground.
