Foundering of the general cargo ship *Tycoon*

Christmas Island | 8 January 2012

ATSB Transport Safety Report
Marine Occurrence Investigation
292-MO-2012-001
Final – 23 May 2013

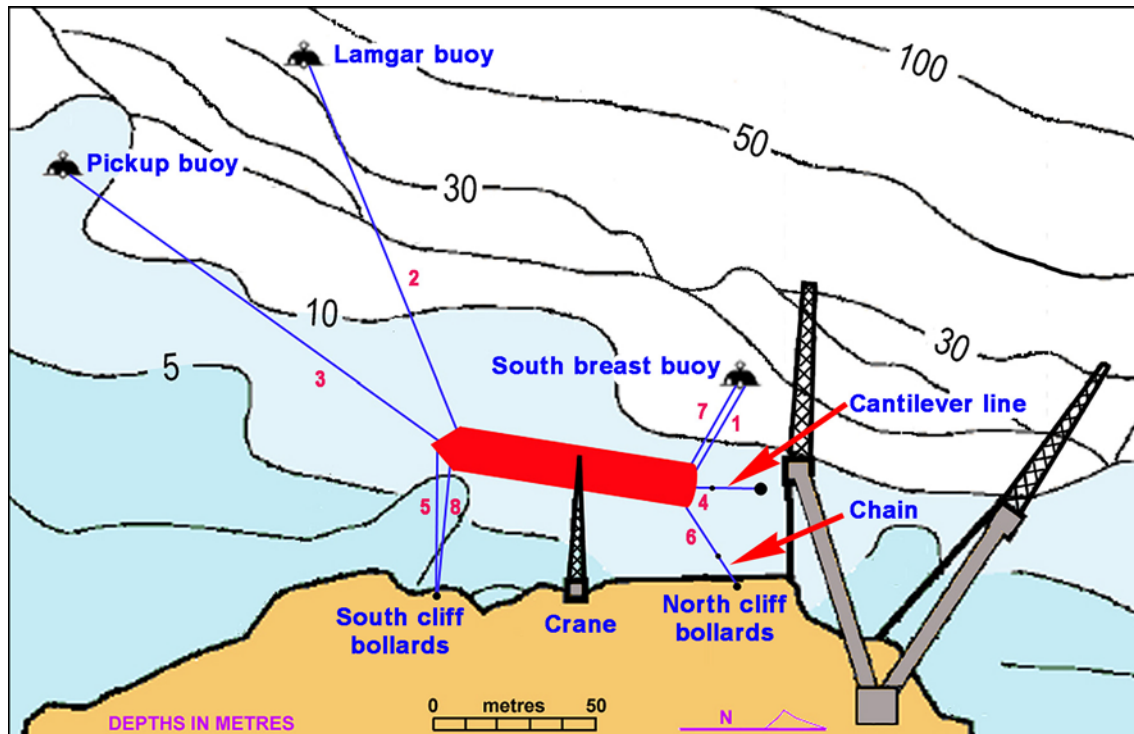
Figure 2: *Tycoon's* mooring arrangement at the inner moorings

At about 0420, the pin in the shackle between the cantilever line (line 4 in Figure 2) and its anchor chain worked free, disconnecting the line from its anchor. The master was advised that the line had gone slack and the crew recovered the ship's mooring line and the cantilever line onto the aft centre mooring winch.

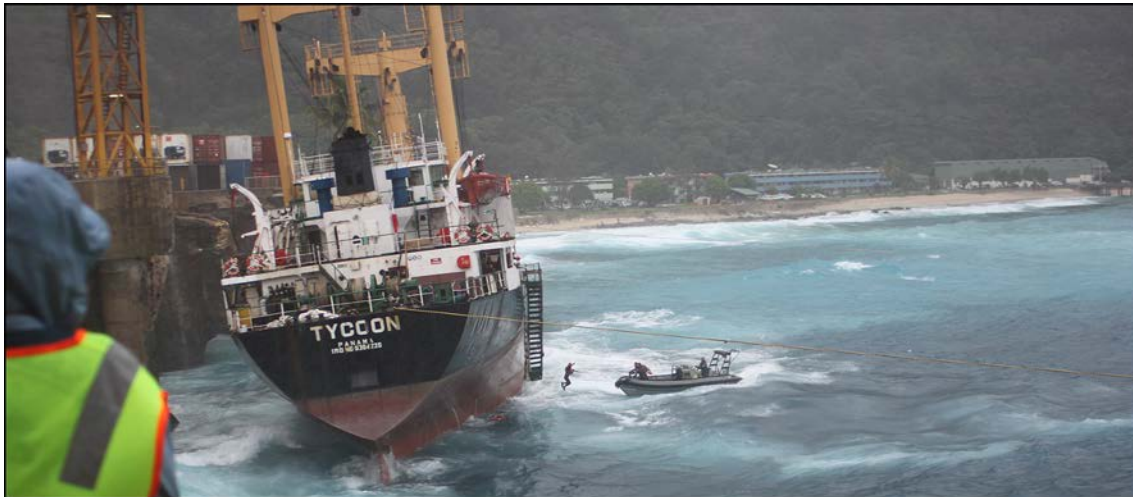
Figure 6: Crew member jumping from the ship

Tycoon's crew lowered the starboard accommodation ladder and then gathered together in lifejackets on the deck adjacent to it. At 1031, the first crew member climbed down the ladder and jumped into the sea (Figure 6). He was quickly pulled on board the RHIB which had come in close to the ship's side.

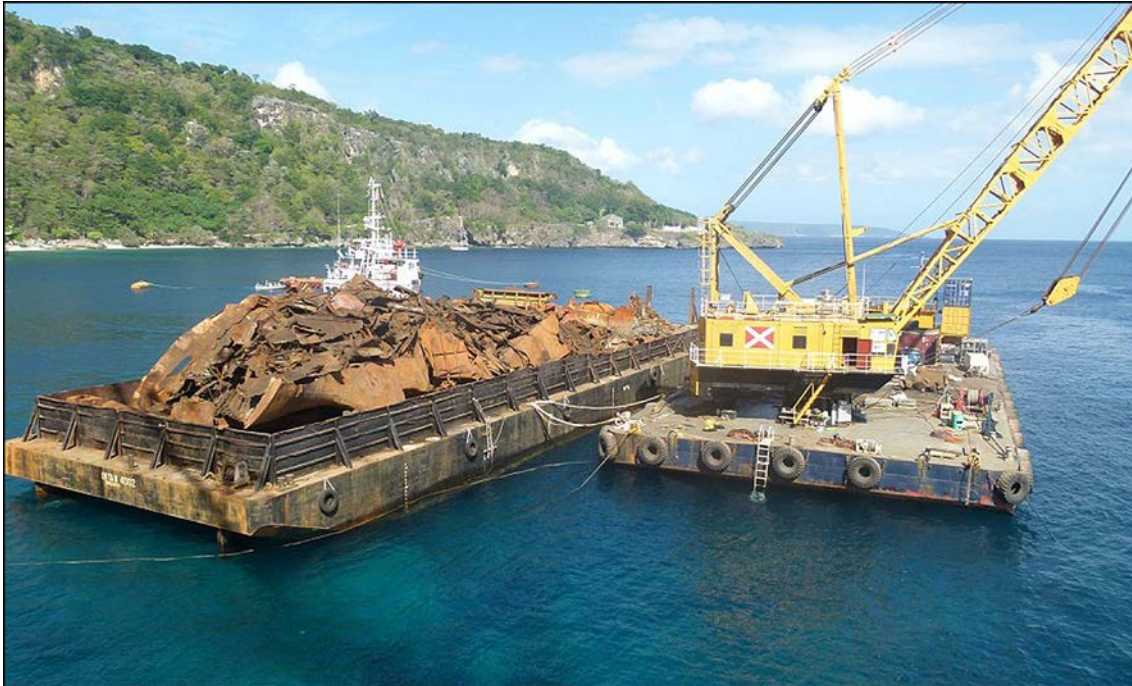
Figure 10: The removal of the wreck of *Tycoon* on 22 July 2012

Titan Salvage completed the removal of the wreck on 26 July (Figure 10). Demobilisation of personnel and equipment was completed by the week ending 3 August and the first ship to be moored in the inner moorings was brought in on 9 August 2012, 7 months after *Tycoon* foundered.

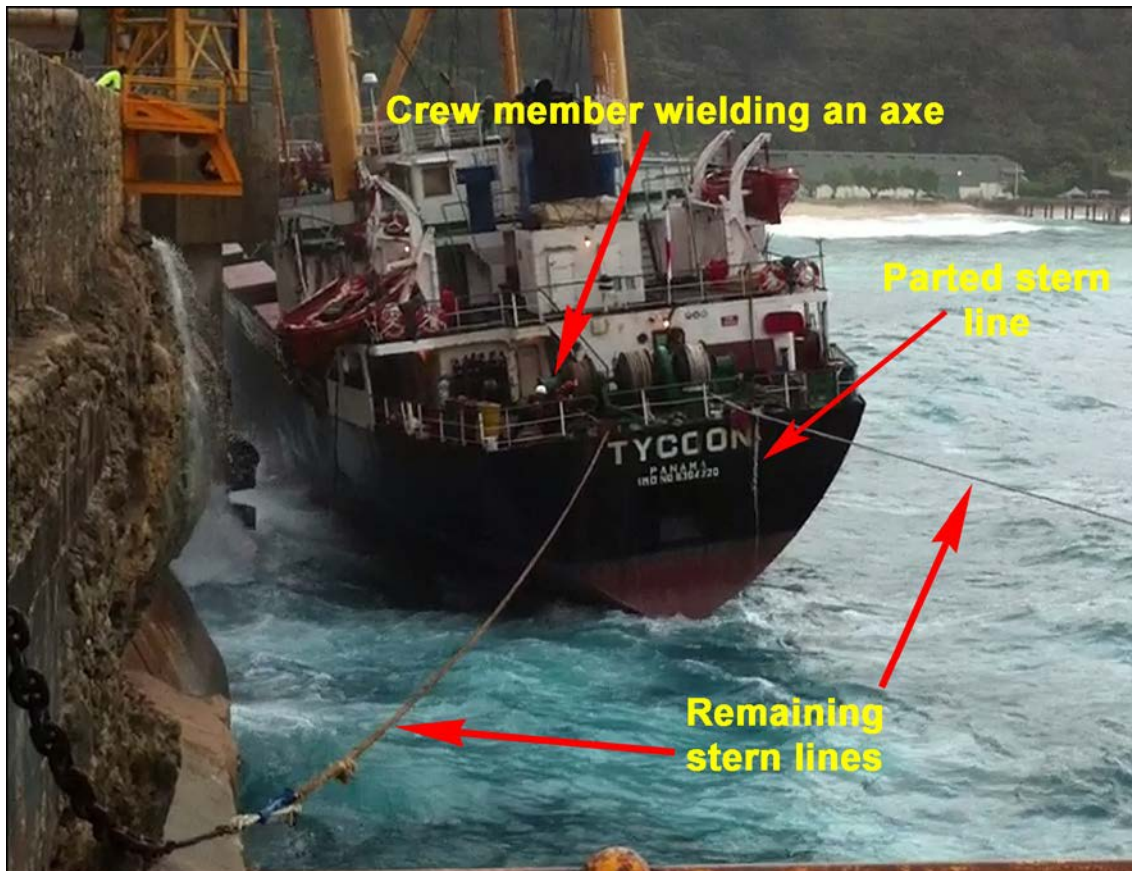
Figure 14: The stern lines being cut in anticipation of *Tycoon* proceeding to sea

When the crew on the poop deck thought that the ship was about to leave for sea, they decided to assist by cutting through the remaining port and starboard breast lines (one of each) (Figure 14). However, their actions made the situation worse and meant that there were no lines out aft and there was nothing to hold the ship's stern off the rock face. It also meant that there was no means for the crew to heave the ship off the pylon and rock face.

The master did not make proper use of the ship's main engine and mooring lines to try and keep the ship at the inner moorings during the early hours of 8 January, relying instead on the pilot for directions. However, by the time the pilot was aware of the situation surrounding *Tycoon*, the weather and sea conditions prevented an effective response to keep the ship from foundering.

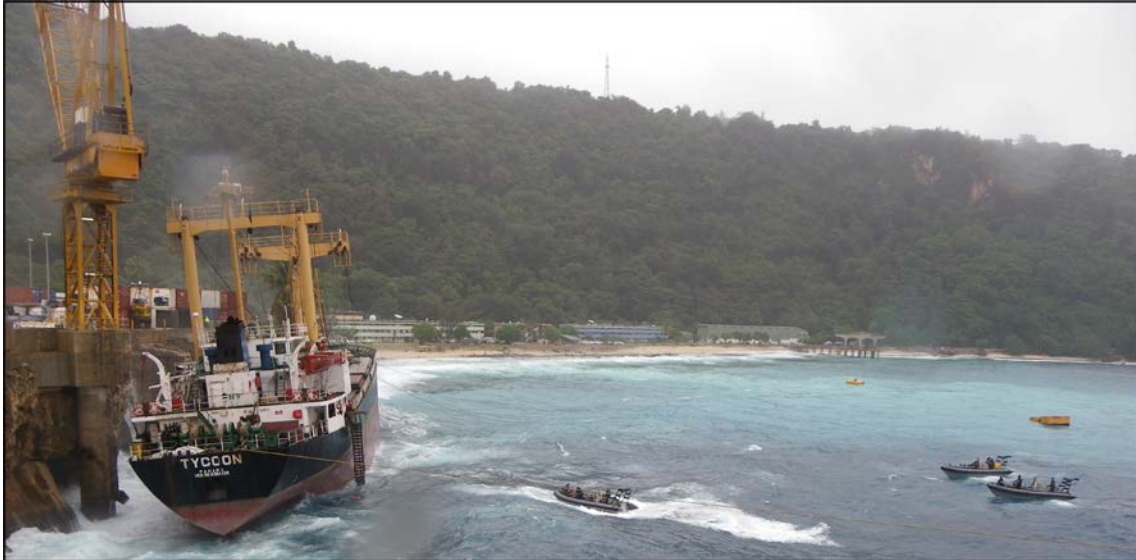
Figure 15: The three Navy RHIBs during the rescue operation

The footage clearly shows that the crews of the three naval RHIBs were able to bring their skills and training in the handling of the RHIBs to the fore when they rescued the crew from the rough seas and in close proximity to the ship's starboard gangway (Figure 15).
