# Collision on ground involving Cessna 150F, VH-ICE

21 km SW of Mittagong (ALA), NSW, 9 February 2013

**ATSB Transport Safety Report**  
Aviation Occurrence Investigation  
AO-2013-027  
Final – 29 May 2013

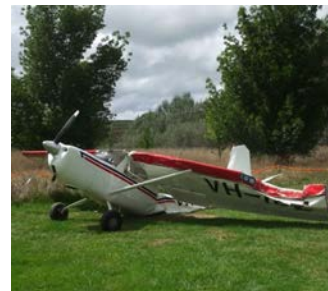
Figure 1: Landing area

After landing to the south, the pilot backtracked along the landing area<sup>3</sup> to conduct a short field take-off in the same direction (Figure 1).
