Landing on a closed runway involving a Cessna 310, VH-TWN

Corowa aerodrome, NSW, 20 February 2013

ATSB Transport Safety Report
Aviation Occurrence Investigation
AO-2013-036
Final – 29 May 2013

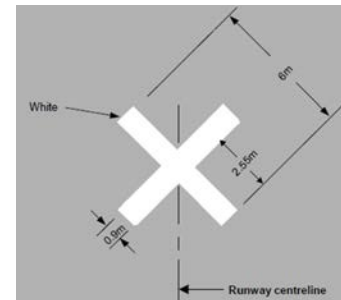
Unserviceability marking

At about 0825, TWN landed on runway 23. Immediately after landing, when about 90-120 m along the runway, the pilot observed an unserviceability cross marker on the ground. The aircraft was taxied to the parking area via runway 14/32, during which time the pilot checked the NOTAM for Corowa and noted that runway 05/23 was closed due to WIP.
