# Collision with terrain involving Grob G-115, VH-ZTM

Jandakot Airport, 15 March 2013

**ATSB Transport Safety Report**  
Aviation Occurrence Investigation  
AO-2013-052  
Final – 28 June 2013

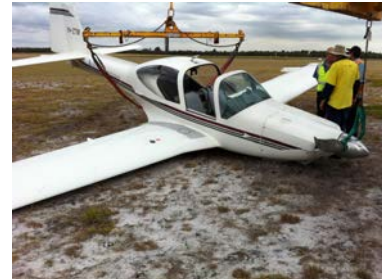
Figure 1: Aircraft damage

At 1135 Western Standard Time,<sup>1</sup> on the student's third solo circuit to runway 06R, ZTM began to drift to the left of the runway centreline. The student elected to go-around and applied full power. Following the application of power, the nose pitched up abruptly and the aircraft then rolled to the left before pitching nose down. The left wing tip contacted the ground and the nose gear and right main gear collapsed before the aircraft came to a stop. The student pilot was able to exit the aircraft without injury, however the aircraft sustained substantial damage.

Grob G-115
