# Landing gear separation involving Piper PA28, VH-JXR

Mangalore Airport, Victoria, 7 January 2013

**ATSB Transport Safety Report**

AO-2013-007

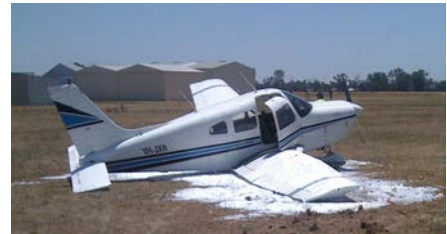
Figure 1: Landing gear assembly

An instructor on the ground watched the aircraft depart and observed an object trailing behind the aircraft. The instructor advised the student via the radio and instructed the student to return and perform a low-level pass so that they could ascertain what the object was. Following the low-level pass, the right main wheel and inner cylinder of the landing gear assembly were observed to have detached from the upper cylinder and to be hanging off the brake line (Figure 1). After a second low-level pass, it was observed that the wheel had completely detached.
