In-flight uncontained engine failure Airbus A380-842, VH-OQA

overhead Batam Island, Indonesia | 4 November 2010

ATSB Transport Safety Report
Aviation Occurrence Investigation
AO-2010-089
Final – 27 June 2013

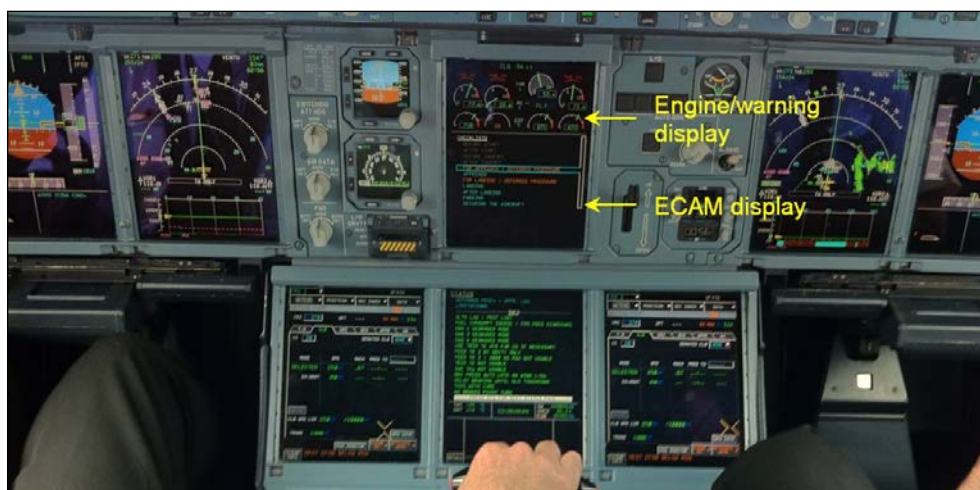
Figure 1: Engine/warning display

The engine/warning display indicated that the No. 2 engine had changed to a failed mode, No. 1 and 4 engines had reverted to a degraded mode⁵ and that No. 3 engine was operating in an alternate mode (Figure 1).

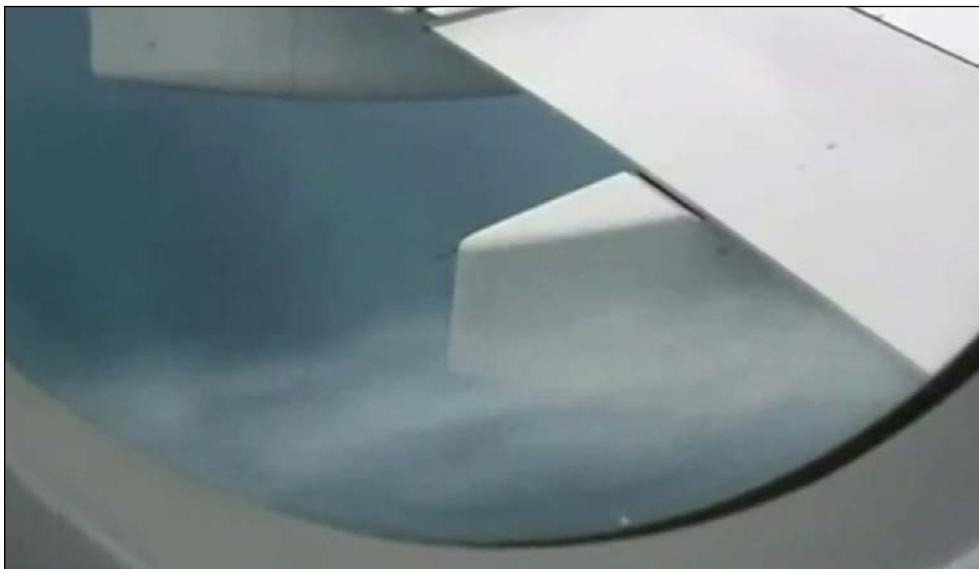
Figure 3: Fuel leaking from the left wing

The second officer proceeded to the main (lower) deck and observed damage to the left wing and fuel leaking from the wing. He recalled that the leak appeared to be coming from underneath the wing in the vicinity of the No. 2 engine, and that the trail was about 0.5 m wide (Figure 3). He reported that he could not see the turbine

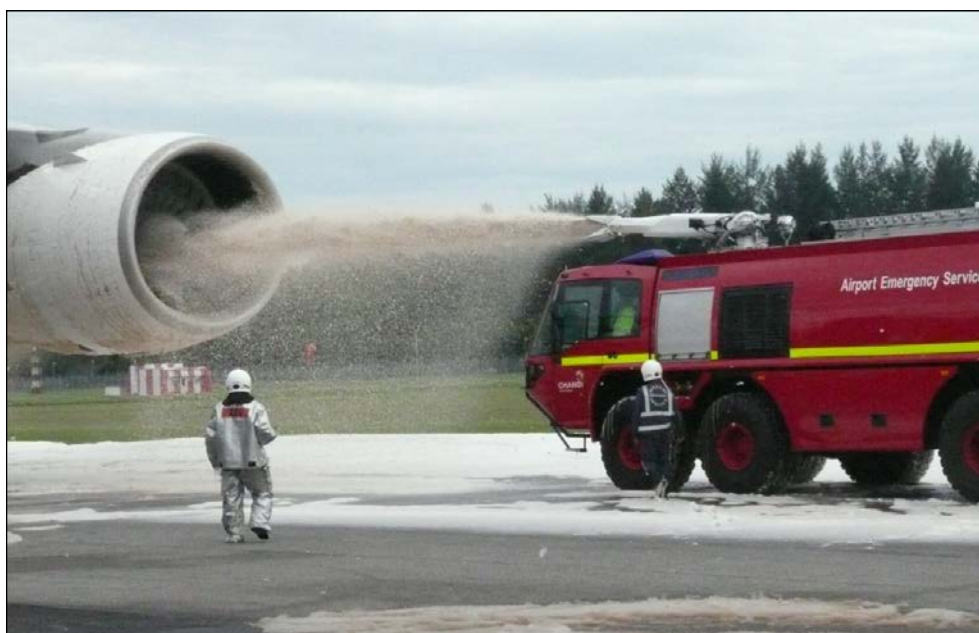
Figure 4: Fire-fighters 'drowning' the No. 1 engine with foam

Maintenance personnel also attended the aircraft and attempted a number of methods to shut down the engine, each without success. Finally, the decision was taken by the operator to 'drown' the engine, initially with water and then with fire fighting foam from the airport emergency services fire vehicles (Figure 4). The No. 1 engine was reported to have been shut down at 06:53:00, about 3 hours after the aircraft landed.

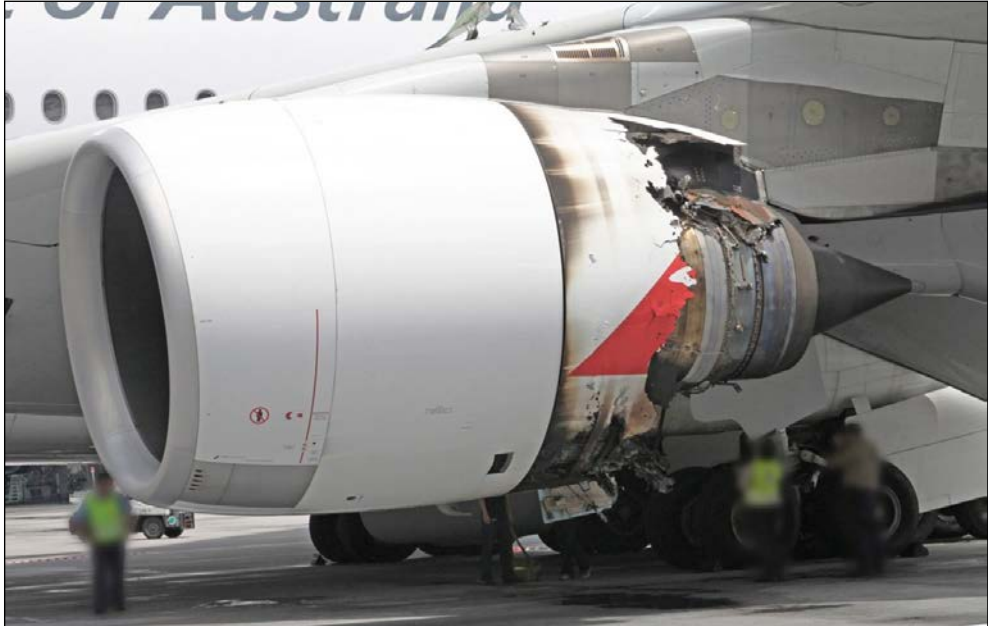
Figure 5: General damage to the No. 2 engine

There was damage to the cowling and thrust reversers towards the rear of the engine and sooting on the rear section of the cowl (Figure 5). There was extensive damage to the turbine region of the engine, detail of which is covered in Part 2 of this report.

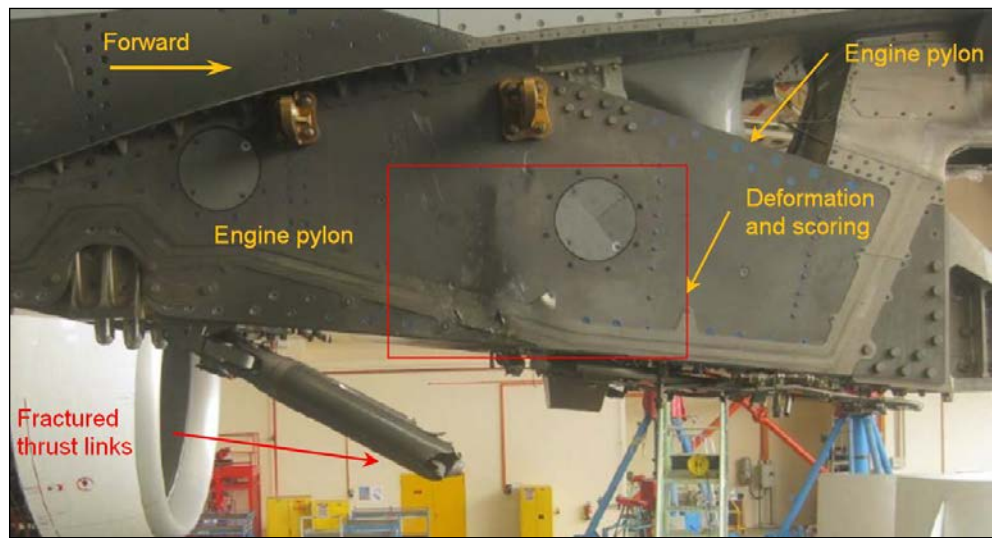
Figure 6: Damage to the No. 2 engine support structure

- No. 2 engine support structure (Figure 6)
- left wing upper and lower skins, front spar and internal ribs (Figure 7 and Figure 8)
- left wing-to-fuselage joint (indentation and scoring).

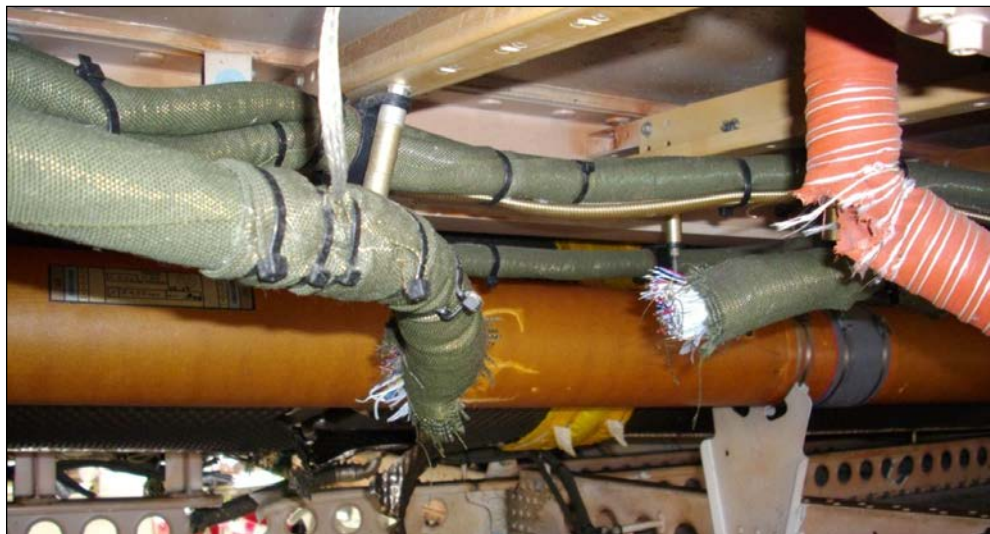
Figure 10: Damage to wiring in the belly fairing

The debris from the engine failure directly damaged a number of systems and a number of other systems were affected as a result. Although some systems sustained direct mechanical damage, most of the affected systems were damaged through debris impact to the respective wiring looms. Two main wiring looms were impacted by debris; one running through the leading edge of the left wing (Figure 9), and the other in the belly fairing (Figure 10). This amounted to damage to about 650 wires in total.

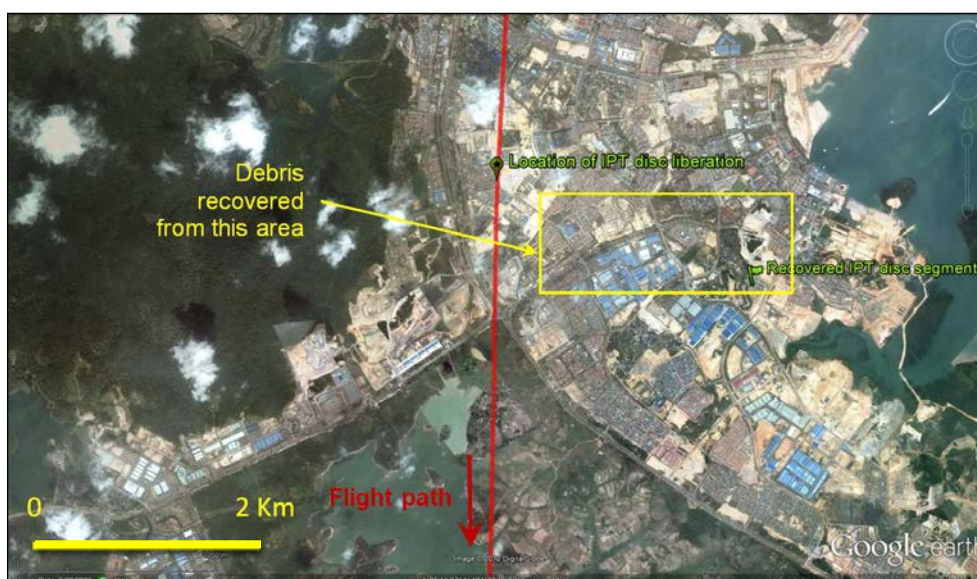
Figure 11: Debris distribution on Batam Island

A significant amount of debris from the aircraft fell over about 1.5 square km on Batam Island (Figure 11). A number of engine and other components were recovered from the island with the assistance of the local residents, Indonesian police, the National Transportation Safety Committee (NTSC) of Indonesia and the engine manufacturer.

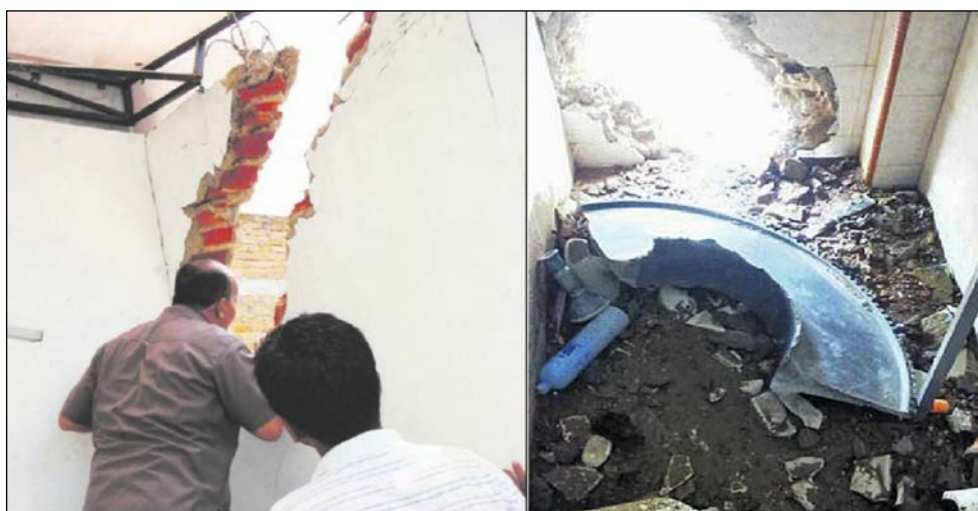
Figure 12: Property damage from a section of the No. 2 engine turbine disc

A section of the intermediate pressure turbine disc (about 40% of the disc) from the No. 2 engine was recovered from a property on Batam Island (Figure 12). Despite a search carried out over several days, no other significant fragments of the turbine disc were recovered. A number of other engine components were recovered, including sections of engine cowling and other components from the No. 2 engine.

Several buildings and other property were damaged by the debris.

The section of the IP turbine disc that was recovered from Batam Island, Indonesia (Figure 12) was examined in detail by the engine manufacturer under the supervision of the ATSB. This section of disc consisted of about 43% of the total disc and weighed about 70 kg. In addition, two radial fractures in the disc and a circumferential fracture in the drive arm were identified (Figure 38). The examination found that all of the fractures were consistent with an overstress of the material. There was no evidence of any pre-existing material defect or damage that contributed to the fractures.

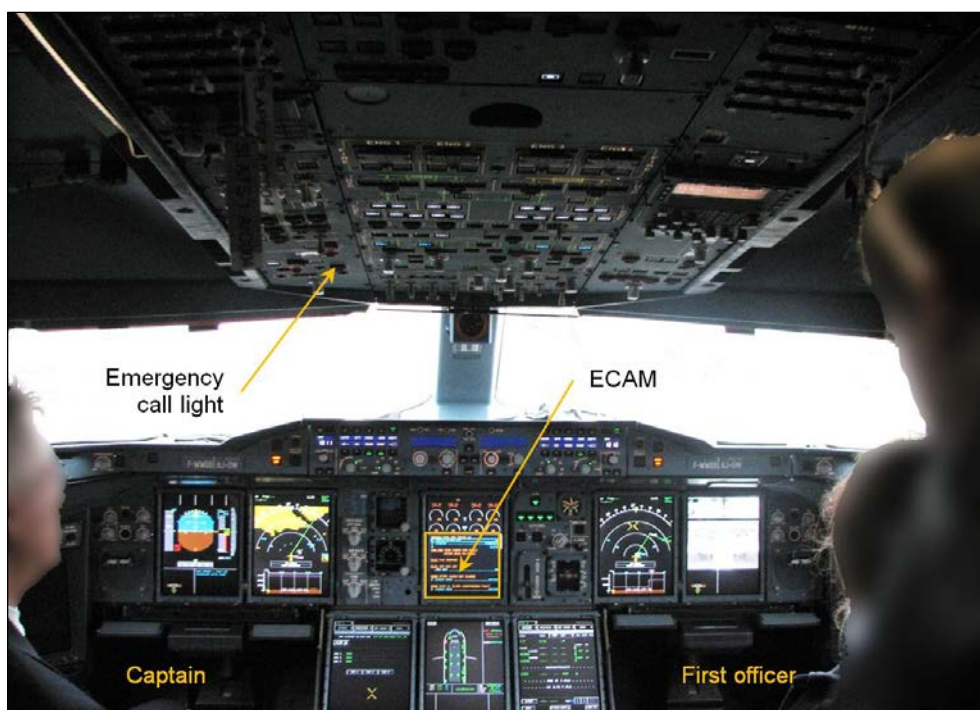
Figure 15: Location of the cabin emergency call light

A number of cabin crew reported that they attempted to contact the flight crew immediately after the engine failure using the cabin interphone system, but were unsuccessful. This included an attempt by the CSM to contact the flight crew via the EMERGENCY contact selection on the cabin interphone system. The emergency contact function illuminated a light on the cockpit overhead panel (Figure 15) and sounded the flight deck horn. The flight crew reported that they associated the emergency contact-activated flight deck horn with the ongoing warnings from the ECAM and so cancelled the horn without recognising its association with the cabin interphone system emergency contact function.

Given the crews' attention on the ECAM and the associated procedures, the location of the cabin emergency call light and the tone of the warning horn were not sufficient to obtain the flight crew's attention. Although this did not result in an unsafe situation, the lack of conspicuity of the cabin emergency call function delayed the transfer of potentially important information to the flight crew.

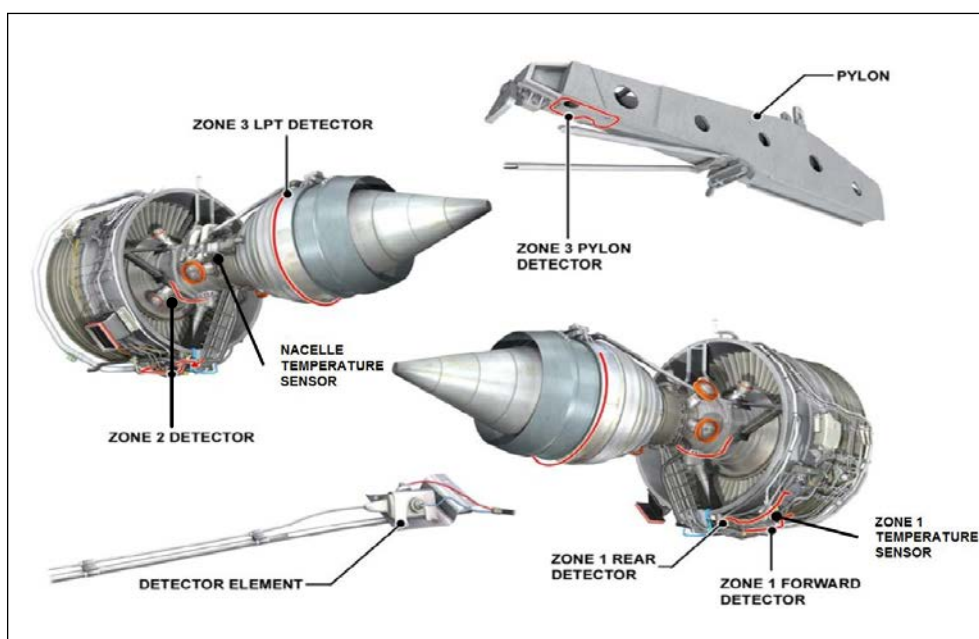
Figure 20: Fire detector layout

During the event, the power supply to No. 2 engine loop A was interrupted when the cable was cut by debris, resulting in a FAULT condition on all of the fire detectors in that loop. The recorded data showed that faults were also detected in loop B of the Zone 2 and 3 detectors. This meant that the only remaining operable engine fire detectors were in zone 1 (the fan casing).

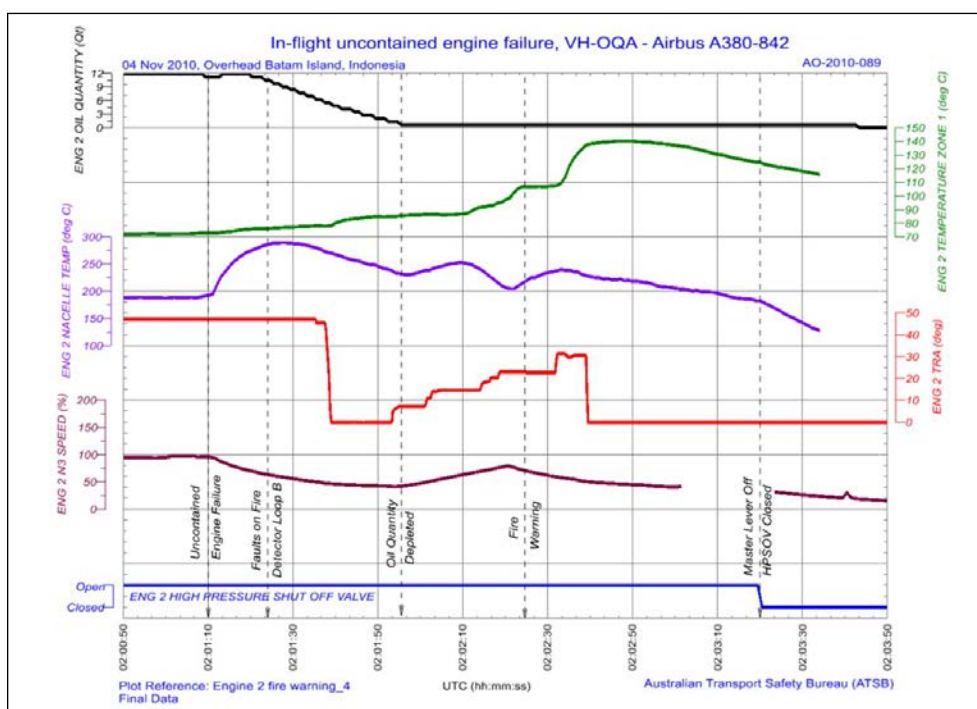
Figure 21: Engine fire – key data

The recorded data showed that at 02:01:52 the No. 2 engine thrust lever was advanced (Figure 21). There were increases in the zone 1 temperature that followed further thrust lever inputs, suggesting a correlation. That apparent correlation became more significant at higher thrust lever settings. When the thrust lever was returned to idle at 02:02:39 the temperature in that zone stabilised.

At 02:02:25 a fire warning was displayed for 2 seconds before being reset. Figure 21 shows that around this time the temperature in zone 1 had increased to about 107 °C and shortly after rapidly increased further, reaching a maximum of about 140 °C before slowly decreasing.

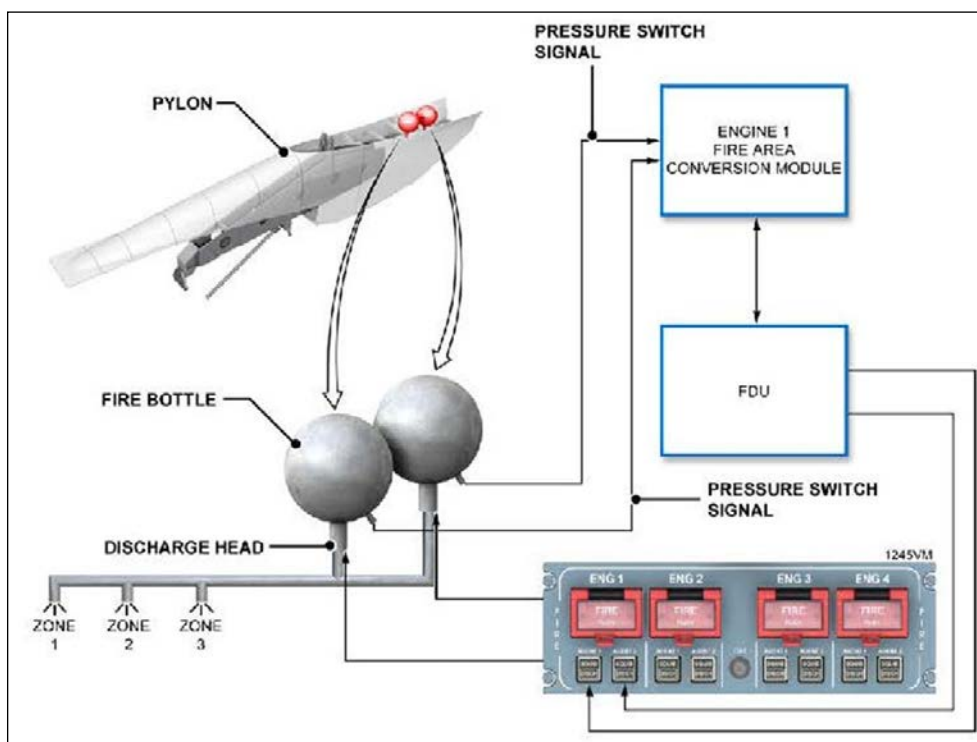
Figure 22: Fire suppression system for engine No. 1 (similar system for engines No. 2, 3 and 4)

The engine fire suppression system consisted of two fire extinguishing bottles for each engine, a control subsystem and a distribution subsystem (Figure 22). A post-flight inspection of the aircraft revealed that one of the No. 2 engine's fire bottles had discharged.

The aircraft manufacturer determined that the damage to the wiring from the uncontained engine failure had prevented the discharge of the second bottle and the provision to the flight crew of an indication of the status of the bottles. This prevented an accurate determination of when the crew attempted to activate the fire suppression system.

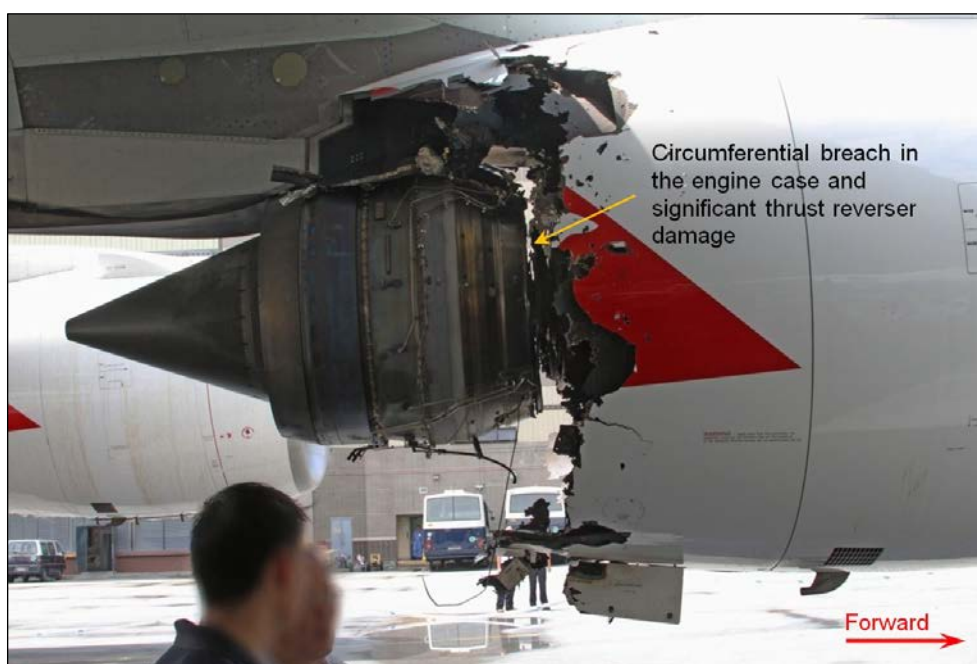
Figure 32: General damage to the engine (looking outboard)

The primary damage to the engine occurred in the region of the IP turbine. An initial ‘on-wing’ visual examination of the engine identified that the entire circumference of the case around the IP turbine was breached and that the IP turbine disc was missing (Figure 32). The thrust reverser cowl and cold airstream⁶¹ duct fairings sustained significant damage and the section of the thrust reverser cowl and cold airstream fairings to the rear of the primary damage had separated from the engine.

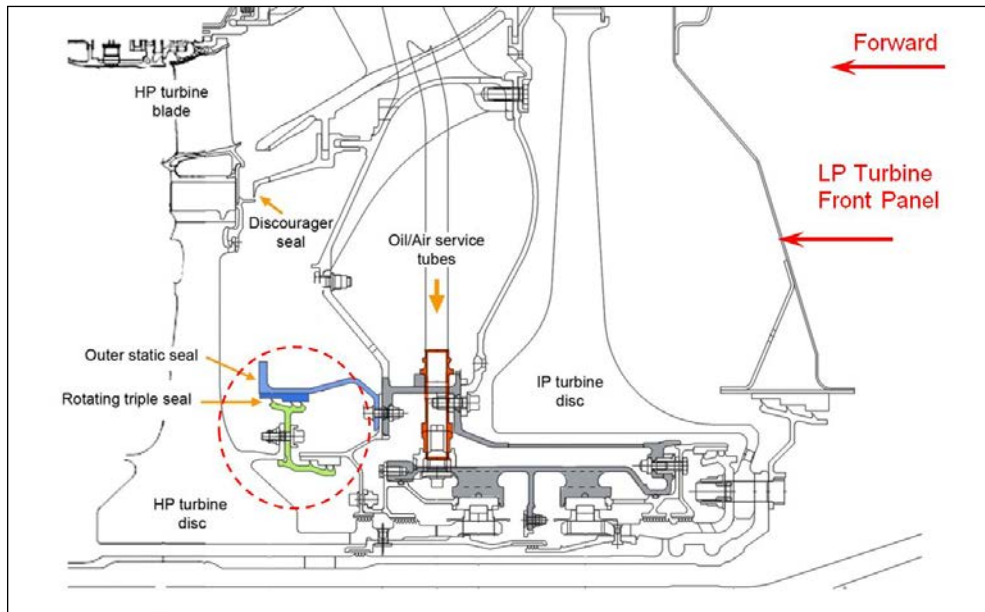
Figure 34: Location of the HP turbine triple seal

Damage was also identified between the HP/IP bearing support structure and the HP turbine. This included scoring of the HP turbine disc and significant damage to the triple seal. The rotating and static portions of the HP turbine triple seal had separated from their support structures (Figure 34), fractured and then entwined within each other (Figure 35). There was a rough, grey deposit on the surfaces within module 05 near the HP turbine shaft that was identified as melted and resolidified metal.

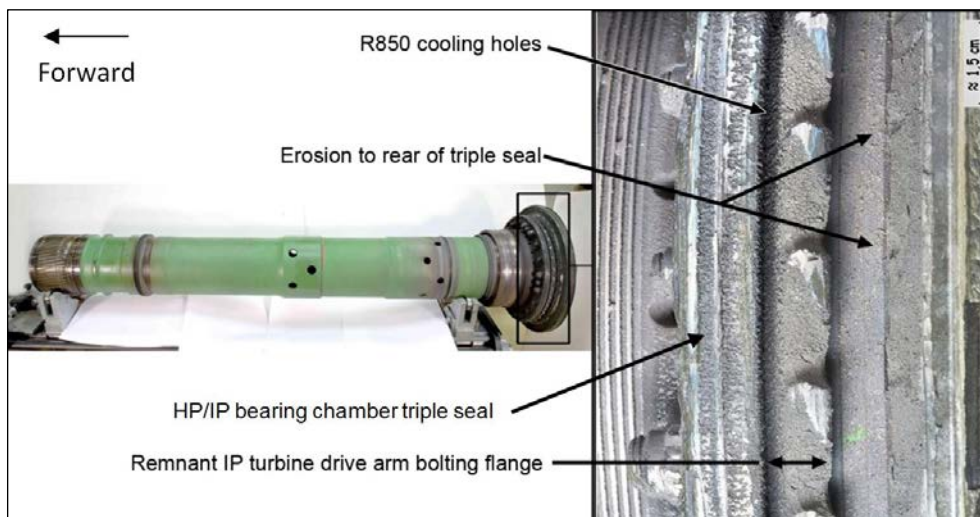
Figure 36: Damage to IP drive shaft

Examination of the IP shaft found that a remnant of the IP turbine drive arm bolting flange was still attached to the drive shaft (Figure 36). The IP turbine drive arm had separated from the bolting flange at the R850 cooling holes. There was a significant amount of heat damage and erosion in and around these cooling holes and the surfaces were coated in rough melted/resolidified material. Although much of the surface was damaged by metal-to-metal contact, sections of the original fracture surface were examined and found to be consistent with tensile and shear overstress.

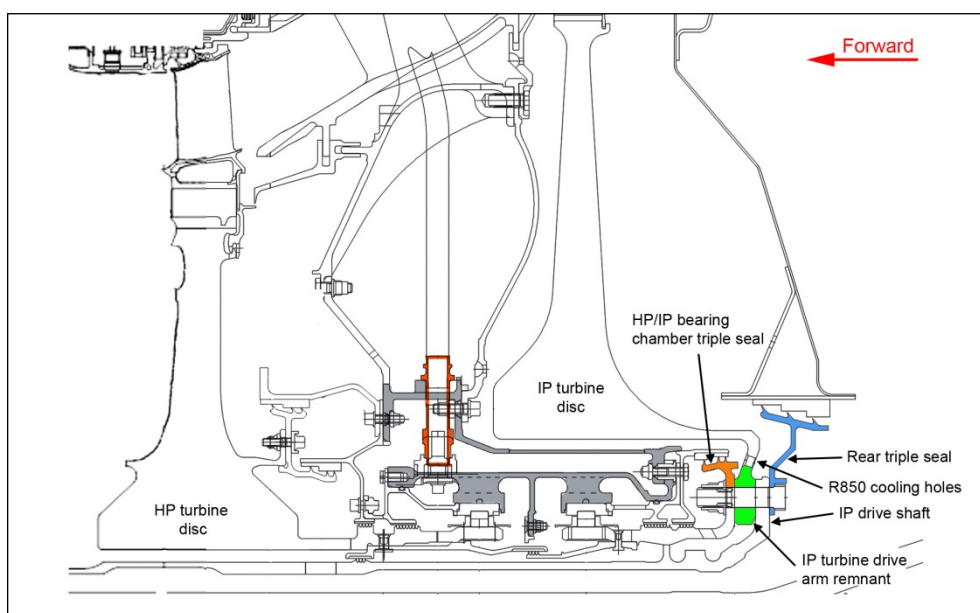
Figure 37: Location of the triple seals

The HP/IP bearing chamber triple seal and the rear rotating triple seal between the IP and LP turbines showed a significant amount of erosion and heat damage (Figure 37). The flange of the rear rotating triple seal also contained erosion pits immediately behind each of the R850 cooling holes.

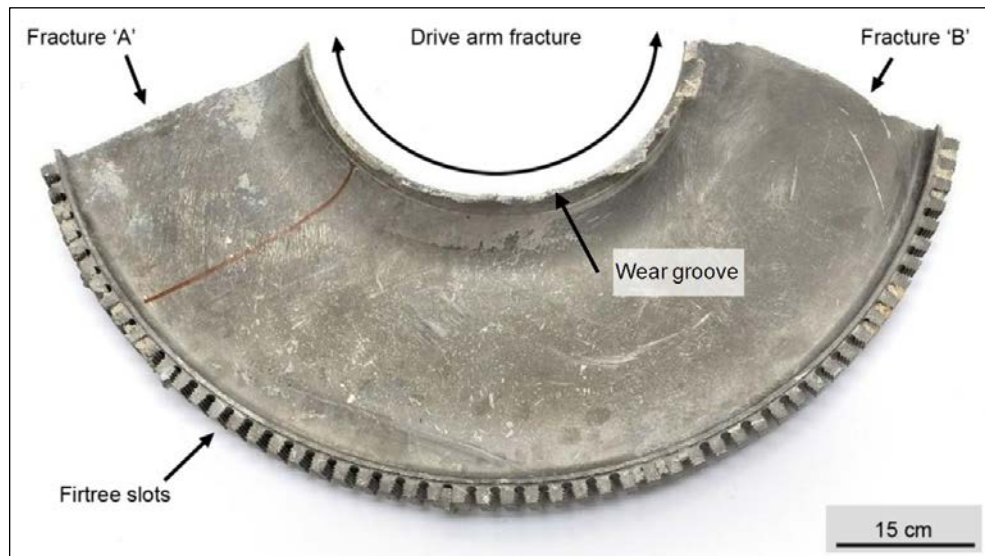
Figure 38: Recovered section of IP turbine disc – looking forward (radial fractures labelled ‘A’ and ‘B’)

The rear face of the disc contained a circumferential wear groove in the radius where the disc transitions to the drive arm. This wear groove was consistent in size and location with the forward flange on the LP turbine front panel.

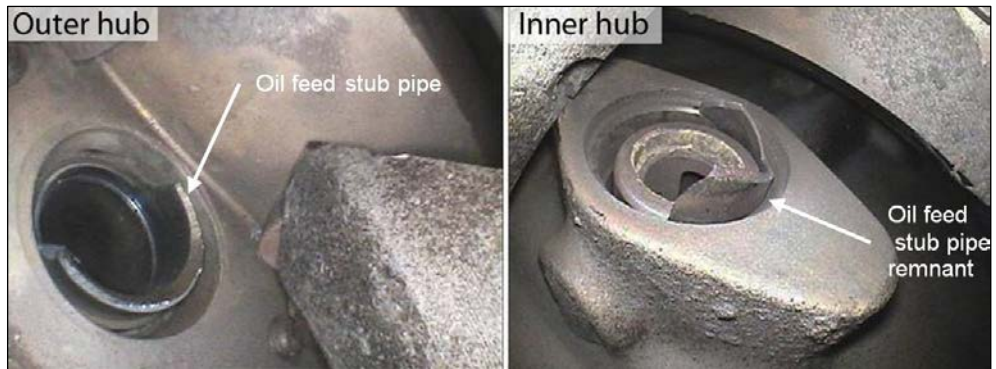
Figure 41: Inner and outer HP/IP bearing hubs at the oil feed pipe location

The oil feed stub pipe had detached and displaced outwards about 30 mm from the inner hub. A remnant of the oil feed stub pipe remained in the inner hub (Figure 41).

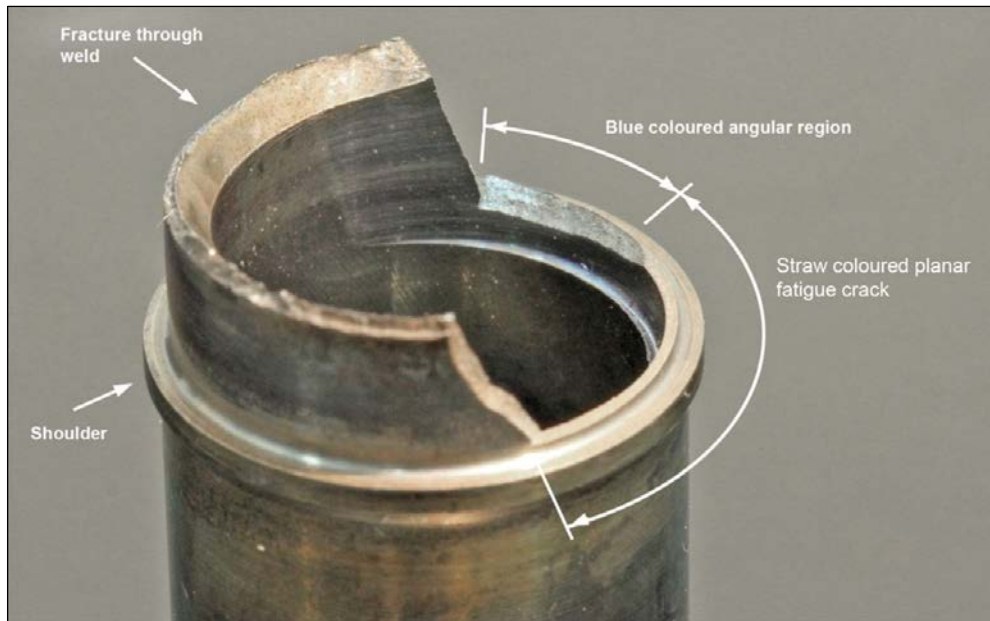
Figure 43: Oil feed stub pipe fracture

The oil feed stub pipe was fractured in two planes, one around the weld that attaches the pipe to the inner hub, and the other further outboard, close to the shoulder where the pipe presses into the inner hub. Three distinct fracture regions were identified on the oil feed stub pipe:

- one through the stub pipe-to-hub weld
- a straw coloured planar region
- a blue coloured angular region (Figure 43).

Detailed laboratory examination of the fracture regions found that the majority of the cracking, including the blue coloured region, was typical of an overstress fracture. The planar region covered an arc of about 90° of the oil feed stub pipe and was identified to be a pre-existing fatigue crack. The origin of this crack could not be precisely determined, however, the general shape of the crack indicated its origin on the outer surface of the pipe before growing inwards.

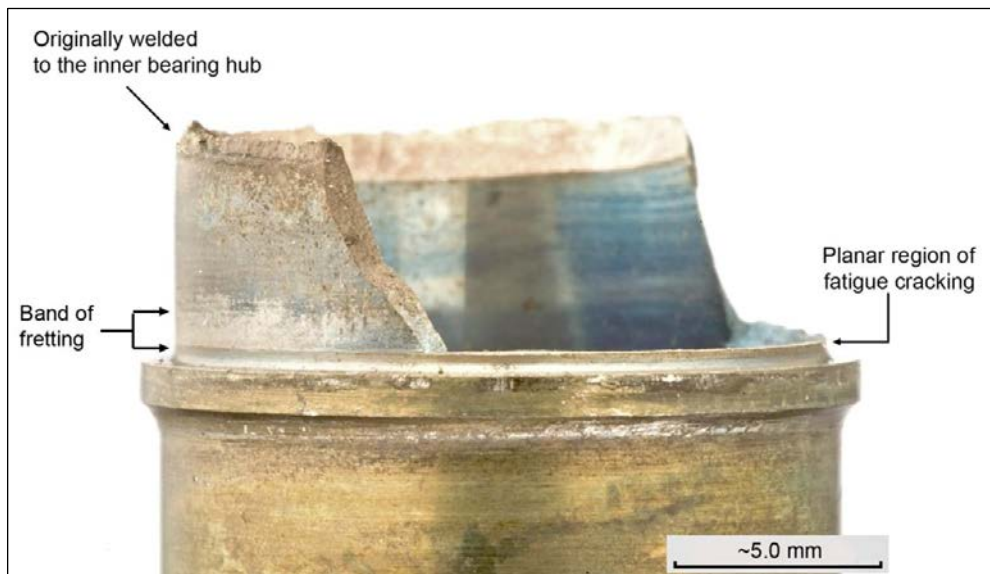
Figure 44: Oil feed stub pipe fretting

A band of fretting was identified on the outer diameter of the stub pipe at a position coincident with the fatigue cracking (Figure 44). The fretting was along the area that formed an interference fit with the inner bearing hub, indicating relative movement between the stub pipe and the inner hub interference bore. The engine manufacturer reported observing similar fretting bands on some of the engine's other HP/IP stub pipes.

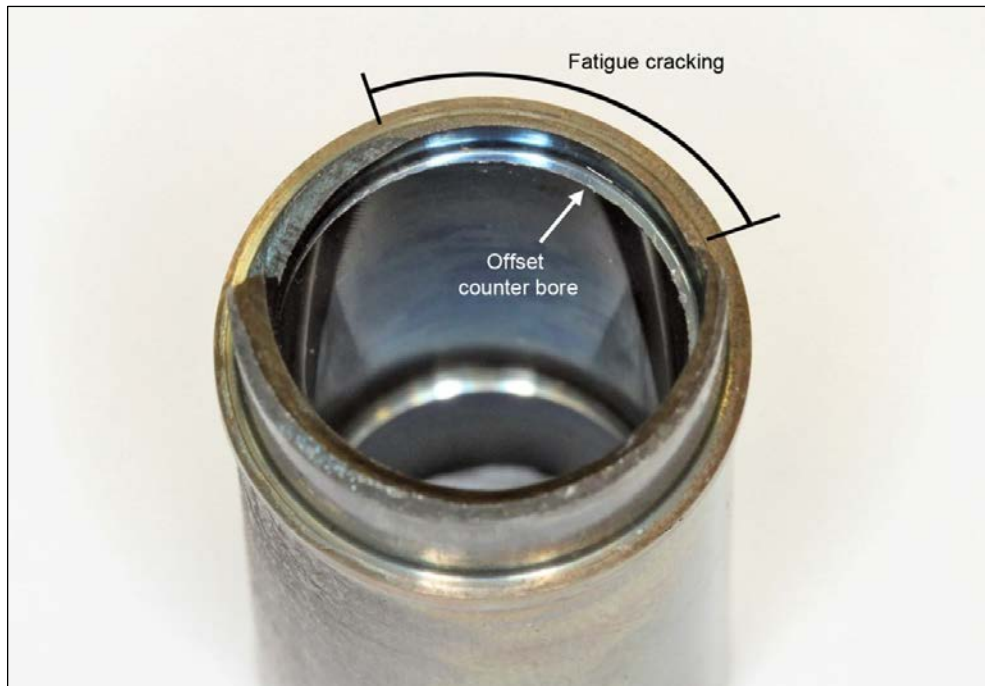
Figure 46: Offset oil feed stub pipe counter bore

The fatigue crack coincided with the thinnest wall section and it was apparent that the counter bore⁶² used during manufacture to enlarge the inner diameter of the oil feed stub pipe to accept the oil filter was offset from the centre of the pipe (Figure 46). The manufacturer's counter boring operation was a two-stage process that initially involved drilling into the pipe end. The pipe end was then reamed⁶³ to a shallower depth than the drilled hole to form a close-tolerance fit for the filter body.⁶⁴ The drilled and reamed sections of the counter bore were misaligned with respect to the centreline of the pipe and each other (Figure 47).

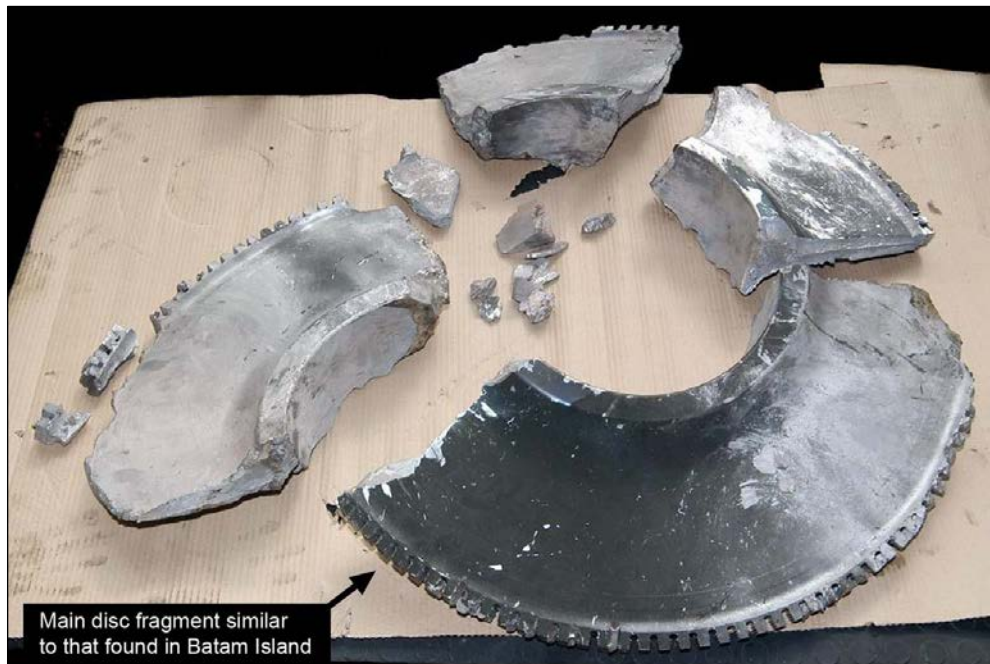
Figure 48: Trent 900 IP turbine disc after overspeed burst test

test IP disc burst into four main fragments, the largest of which was similar in size to the one found on Batam Island from the No.2 engine in VH-OQA (Figure 48).

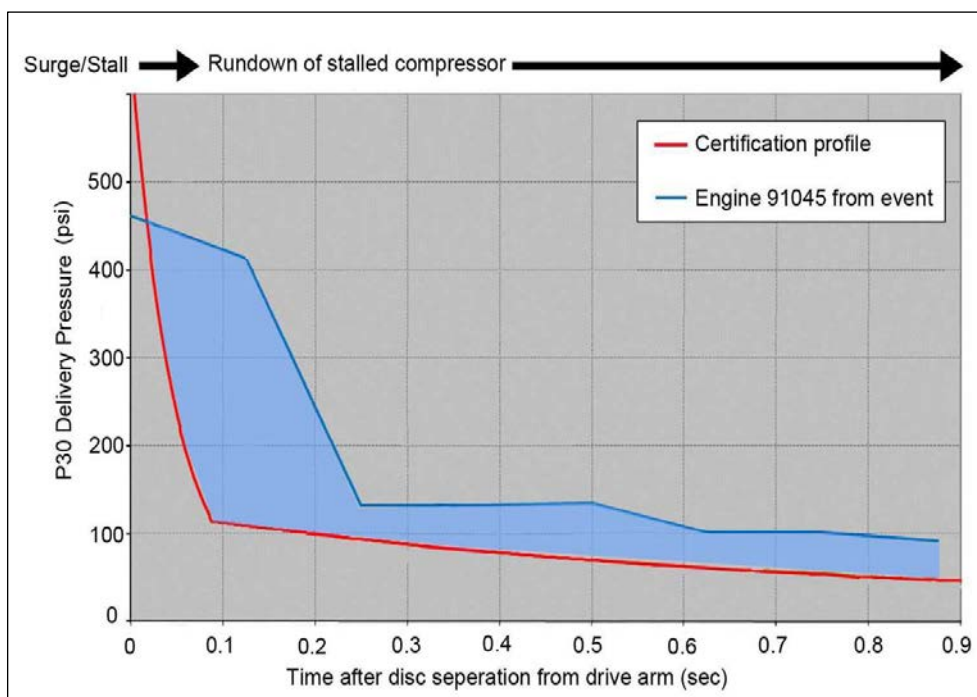
Figure 49: Post-surge engine behaviour – a comparison of the HP compressor pressure at certification and in ESN 91045

The recorded data from the uncontained failure of ESN 91045 identified an engine behaviour that differed from that predicted following a drive shaft failure. The data showed that when the drive arm failed at the R850 holes, the engine surged as expected. However, the air pressure in the engine did not decay to the level predicted from the manufacturer's modelling. A comparison between the expected 'certification' P30 delivery pressure profile and that recorded during the uncontained failure in ESN 91045 is presented in Figure 49.

The engine manufacturer determined that the higher than expected pressure recorded during the failure was due to a partial recovery of the HP compressor. That recovery was unexpected, and according to the engine manufacturer had not been previously observed. The additional pressure provided by the HP system following the surge (indicated by the blue shaded area in Figure 49), accelerated the now unloaded IP turbine beyond the predicted terminal and burst speeds.

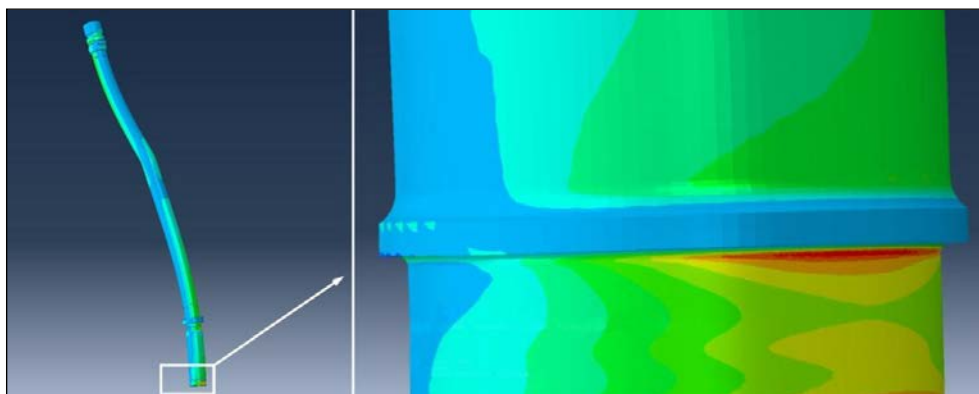
Figure 50: Oil feed stub pipe stress distribution

The stress analysis identified that the peak stress in the oil feed stub pipe occurred on the outer surface of the pipe, between the shoulder and the interference fit in the inner hub. That peak stress was highly localised, and was significantly greater than the other stresses in the pipe (Figure 50). The location of the peak stress corresponded with the location of the fatigue crack in the oil feed stub pipe in the occurrence engine.

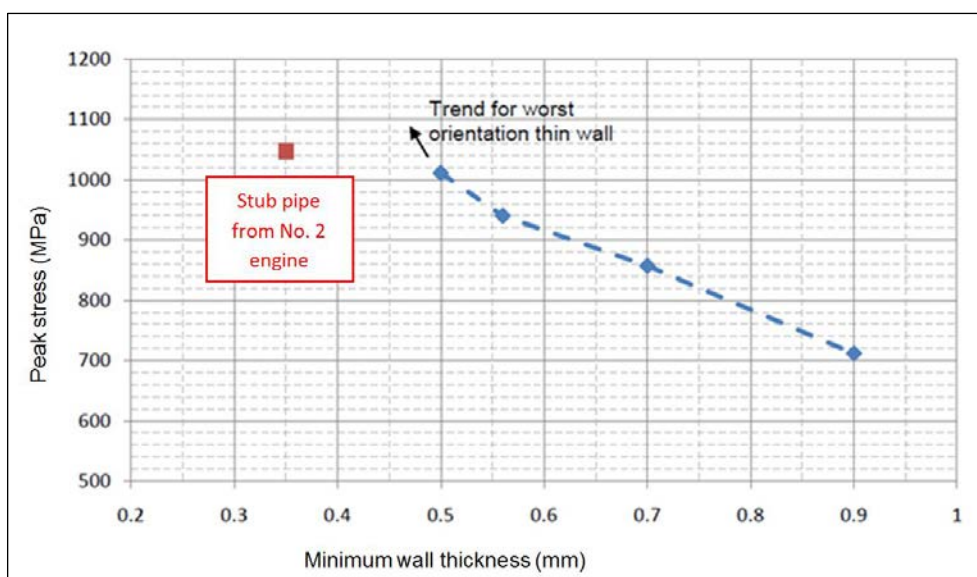
Figure 51: Effect of wall thickness on peak stress

To assess the potential for similar fatigue cracking on the remainder of the Trent 900 engine fleet, the manufacturer analysed a number of other misaligned counter bore scenarios. The movement of the hub was directed along the length of the engine and moved rearward as thrust increased. This would generate bending stresses that would be greatest if the minimum wall thickness was towards the rear of the engine. Thus, in order to be conservative, the manufacturer's modelling was based on the minimum wall thickness being located in that position. The minimum wall thicknesses assessed were 0.50, 0.56, 0.70 and 0.91 mm. The resulting stress distributions reflected that shown in Figure 50. The peak stresses recorded below the shoulder in the manufacturer's testing are presented in Table 8 and Figure 51.

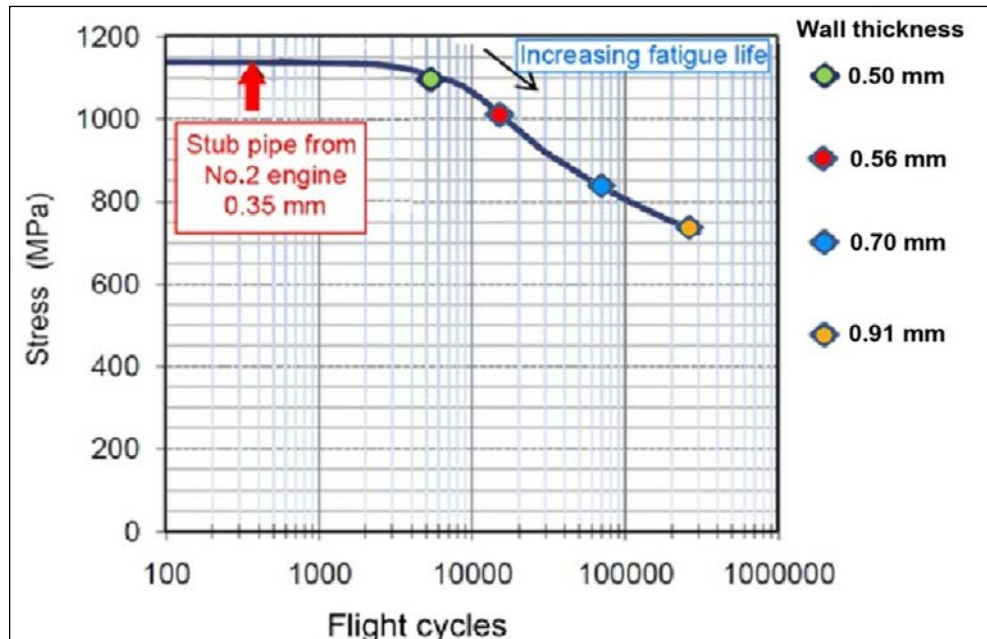
Figure 52: Calculated fatigue lives

A detailed vibration survey was also carried out by the manufacturer and it was determined that the number of engine cycles (low-cycle fatigue) was the primary contributor to the fatigue in the oil feed stub pipe, rather than the effects of a high frequency vibration (high-cycle fatigue). Based on these findings, the manufacturer carried out a fatigue life analysis of the oil feed stub pipe. This analysis conservatively assumed that the engine developed full thrust for each of its operating cycles, effectively representing a worst case scenario in an engine's life.⁷³ The resulting worst case fatigue lives are presented in Table 9 and Figure 52, along with ESN 91045's actual life of 677 cycles at the time of the uncontained failure.

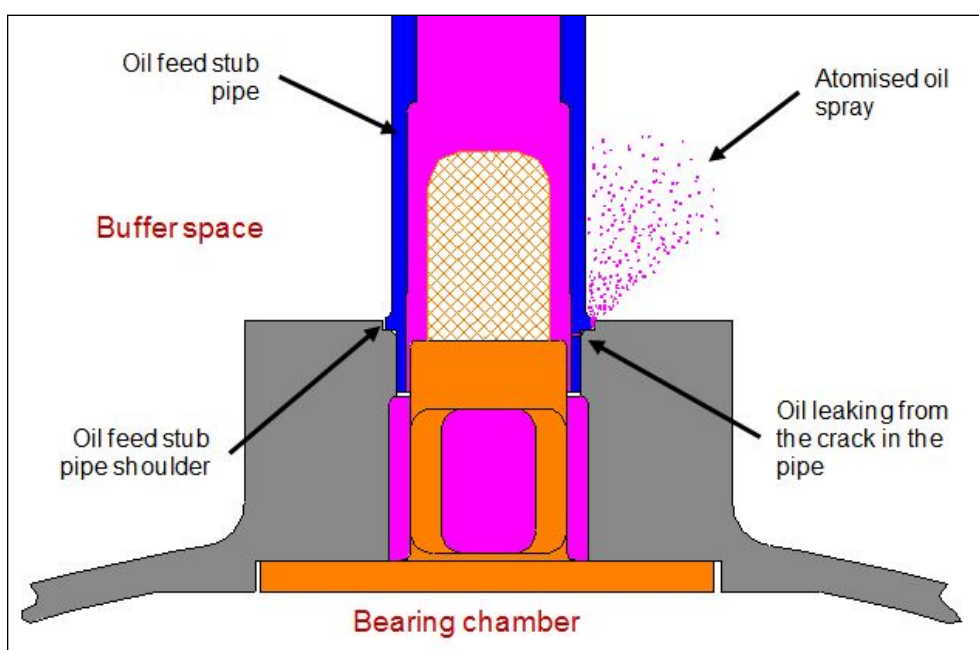
Figure 57: Oil leak into the buffer space

As described in Part 2 of this report, a fatigue crack initiated and grew in the HP/IP oil feed stub pipe below the shoulder where it fits into the HP/IP bearing chamber inner hub. It was not determined when the crack started; however, during the occurrence flight the crack grew to a size that allowed oil to leak out of the pipe and into the buffer space. The leak was at a low rate but at a pressure that likely resulted in an atomised oil spray (Figure 57).⁷⁷

The temperature in the buffer space was reported by the manufacturer to be in the range of 365 to 375 °C. The synthetic oils used in the engine had auto-ignition temperatures as low as 280 °C. A comparison of these temperatures indicates the potential for auto-ignition and, given that there were no other ignition sources identified, it was likely the leaking oil auto-ignited when it atomised on entry into the buffer space.

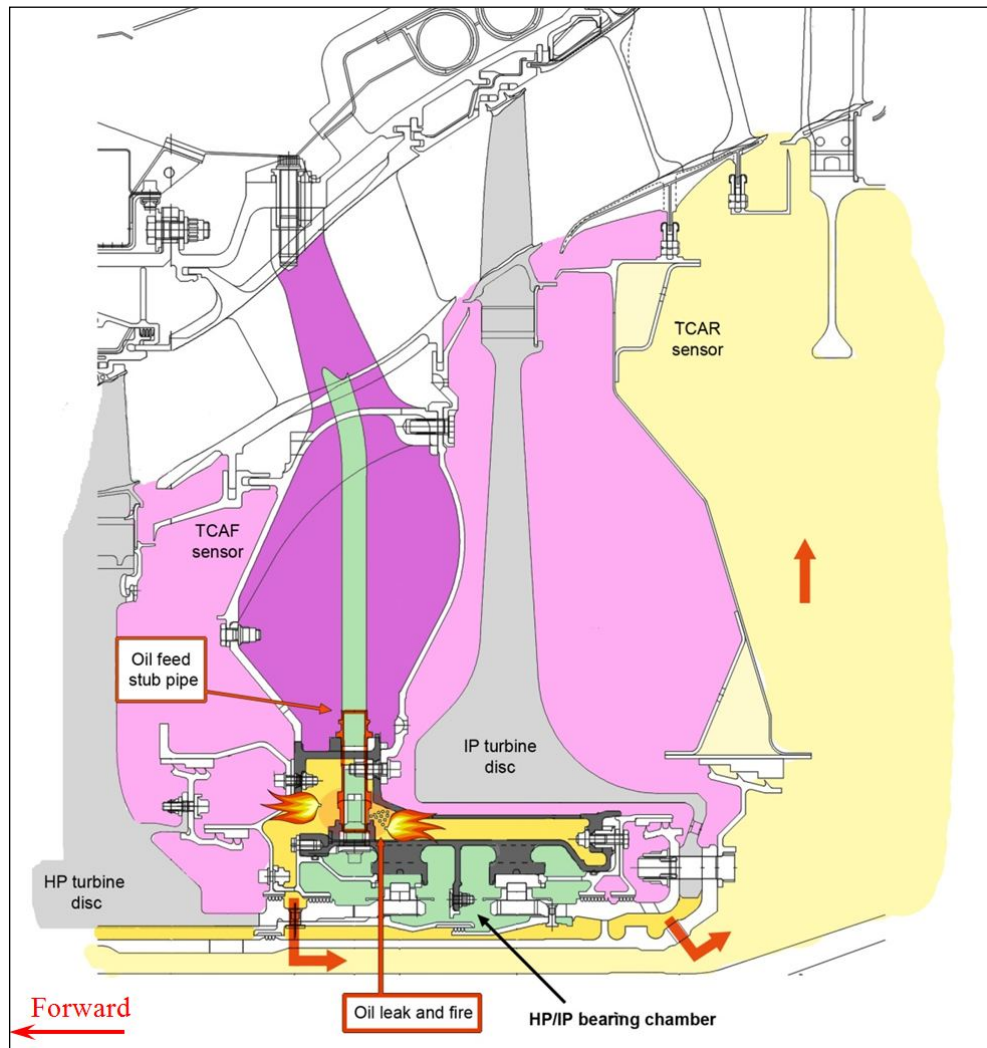
Figure 58: Oil leakage and fire

The direction of the airflow was from the buffer space, along the IP drive shaft and into the low pressure (LP) turbine cavity (represented as red arrows in Figure 58), where the TCAR sensor was located. That airflow directed a portion of the fire forward from the leaking oil pipe and onto the front of the HP/IP buffer space.

Given that the air temperature, as measured by the TCAR sensor, started to increase at about 02:00:07, 60 seconds before the engine failure, it is likely that the fire started shortly before that time.

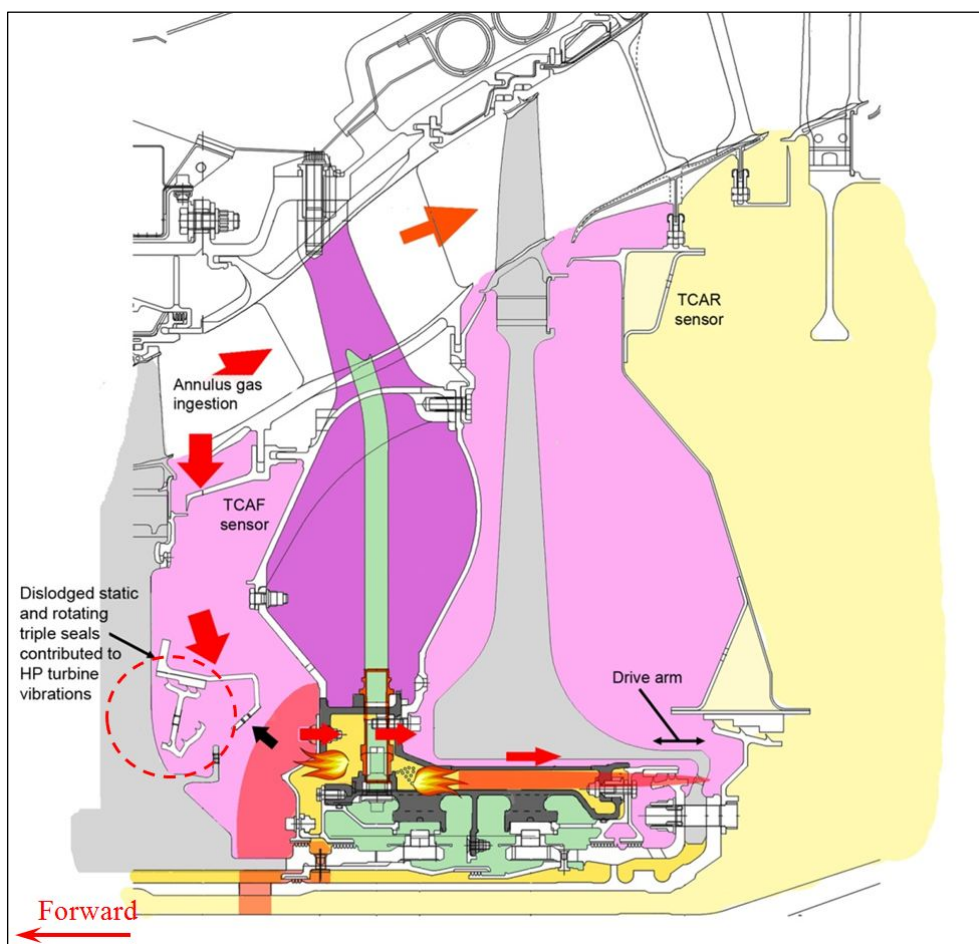
Figure 59: HP turbine triple seal failure

when the triple seal separated from the structure and the static and rotating portions became entwined, scoring the rear face of the HP turbine disc (Figure 59).

The design of the engine was such that the pressure within the buffer space and behind the IP turbine was lower than the hot (annulus gas) airstream exiting the HP turbine. This meant that when the triple seals were breached, those hot gases were drawn into the space behind the HP turbine disc, where the TCAF sensor was located (Figure 59).
