In-flight uncontained engine failure Airbus A380-842, VH-OQA

overhead Batam Island, Indonesia | 4 November 2010

ATSB Transport Safety Report
Aviation Occurrence Investigation
AO-2010-089
Final – 27 June 2013

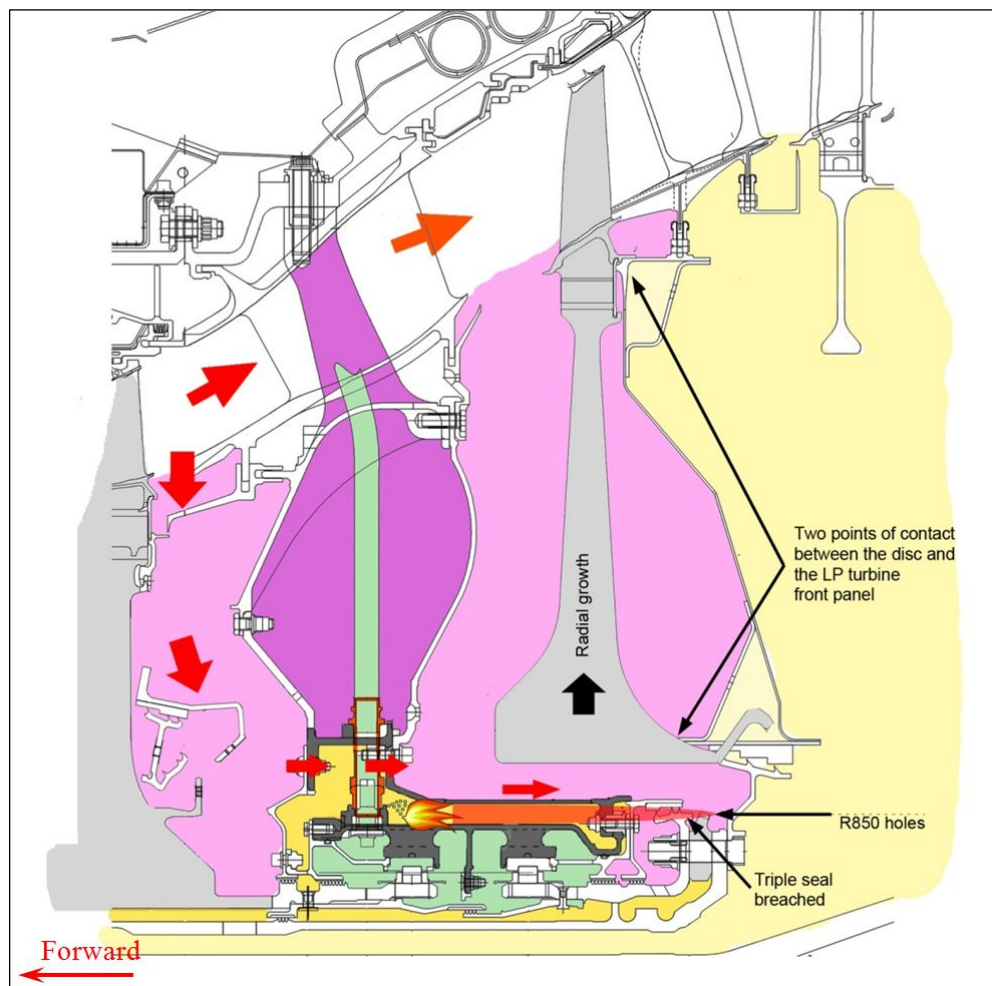
Figure 60: Drive arm heating and disc separation from the drive shaft

The IP turbine drive arm rapidly heated in the area of the R850 holes, reducing the strength of the material. The flame also eroded areas of the drive arm around the holes, further reducing its strength and, at 02:01:07 the drive arm failed in overstress, separating the IP turbine from the IP drive shaft. As a result of the air pressure loads across the turbine, the unrestrained turbine moved rearwards and contacted the LP turbine front panel (Figure 60).

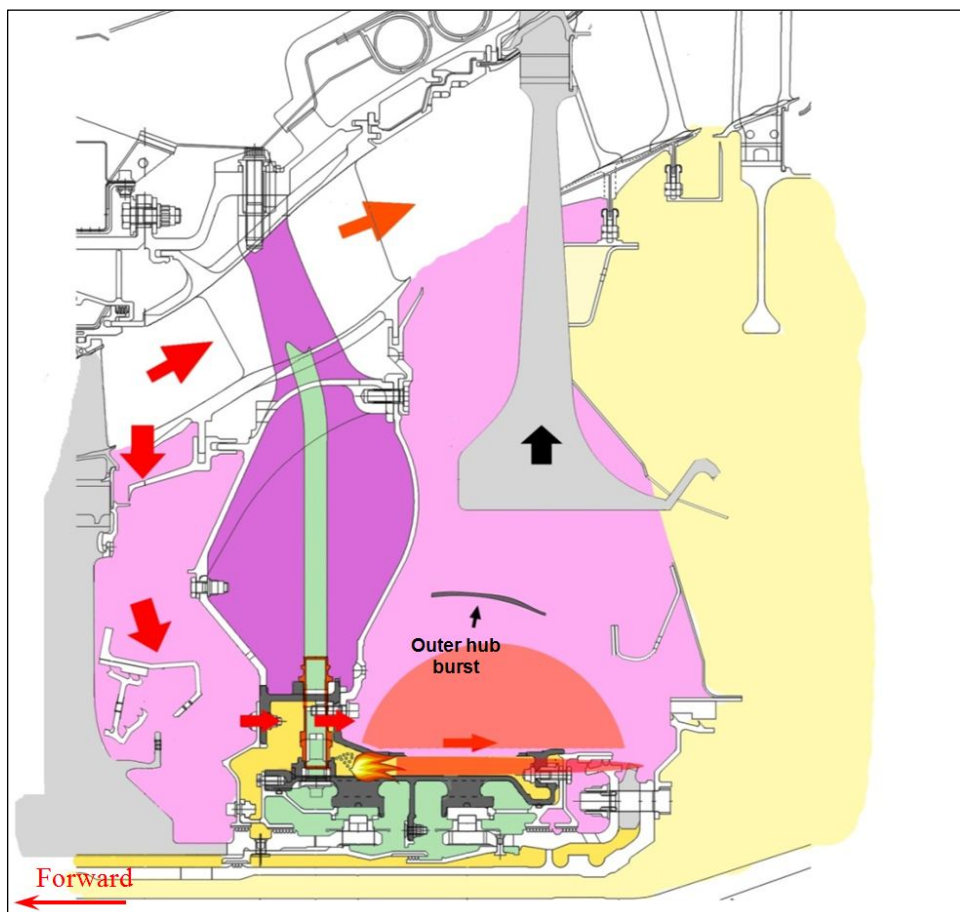
Figure 61: Unrestrained IP turbine disc acceleration and burst

Although the pressure in the engine rapidly decreased, there was still sufficient air flow to accelerate the unrestrained IP turbine disc. With the partial recovery of the HP system, the pressure of the air passing through the IP turbine was greater than expected. The friction between the disc and the LP front panel, and the loss in efficiency from the IP turbine blades as the disc moved rearwards out of the normal airflow, was insufficient to prevent the disc from accelerating past its maximum design rotational speed. As the rotational speed increased, the stresses within the IP disc increased, it expanded radially and at 02:01:11, 4 seconds after its separation from the drive arm, the disc material failed in overstress and the disc burst (Figure 61).

When the turbine case was breached the pressure within the IP disc space dropped to atmospheric pressure. That drop in pressure likely resulted in the heat-weakened HP/IP bearing chamber outer hub bursting (Figure 40 and Figure 61).

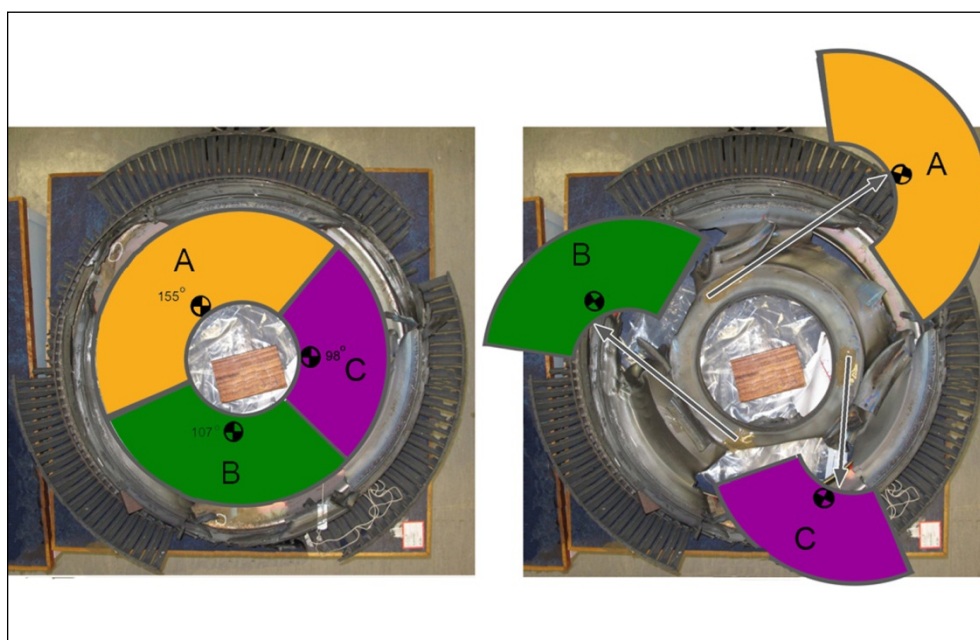
Figure 62: Initial disc segment trajectories, looking rearward

The disc fractured into three primary segments that were projected outwards with a force sufficient to breach the engine casing and damage the aircraft. The damage to the LP turbine front panel and LP turbine blades indicated that these segments were initially projected outwards in different directions (Figure 62).

Note: Segment A was recovered from Batam Island. Segments B and C were not recovered. The size of segments B and C were estimated from turbine blade fragments that were recovered from the aircraft, Batam Island and from the damage to the LP front panel.

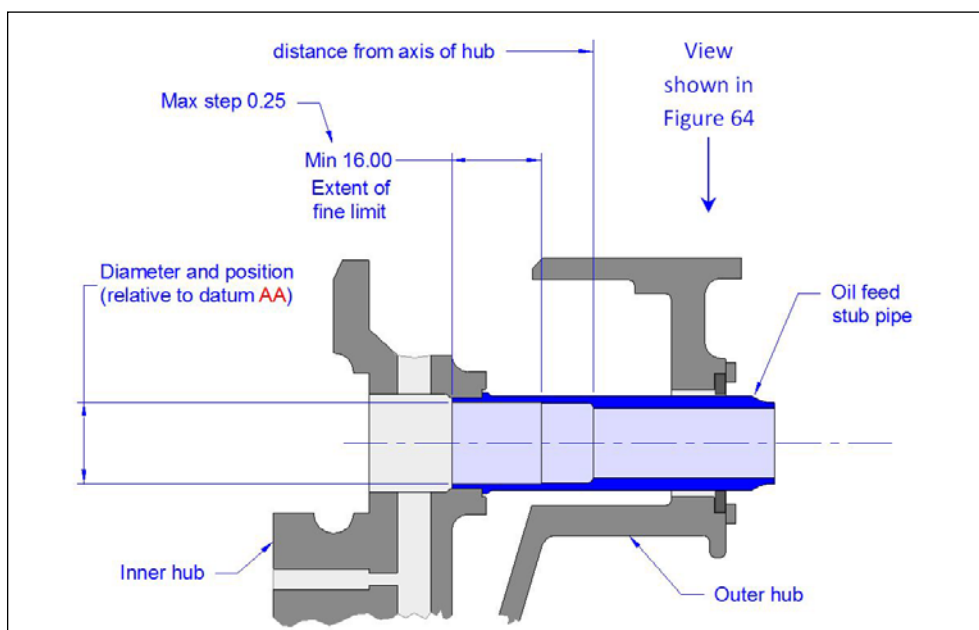
Figure 66: Representation of the design definition drawing that defined the oil feed stub pipe counter bore

The ATSB determined that the nominal wall thickness of the oil feed stub pipe within the counter bore was 0.91 mm. Using the 'worst case' tolerance combination of the interference bore at its smallest size, the oil feed pipe counter bore at its maximum size and the positional tolerances at their extreme values in opposite directions, the minimum permissible wall thickness was calculated to be 0.82 mm.

Note: the above view is from the side of that shown in Figure 64, consistent with how it was depicted on the design definition drawings.

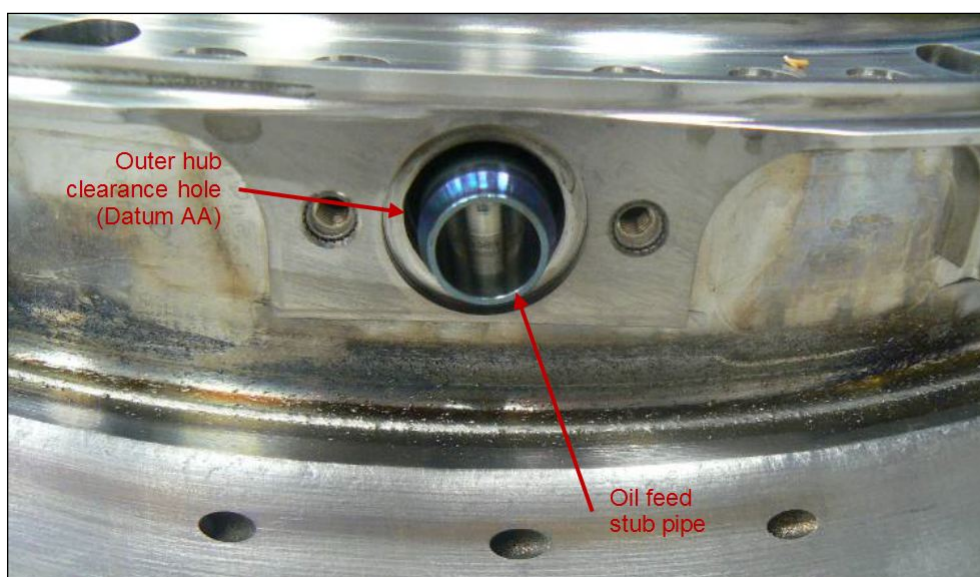
Figure 67: Inaccessibility of Datum AA with the oil feed stub pipe installed

Following the manufacturing acceptance of the design definition and during the preparation of the manufacturing specification and instructions, the MEs identified that the oil feed stub pipe needed to be fitted and welded in place before the oil feed stub pipe counter bore could be machined. Because the pipe was in place, the inner surface of the clearance hole in the outer hub was not accessible to the machining or inspection probes. As a result, datum AA could not be used as a reference for further machining operations (Figure 67).

There was no indication that the design or manufacturing personnel identified, either before or during the manufacturing acceptance of the design definition drawings, that datum AA would be inaccessible following fitment of the oil feed stub pipe into the hub assembly.

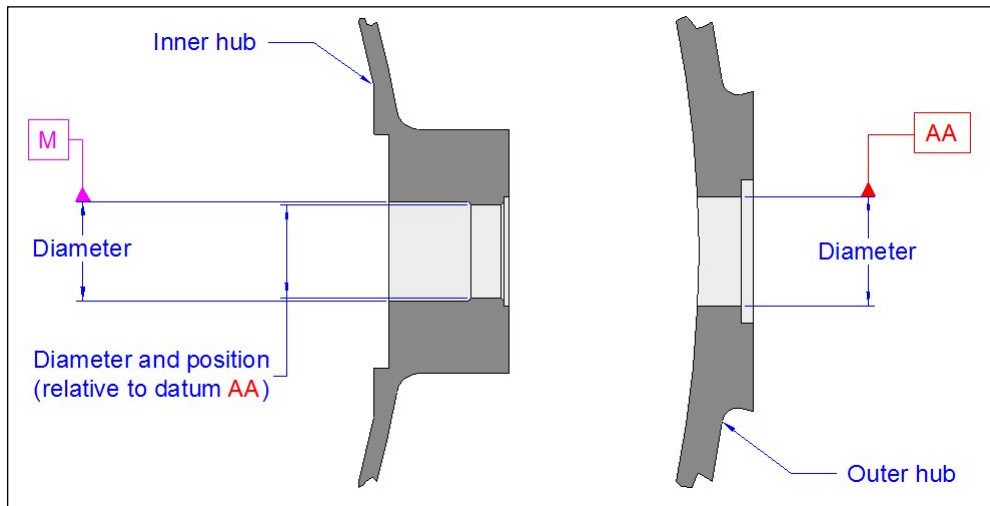
Figure 68: Representation of the manufacturing stage drawing that identified datum M

Because no positional tolerance was specified for the inner hub counter bore, datum M was not geometrically constrained. The result was that, according to the manufacturing stage drawings, there was no positive geometric connection between datum M and the interference bore.

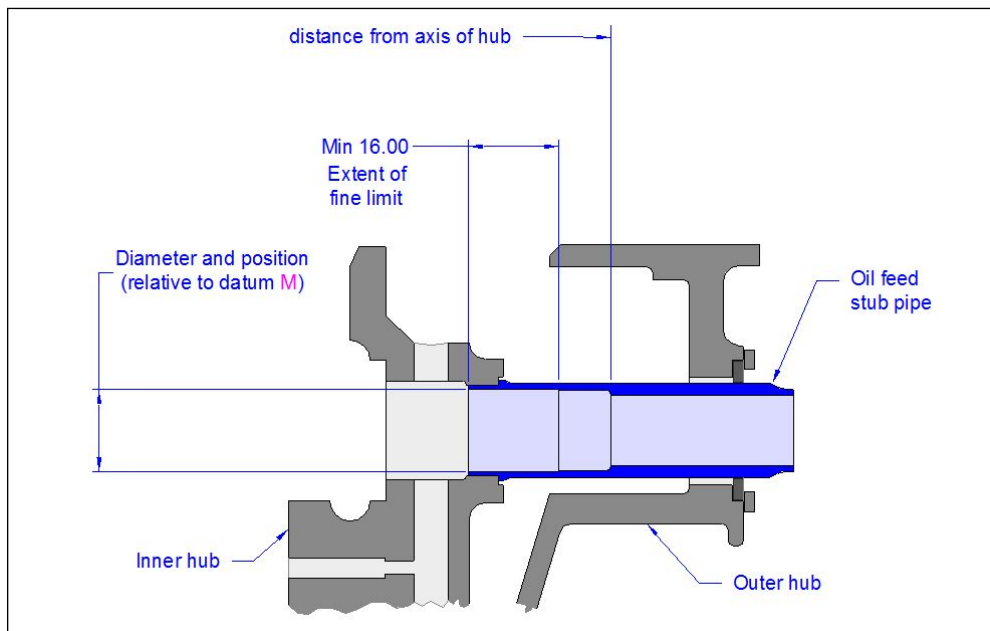
Figure 69: Representation of the manufacturing stage drawing that defined the oil feed stub pipe counter bore

The oil feed stub pipe counter bore detail on the manufacturing stage drawing differed from the design definition in that the positional tolerance for the feature was referenced to datum M, rather than datum AA. The positional tolerance on the drawing was specified as $\varnothing 0.2$ mm, rather than the 0.1 mm specified on the design definition.

There were significant differences between the sizes of the positional tolerances specified on the design definition and manufacturing stage drawings. The ATSB did not identify an explanation to account for those differences.

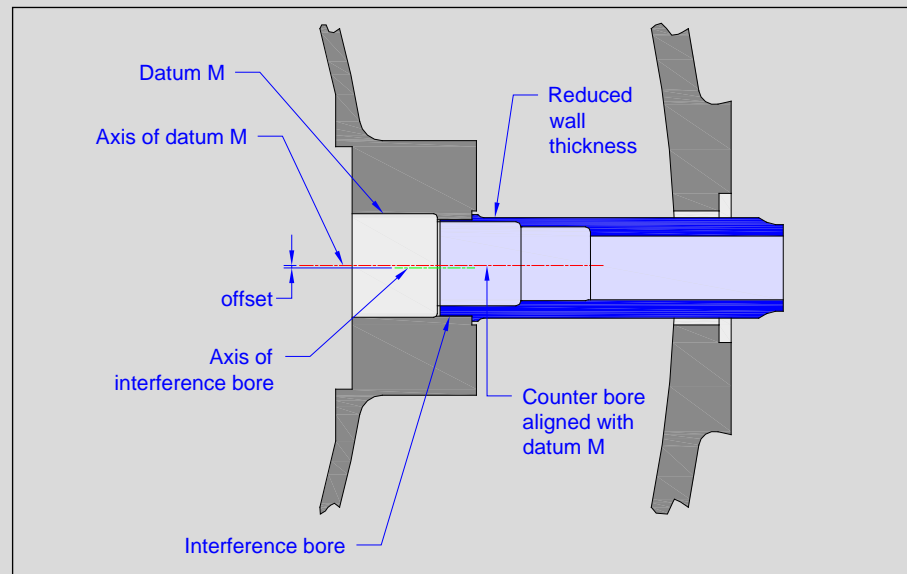
Figure 76: Reduced oil feed stub pipe wall thickness due to misalignment

misalignment of the oil feed stub pipe counter bore with respect to the outside diameter of the stub pipe. This would in turn result in a reduced wall thickness within the stub pipe (Figure 76).

The engine manufacturer was unaware of the potential for a reduced oil feed stub pipe wall thickness until identified in March 2009. Detail regarding the identification of this and how it was managed is provided in sections 4.12 and 4.13 of this report.

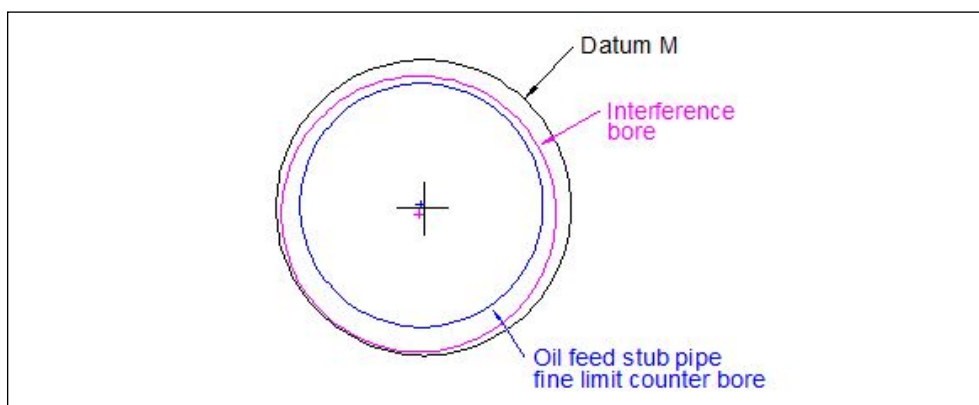
Figure 85: Graphical representation of the true positions of the bores and datum M on the oil feed stub pipe from hub 0225

A dimensional examination of the oil feed stub pipe from hub 0225 was carried out by the ATSB. That examination found that the (Figure 85):⁹²

When hub 0225 was manufactured, the true position of the interference bore was probably in excess of the limits contained within the CMM program for the OP 70 inspection. Given the extent of the deviation of the as-measured true position from the acceptable tolerance, it would have been expected that the CMM detected the difference and produced an error on its report. The expected error was estimated to have been in the range from $\varnothing 0.40$ to $\varnothing 0.48$ mm.

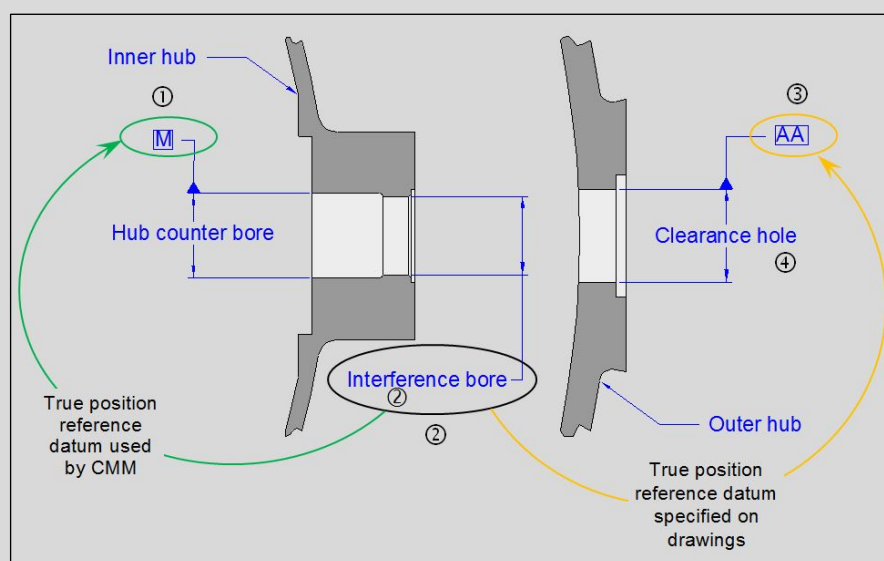
Figure 88: Differences in the interference bore reference datums

Both the manufacturing engineer who prepared the concession form and the non-conformance authority would have been unaware that the CMM had actually measured the true position of the interference bore relative to datum M, not datum AA as listed on the design definition (Figure 88). Given that the results of the wire gauge checks indicated that there was not a clearance issue, it was reasonable for the non-conformance authority to have determined that the non-conforming part was acceptable for use and to have approved the concession without understanding that there was a potentially thin wall on the stub pipe.

Because the manufacturing stage drawings also showed the position of the interference bore relative to datum AA, reference to those drawings during the preparation and sentencing of the concession would not have provided any further indication of the possible reduction in wall thickness.

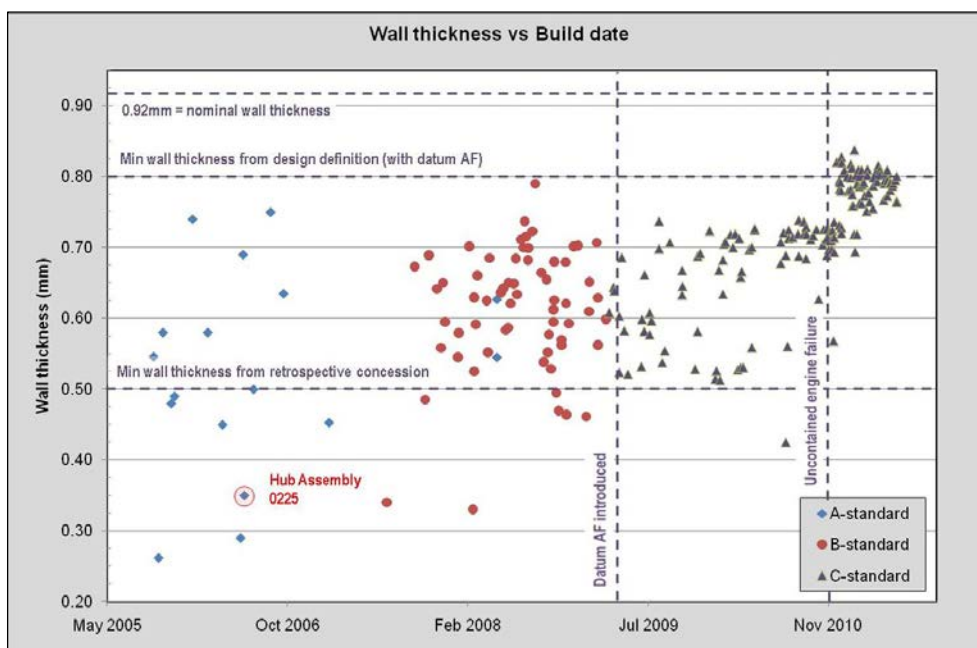
Figure 91: Oil feed stub pipe wall thickness survey, determination and estimates (No. 2 engine hub assembly from VH-OQA highlighted)

Measurements were taken between the internal pipe diameter and the drilled counter bore, and the wall thickness estimated from those measurements. There were a number of limitations on that method, including assumptions that the reamed counter bore was offset in the same direction as the drilled counter bore (which, in the case of ESN 91045 was not), of nominal dimensions for all other features, and that the inside diameter of the pipe was coaxial with the interference bore.

Note: The wall thicknesses from 17 of the 38 A-standard HP/IP bearing support assemblies produced were available to the ATSB.

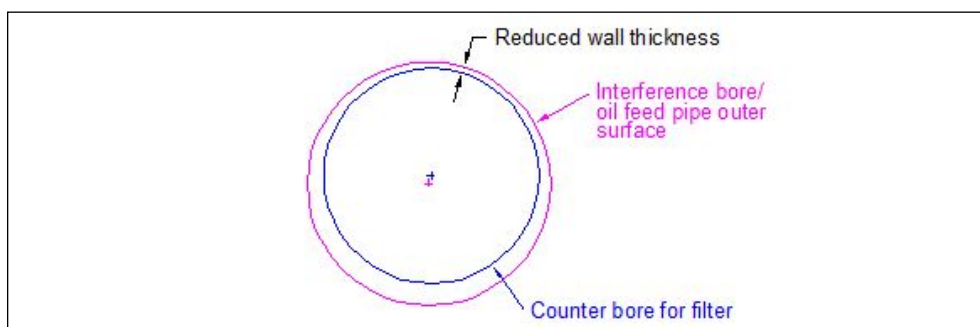
Figure 92: Effect of misaligned counter bore on pipe wall thickness

After the oil feed stub pipe was fitted to the hub, the oil feed stub pipe counter bore was machined using the inner hub counter bore as the reference datum to position the counter bore. Because the inner hub counter bore was misaligned with the axis of the stub pipe, so too the oil feed stub pipe counter bore was misaligned with the axis of the stub pipe. This resulted in a locally thin wall in the oil feed stub pipe (Figure 92).

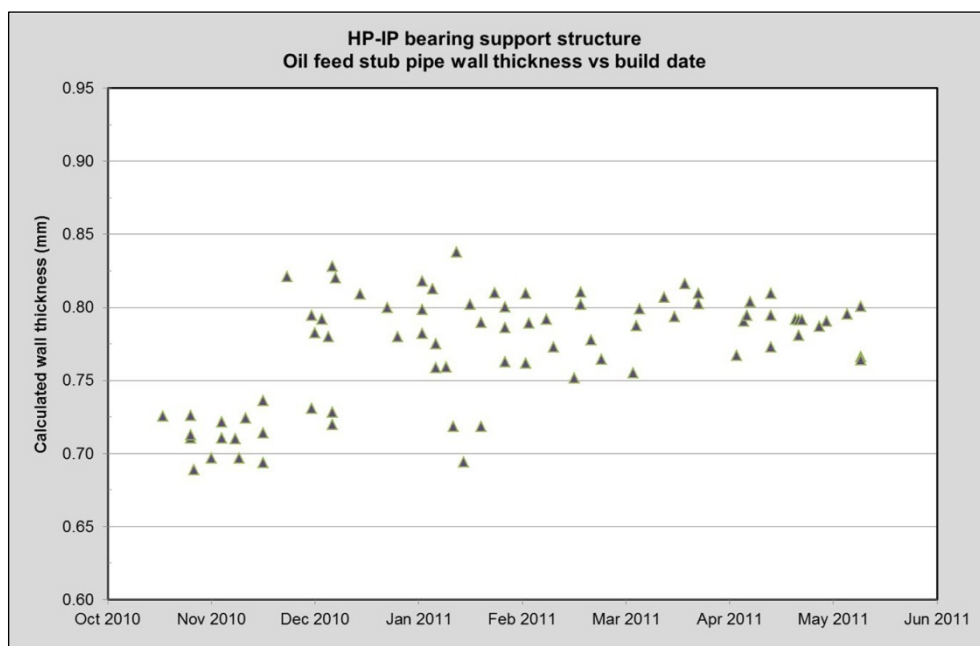
Figure 93: Production data for the HP/IP bearing support structures that were manufactured at the Hucknall facility

Following the occurrence, the stub pipe wall thickness production limit was restricted to 0.70 mm for all newly manufactured engines (Figure 93). The revised limit was introduced in December 2010, along with enhanced techniques for the measurement of critical dimensions within the counter bore region.

Rolls-Royce production data showed that, after the introduction of this revised limit in December 2010, the quality control of the manufacture of the HP/IP bearing support structure at the Hucknall facility had improved (Figure 93).

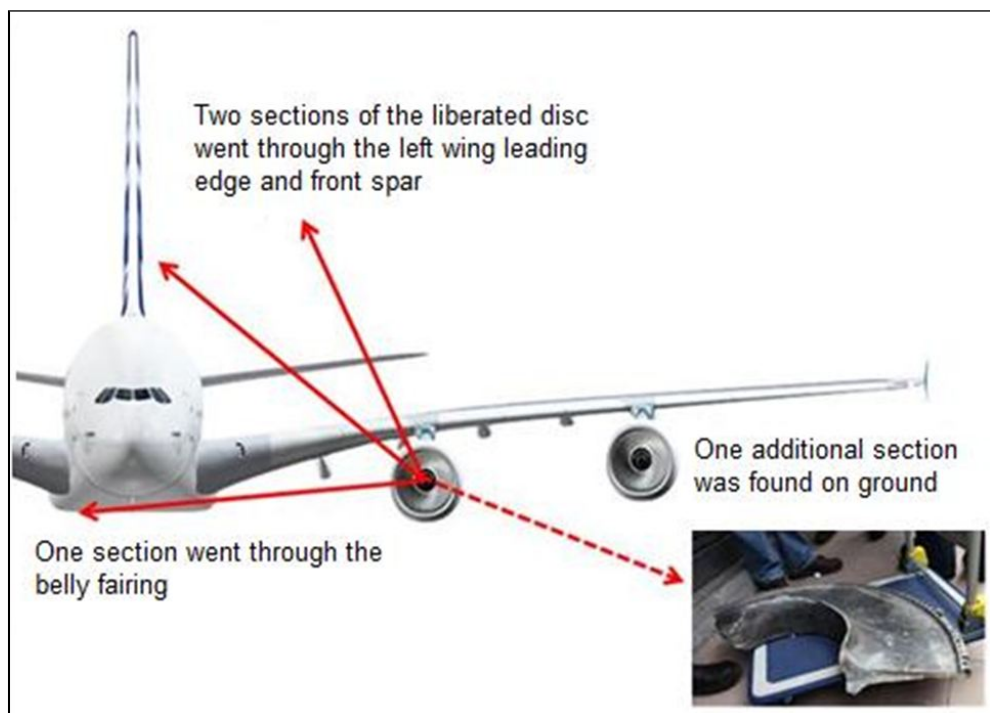
It is likely that at least one of the three main disc fragments broke up into smaller pieces during its initial ballistic trajectory through the engine case, before impacting the left wing structure. A smaller disc fragment and associated engine debris penetrated through the wing-to-body fairing and impacted airframe structure. Smaller, high-energy disc fragments and engine debris also impacted the airframe, resulting in significant damage (Figure B1).

Figure B1: Trajectory of the major disc segments. Two main fragments impacted the wing. A smaller, high energy fragment followed a different ballistic trajectory and penetrated the fuselage belly fairing structure.

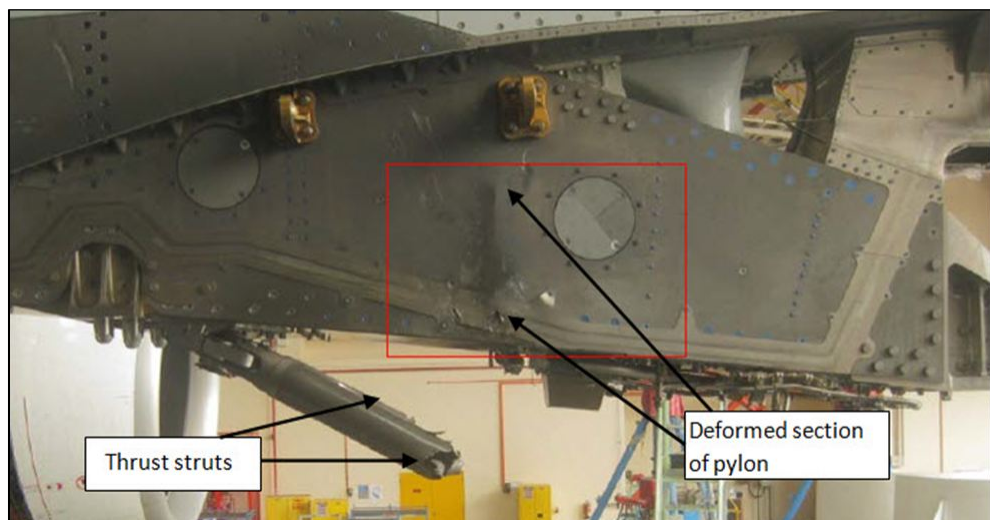
The engine pylon attached the engine to the wing. The No. 2 engine pylon sustained impact damage to its sidewalls including bending, scratches and small gouges. A section of the pylon was deformed along its length and width (Figure B2).

Figure B2: Inboard side of the No. 2 pylon highlighting the deformation and the severed thrust struts (links)

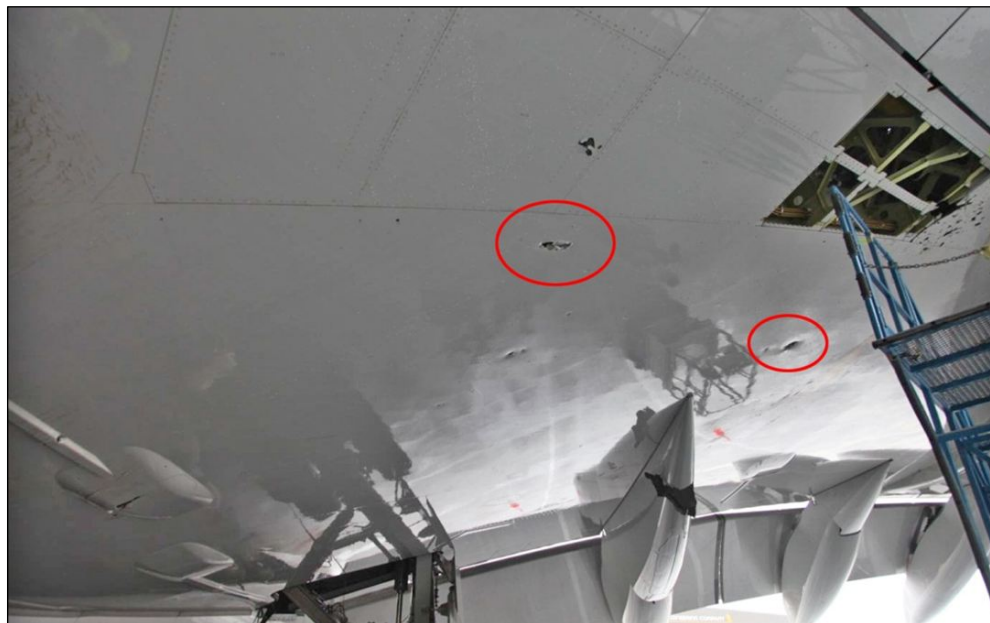
Damage to the left wing lower skins included two puncture holes and impact damage including scores, dents and gouges measuring from a few millimetres to about 200 mm in length (Table B1). Most of the damage was concentrated between ribs No. 8 to Rib No. 14, with additional damage evident further outboard. A significant amount of fuel leaked from feed tank No. 2 as a result of the puncture holes.

Figure B11: Lower wing skin perforations (circled) leading to fuel leakage from the No. 2 feeder tank

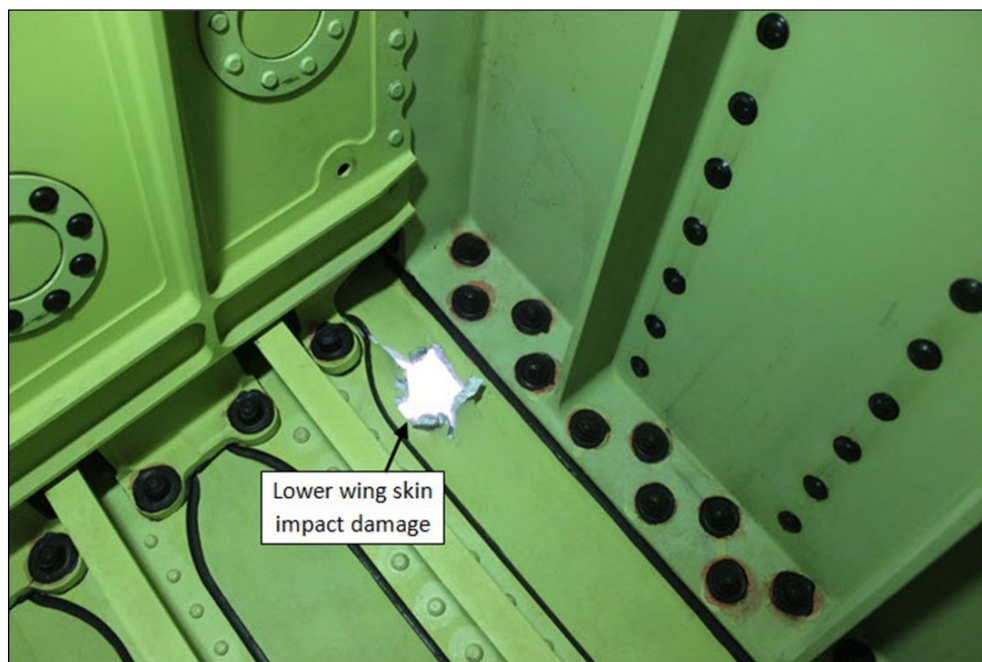
Figure B12: Puncture damage to the left-lower wing skin looking forward from inside the wing

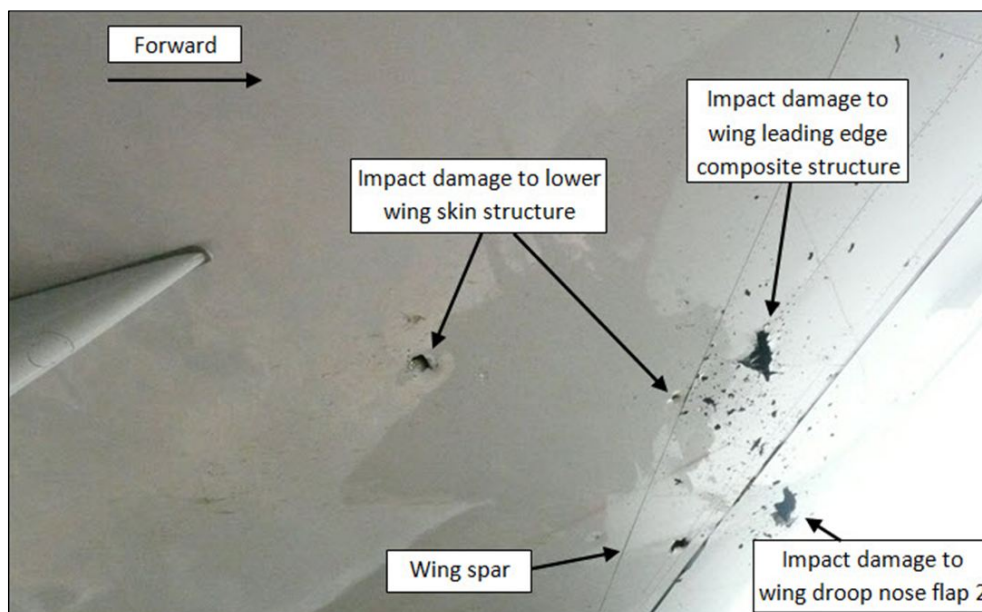
Figure B13: Impact damage to the lower wing skin

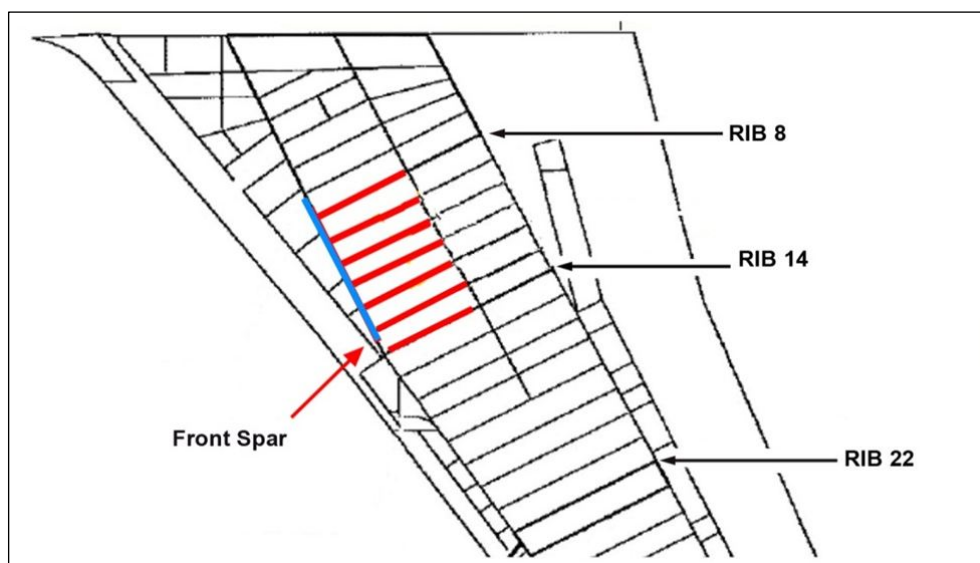
Figure B20: Location of major damage to ribs No. 8 to 14 (highlighted) and the front spar within the wing structure

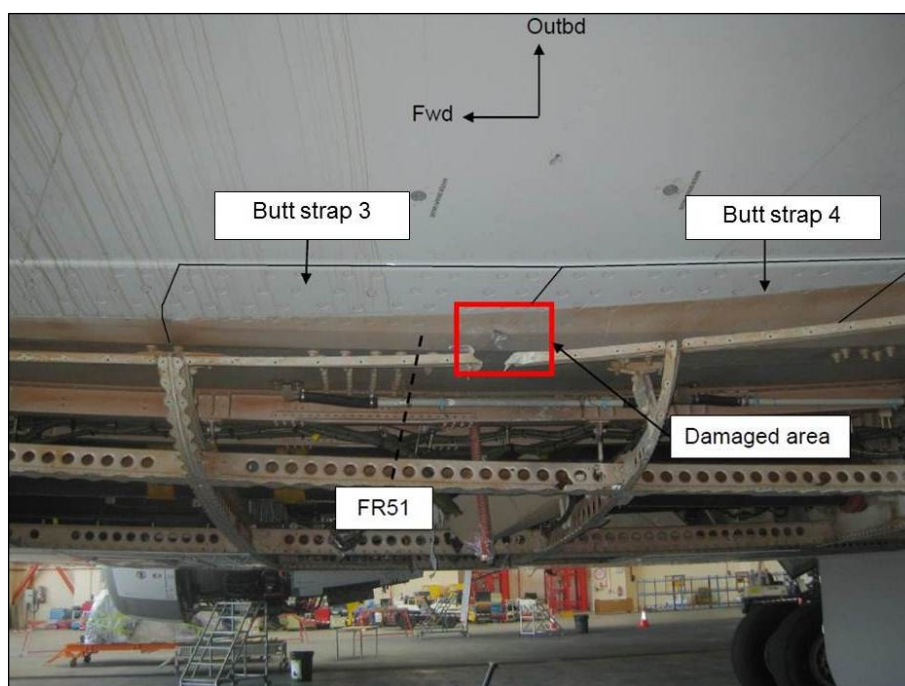
A butt-strap is a drop-forged fitting that overlaps and fastens the wing to the fuselage in conjunction with other structural components. Butt-straps No. 3 and 4 are located at the lower fuselage joint between Frames 46 and 56. These straps sustained impact damage, included gouging over an area of about 76 cm² from liberated engine debris between frames 51 and 52 (Figure B21, Figure B22, Figure B23).

Figure B21: Butt-straps No. 3 and No. 4 with damage highlighted

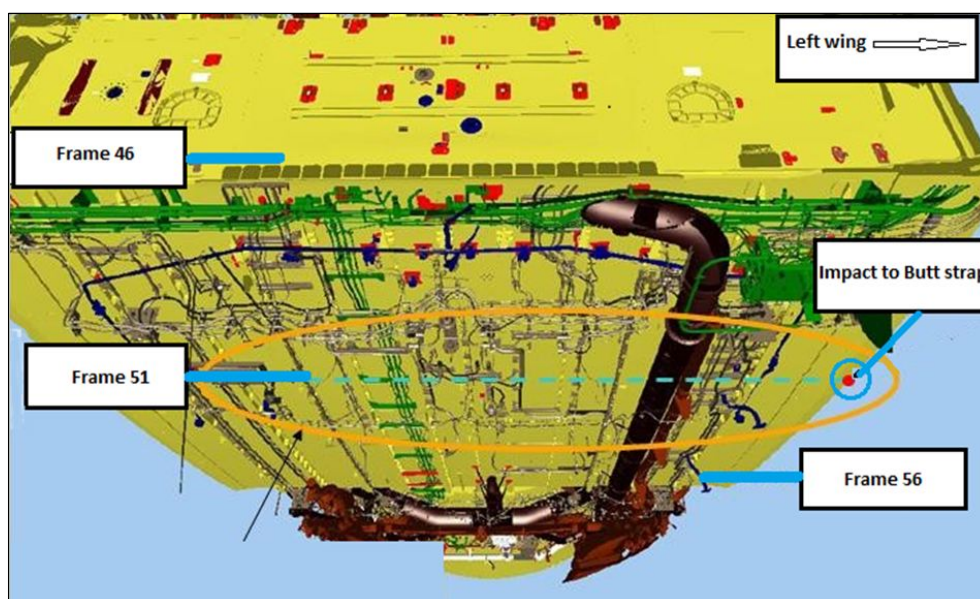
Figure B23: Schematic of the butt-straps damage between Frame 52 and 51

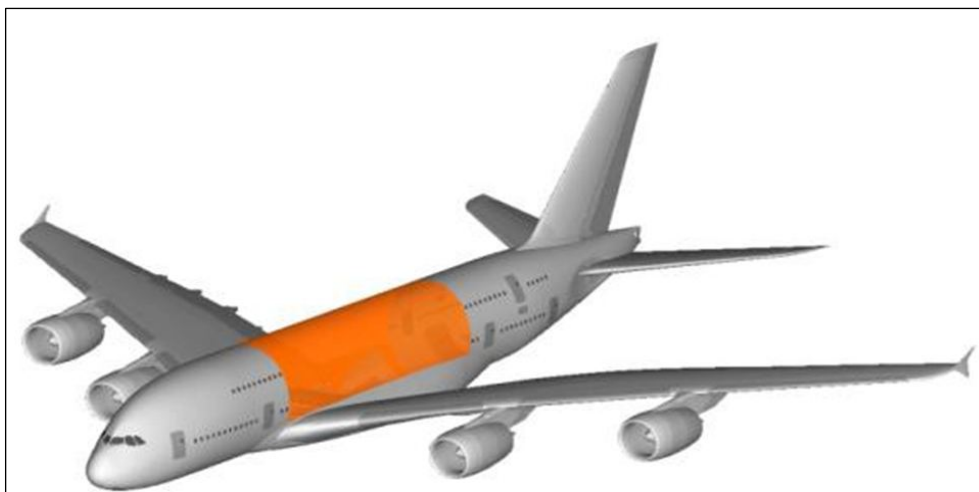
Figure B24: Centre fuselage – section 15 highlighted in orange

- Three fuselage skin panels were damaged in section 15 (Figure B24 and Table B3) that damage included:
- FR46-FR62, STGR6LH-STGR22LH, 39 items of impact damage (scratches, gouges and dents) and 6 windows damaged in that location.
- FR46-FR62, STGR22LH-STGR39LH, 19 items of impact damage (scratches, gouges and dents) and 1 window damaged in that location.
- FR62-FR74, STGR22LH-STGR39LH, 4 items of impact damage (scratches, gouges and dents) and 1 window damaged in that location.

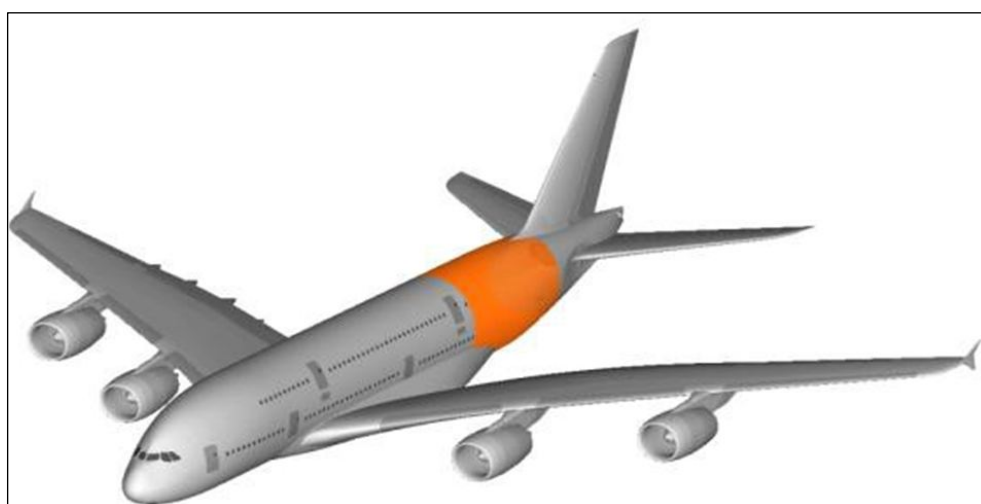
Figure B25: rear fuselage – section 19 highlighted in orange

- FR74-FR89, STGR6LH-STGR22LH, 5 items of impact damage (scratches, gouges and dents) in that location.
- FR74-FR81, STGR22LH-STGR39LH, 5 items of impact damage (scratches, gouges and dents) in that location.
- FR81-FR89, STGR22LH-STGR39LH, 3 items of impact damage (scratches, gouges and dents) in that location.

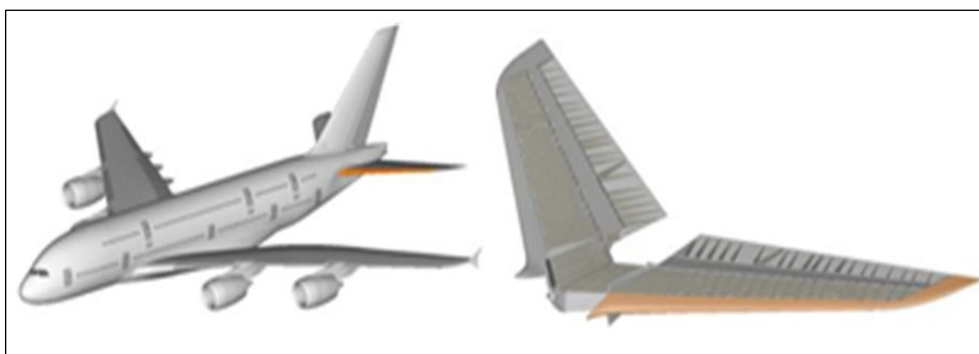
Figure B26: Trimmable Horizontal Stabiliser leading edge skin panels highlighted in orange

The left side of the trimmable horizontal stabiliser leading edge (Figure B26) was damaged from engine and airframe debris at five locations along the leading edge (scratches, gouges and dents). Damage at that location required repair prior to flight.

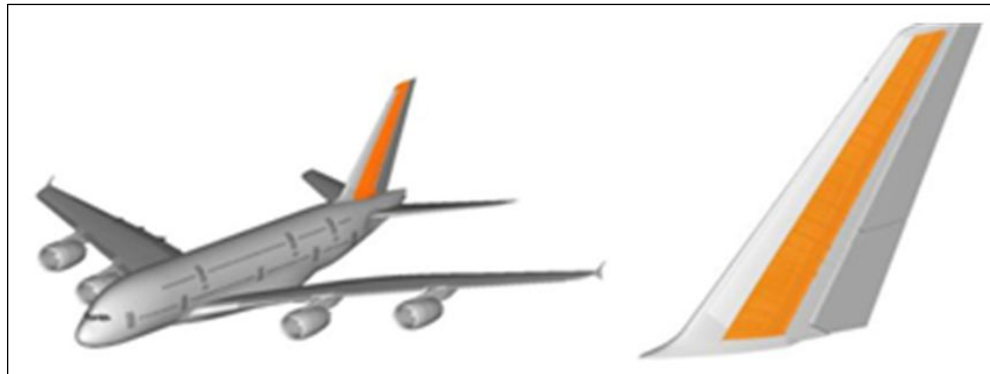
Figure B27: Vertical stabiliser spar box skin highlighted in orange

The left side of the vertical stabiliser (Figure B27) was damaged from engine and airframe debris at five locations along the leading edge (scratches). Damage at that location required repair prior to flight.

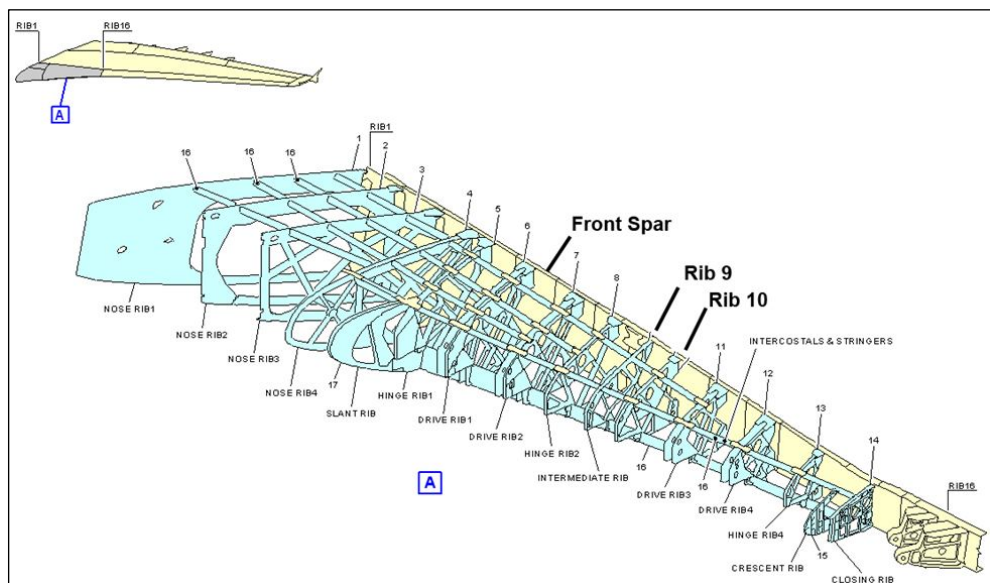
Figure B28: Wing leading edge sub structure diagram

The left wing leading edge substructure, droop nose flaps, composite skins and components in that area, between the number two engine and the fuselage (Figures B28-B30) were subject to significant impact forces. Although the damage incurred was significant, it was not considered to be major structural damage.

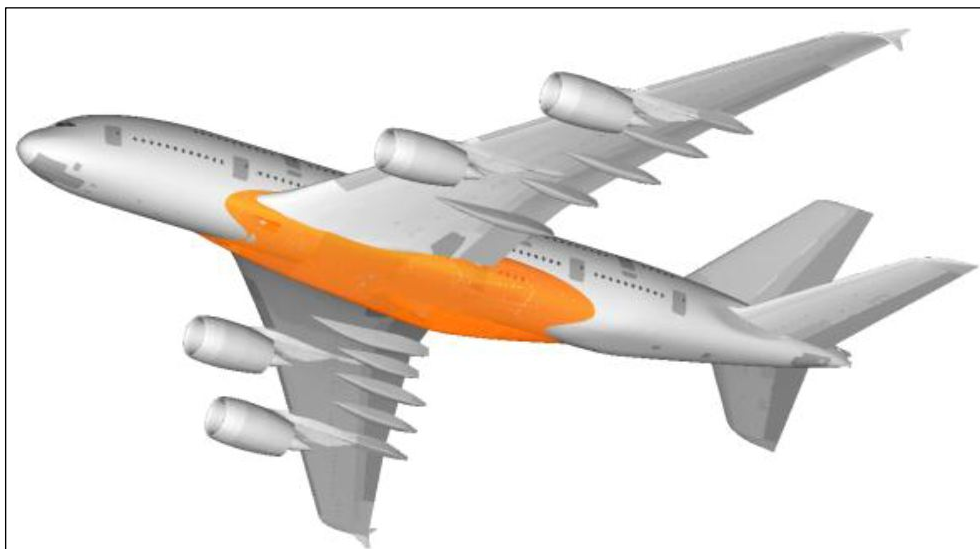
The belly fairing and centre wing box structure (Figure B31) of the aircraft sustained significant damage from engine fragments. A smaller-sized, high-energy disc fragment penetrated the belly region of frame 51 (Figure B32 to Figure B36).

Figure B31: General location of the belly fairing panels on the A380 aircraft highlighted in orange

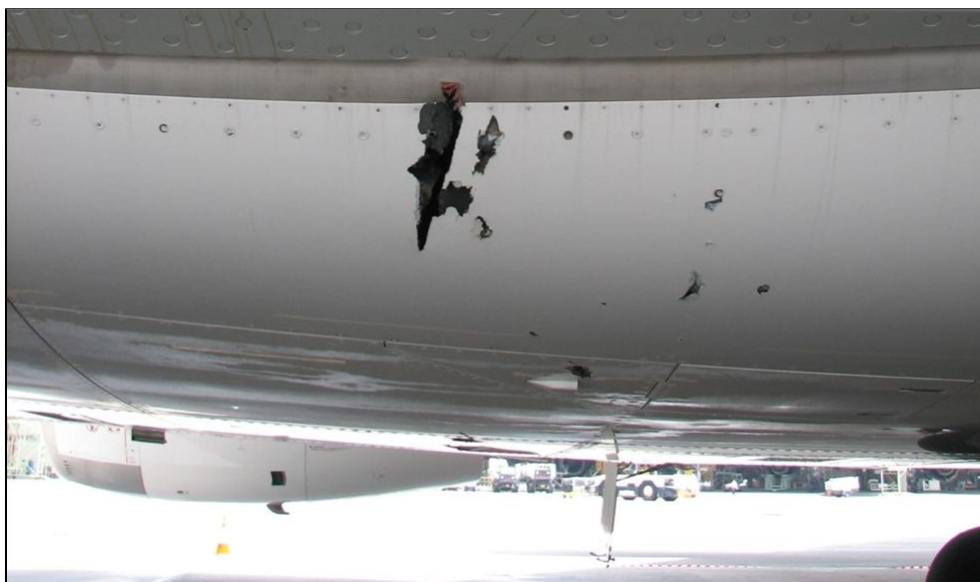
Figure B32: A smaller, high energy fragment of the IP turbine cut a swath directly through the belly fairing of the aircraft—view looking to the right of the aircraft with the No. 3 engine in the background.

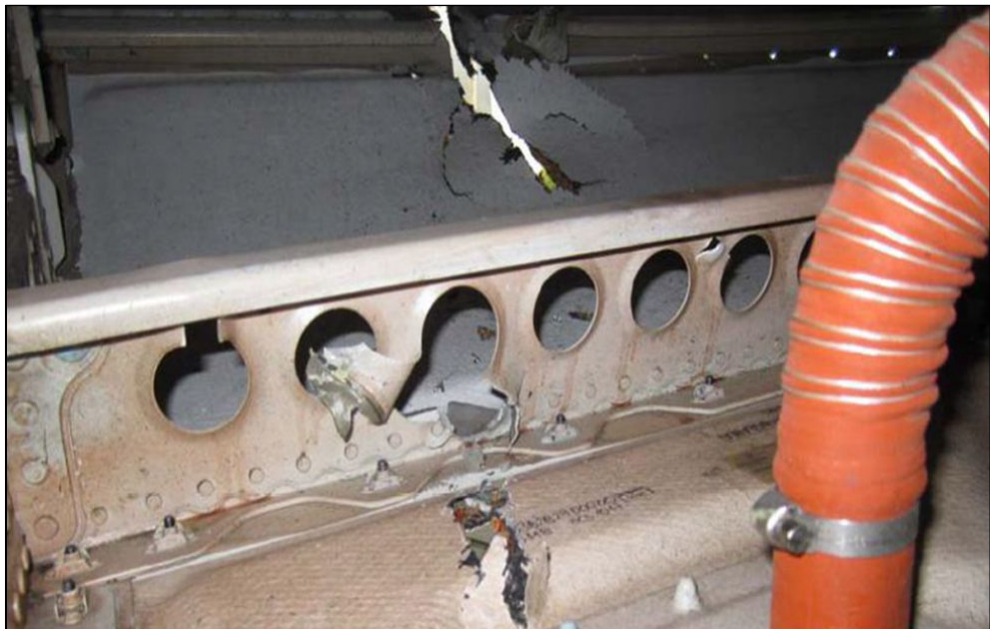
Figure B36: Stringer 5 LH impact damage

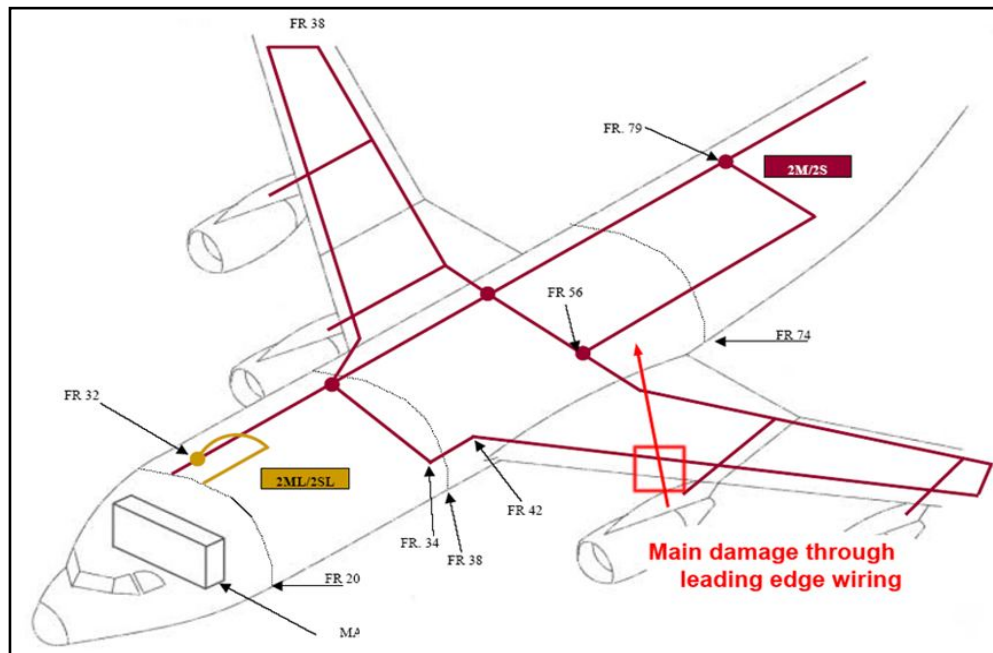
Figure B38: Representation of the disc fragment trajectory through the aircraft left wing leading edge which severed numerous wiring harnesses

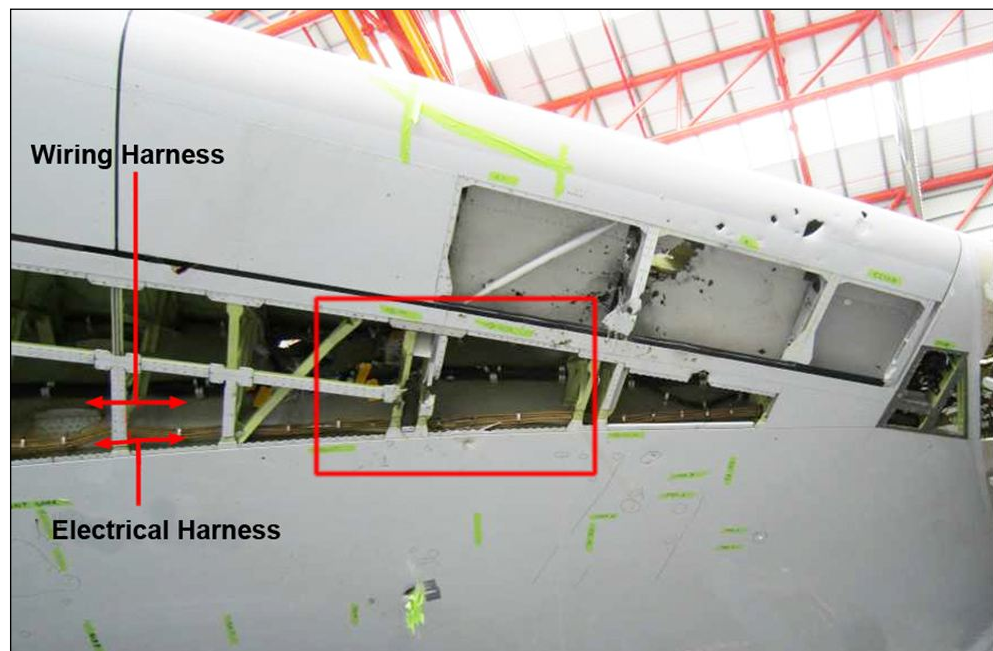
Figure B39: General location of the wiring harness damage within the leading edge of the left wing—red framed area expanded in Figure B40

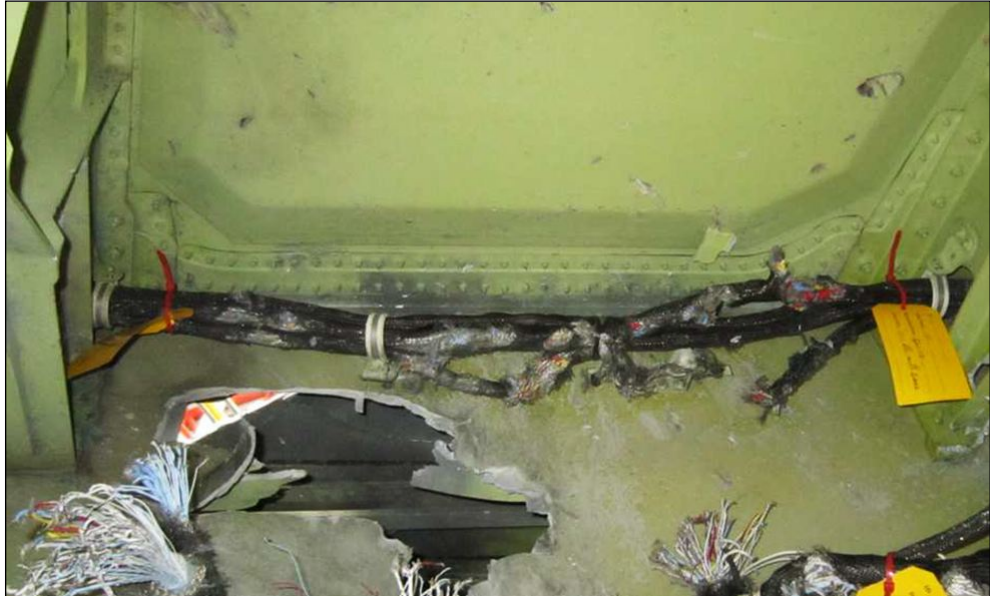
Figure B44: Main damage to the route 1P route harnesses (looms 3025VB, 3027VB, 3031VB and 3033VB), between Rib 9 and Rib 10 of the left wing lead edge. All wires within the harness were completely severed. The debris entry/exit hole through the front spar is also evident
