In-flight uncontained engine failure Airbus A380-842, VH-OQA

overhead Batam Island, Indonesia | 4 November 2010

ATSB Transport Safety Report
Aviation Occurrence Investigation
AO-2010-089
Final – 27 June 2013

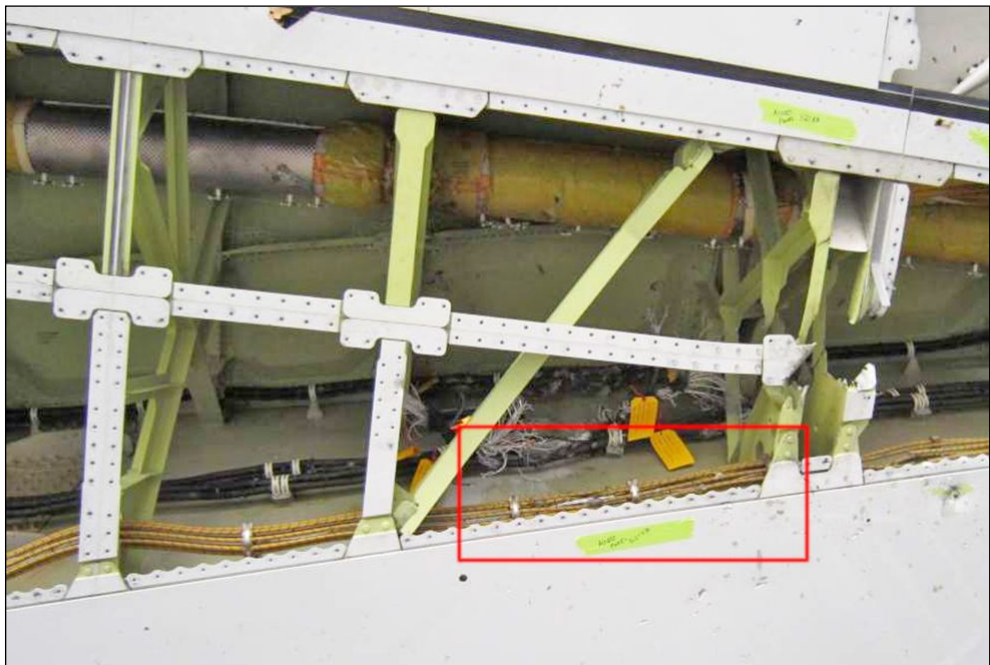
Figure B45: Detailed locations of damage to the 1G route (electrical harness 3029VB), primarily between Rib 9, 10 and 11 of the left wing; four of the 9 feeder and exciter cables have been severed—red framed area expanded in Figure B46

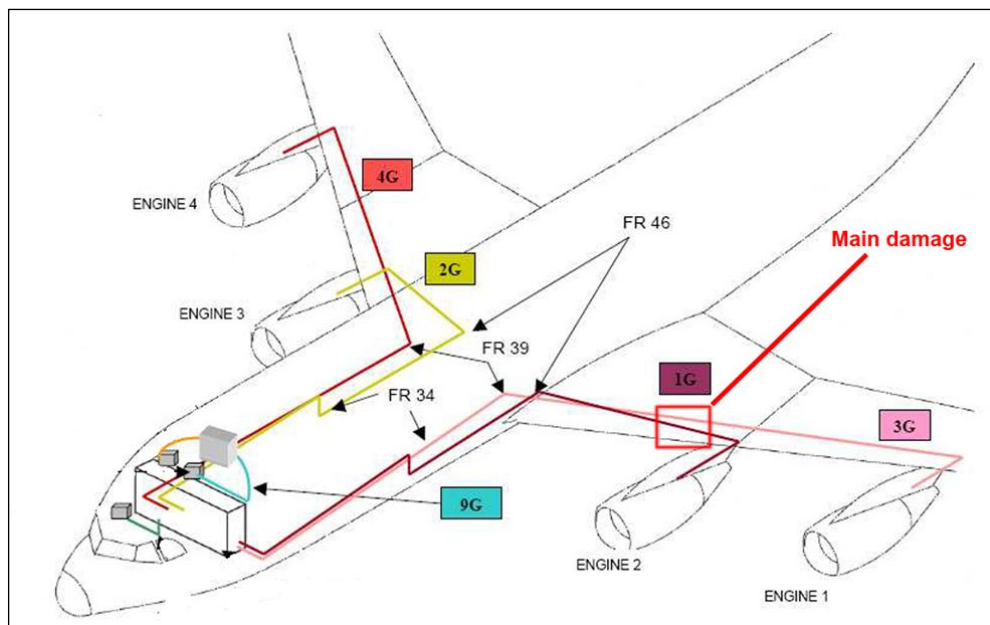
As the electrical system was locked in the air mode, only APU generator A was available to supply power following the shutdown of engines No. 3 and 4. This resulted in only AC BUS 1 and the essential bus bar continuing to be supplied with AC power. This limited power source resulted in some flight deck display screens being lost and only the VHF 1 radio being available for use by the flight crew.

Figure B55: Engine feeder routing and the main damage location

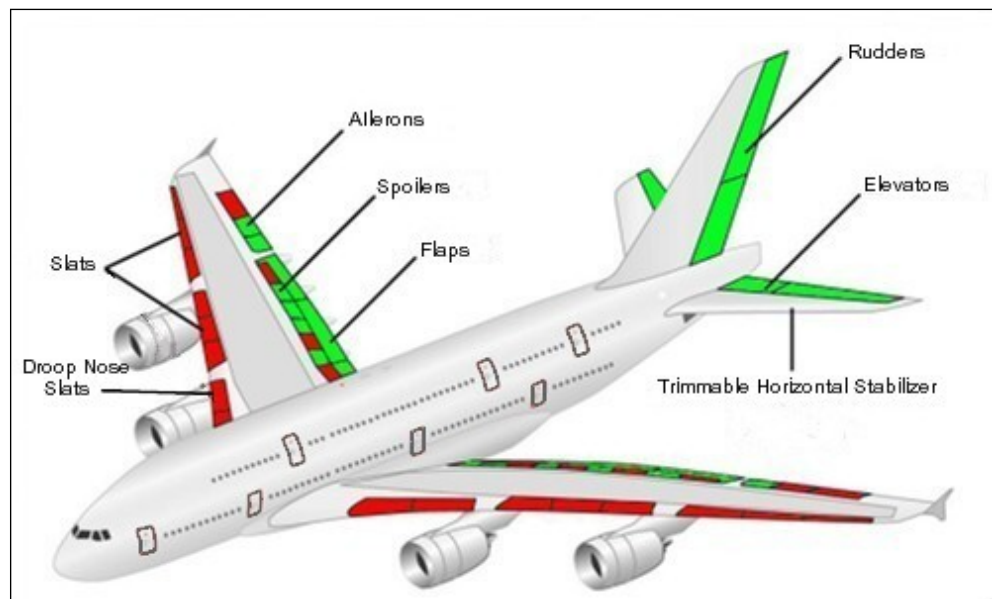
The availability of the primary and secondary flight control surfaces following the uncontained engine failure and subsequent ECAM actions by the crew are depicted in Figure B56.

Figure B56: Flight control surface status following the engine failure and ECAM actions by the crew (unavailable control surfaces highlighted in red)

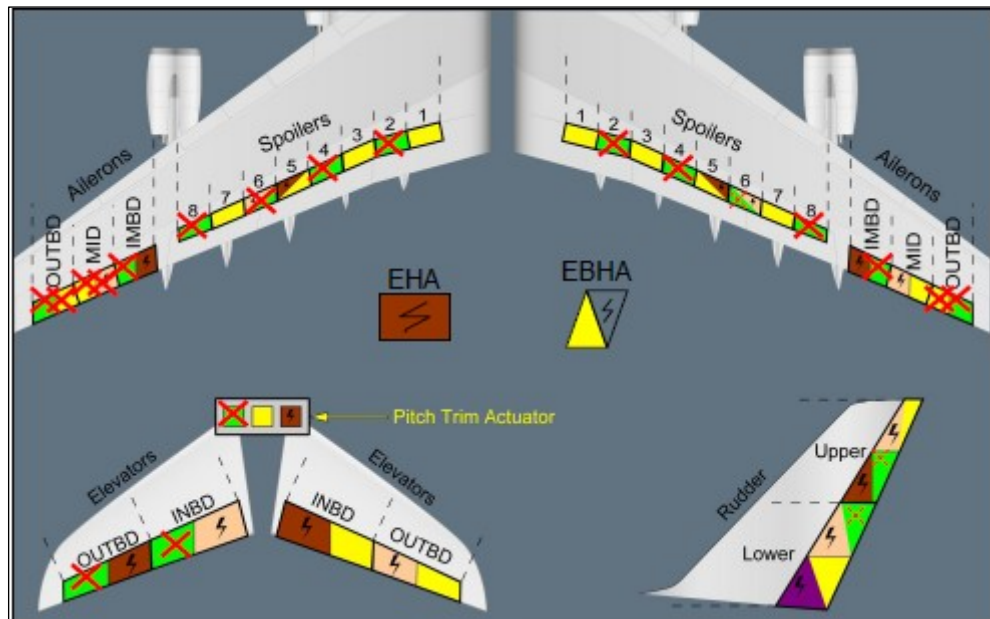
Figure B58: Primary flight controls actuation system (a red cross indicates the loss of actuator operation after the engine failure)

The loss of the Green hydraulic system and impact damage to the aircraft's wiring combined to affect the availability of the left aileron system for the remainder of the flight. As a result, the outboard aileron Yellow and Green servocontrols, mid aileron EHA and Yellow servocontrol and the inboard aileron Green servocontrol were unavailable. As a result, the left outer and mid ailerons were disabled. (Figure B58).

Each wing had eight spoilers, numbered 1 to 8 outwards from the aircraft centreline (Figure B58). The loss of the Green hydraulic system and wiring damage resulted in the unavailability of spoilers 2, 4, 6 and 8 on the left wing and of spoilers 2, 4 and 8 on the right wing.

Pitch trim operation was unaffected following the uncontained engine failure. The trimmable horizontal stabiliser had three independent actuators, numbered 1 to 3 from left to right, for redundancy (Figure B58). The loss of the Green hydraulic pressure rendered the No. 1 actuator inoperative, while actuators 2 and 3 continued normal operation.

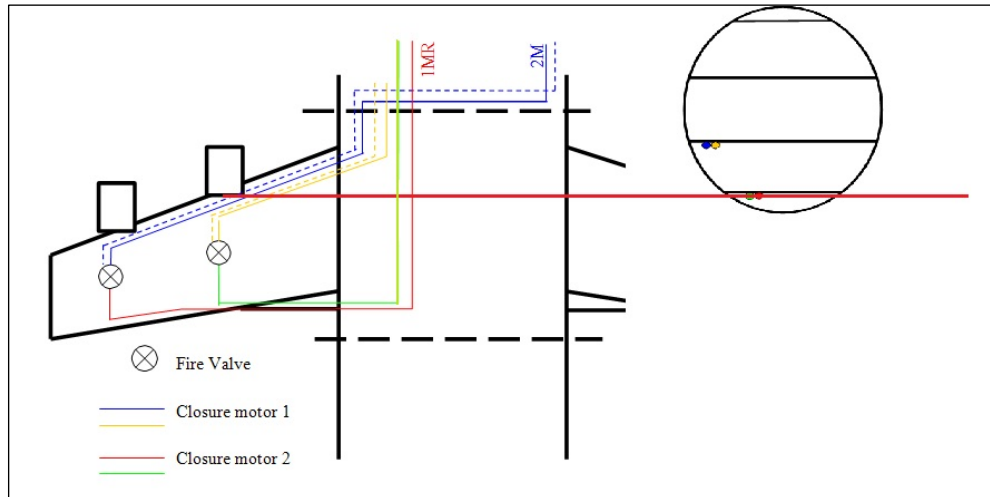
Severing of signal wires in the left wing leading edge and belly fairing of the aircraft contributed to the loss of control of the No. 1 engine LPSOV. This resulted in the inability to shut down that engine after the aircraft had landed at Changi Airport, Singapore. Although the leading edge wing damage was from major disc fragments, the damage to the belly fairing and its internal wiring was established to be from a smaller fragment.

Figure B62: Schematic showing the trajectory of the disc fragments as they exited the No. 2 engine case and impacted the left wing and airframe. A smaller, high energy disc fragment penetrated the belly fairing and severed the LPSOV control wires for the No. 1 and No. 2 engines

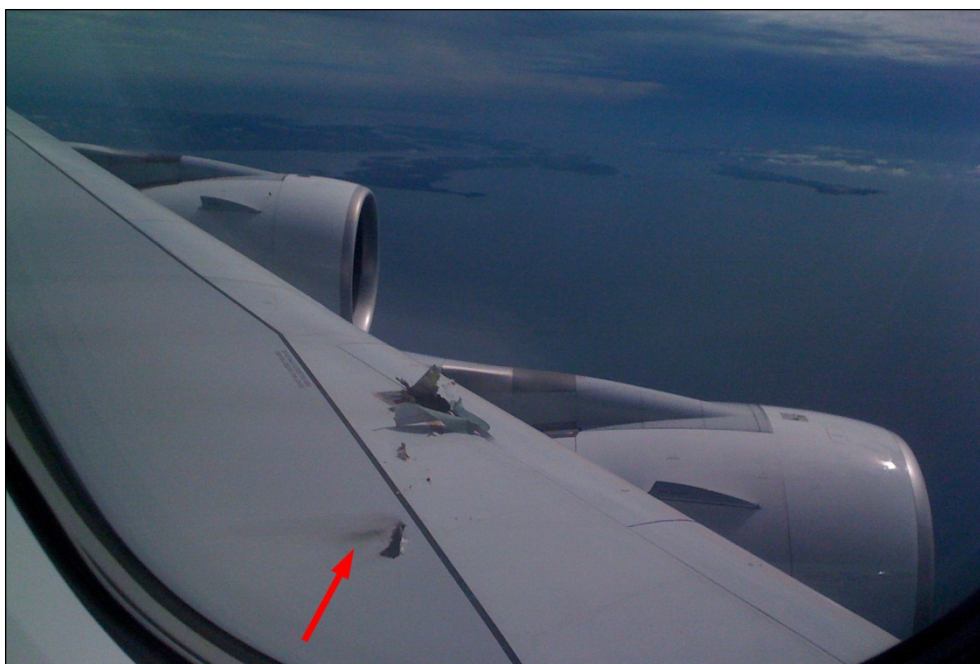
Figure D1: View from the window on the upper deck, left side showing the presence of smoke/dark residue on the aft side of the hole (arrowed)

Photographs supplied by the witness, those taken after the aircraft had landed and visual confirmation by the ATSB all showed the presence of smoke/dark residue on the aft side of the hole in the upper wing skin (Figure D1 and Figure D4).

A review of the damage observable from the passenger's seat on the upper deck indicated that the engine mechanicals and structure could be seen through the arrowed hole in Figure D1.

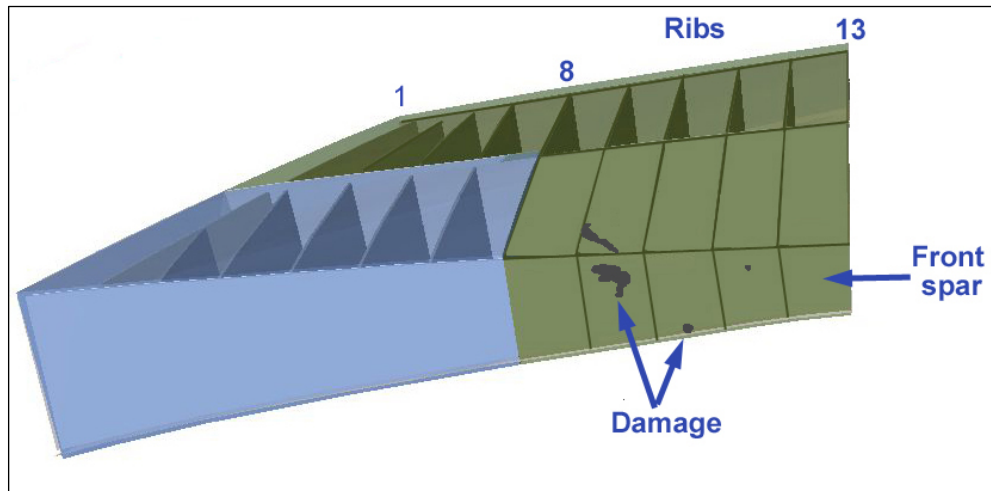
The LIT structure was considerably damaged by debris from the No 2 engine failure. The damage resulted when a large segment of the liberated IP turbine disc struck the wing bottom skin and passed through the front spar and LIT structure, before exiting through the wing upper skin. As a result of the disc's trajectory, the most significant damage to the LIT occurred to the front spar between ribs 9 and 10, and the upper wing skin in the region of rib 9 (Figure D3 to Figure D5). Table D1 provides the dimensions of the through-penetrations that were identified in the LIT.

Figure D3: Schematic of the LIT (green) and feed tank 2 (blue), showing the location of the major front spar and top skin damage

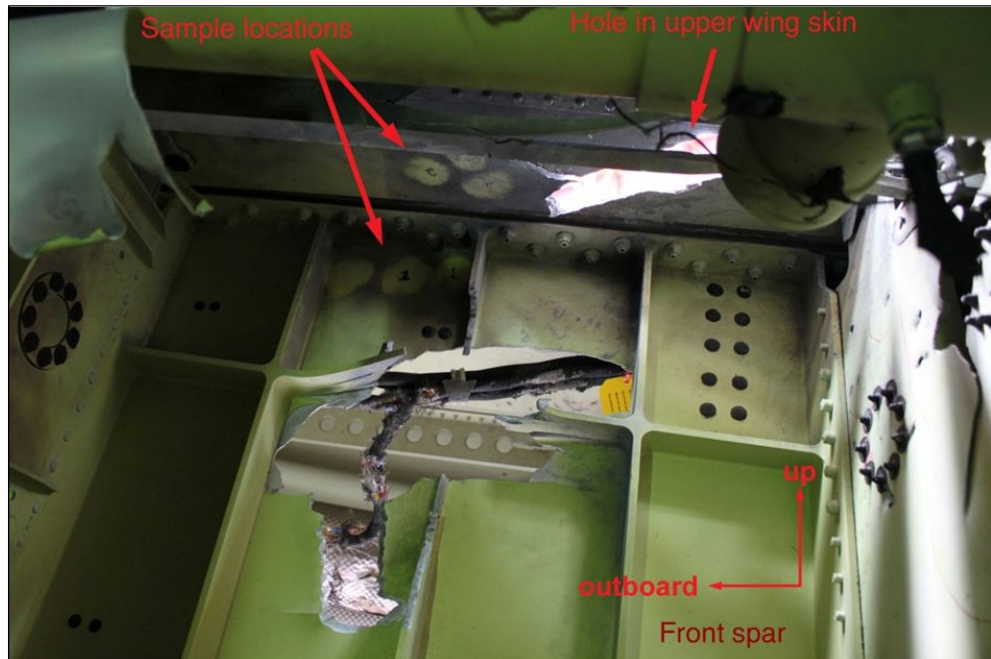
An examination of the internal surfaces of the LIT showed the residue to be principally located on the upper regions of the front spar (above the large hole), and along the underside of the top skin on the surfaces of the stringers (Figure D5 and Figure D6). The residue was also observed within the vent pipe shown in Figure D6. No evidence of dark residue was observed on either the wing underside, or on the front droop-nose structure.

Figure D5: Damage and residue on the front spar (viewed forward from inside the LIT)

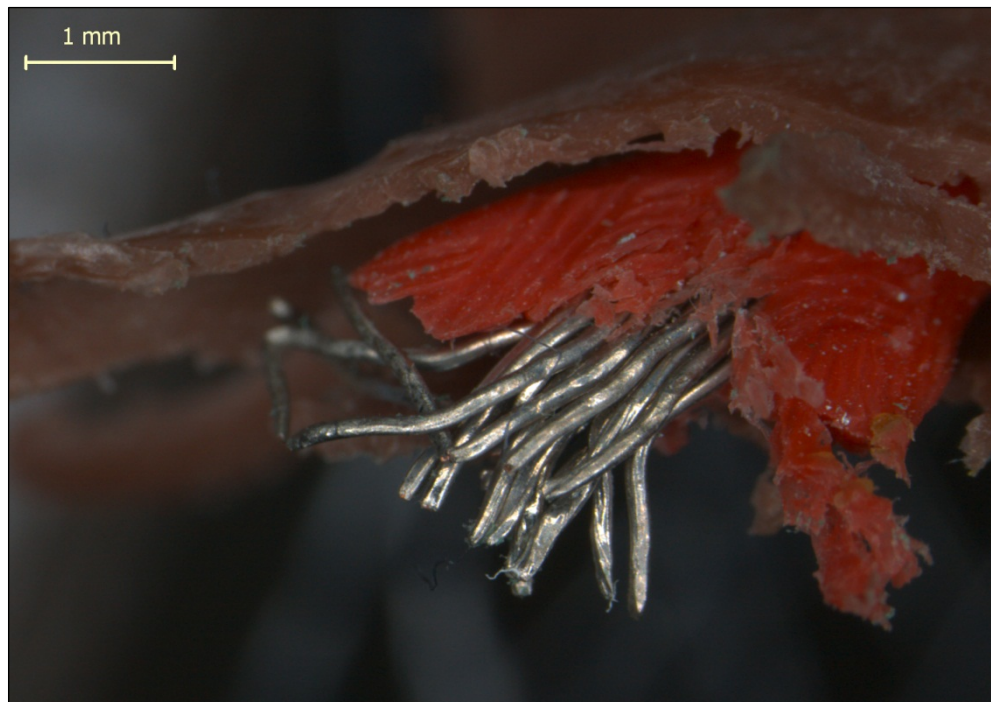
The section of FQIS wiring supplied was a y-shaped piece, approximately 1.2 m long, which had been severed during the engine failure. A small area of additional damage was observed towards the end of one of the sections. A visual inspection of the exposed wires showed severe mechanical damage; many of the conductors exhibited significant deformation as a result of contact with the liberated engine debris. The inspection identified a number of ‘cup and cone’ and angular shear fractures, all consistent with tensile overstress failure (Figure D8). No evidence of any discolouration or arcing was observed on the fractured ends of the wires, and the plastic coating did not exhibit any discolouration, burning or charring.

Figure D8: Magnified view of the severed end of the FQIS wiring

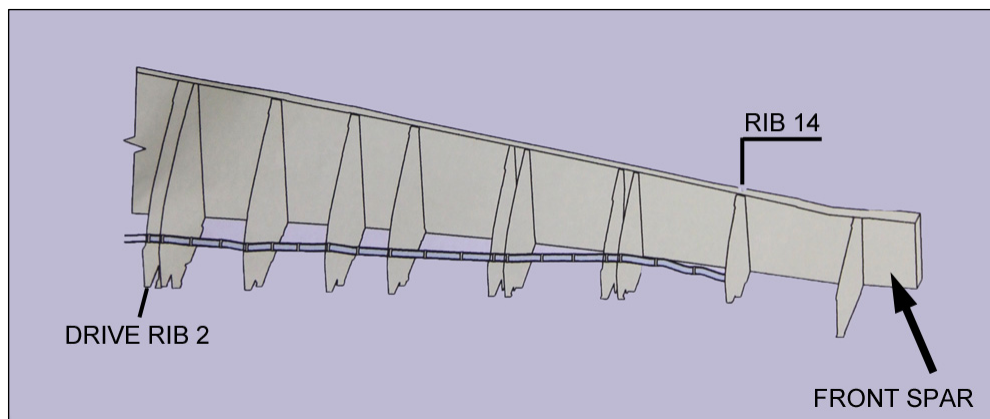
The VFG feeder cables for the No. 1 (VFG1) and No. 2 (VFG2) engines were located in the bay forward of the front spar (Figure D9). The VFG1 and VFG2 feeders had been severed at the left wing leading edge. An examination by Airbus reported that there was no visible trace of arcing, short circuit or overheats on any cable.

Following removal from the aircraft, sections of both feeder cables were sent to the ATSB's Canberra facilities for further examination. The VFG1 cable section had been completely severed, while the section of VFG2 cable had some remaining wires intact.

Figure D9: Location of VFG1 and 2 feeder cables along the wing front spar

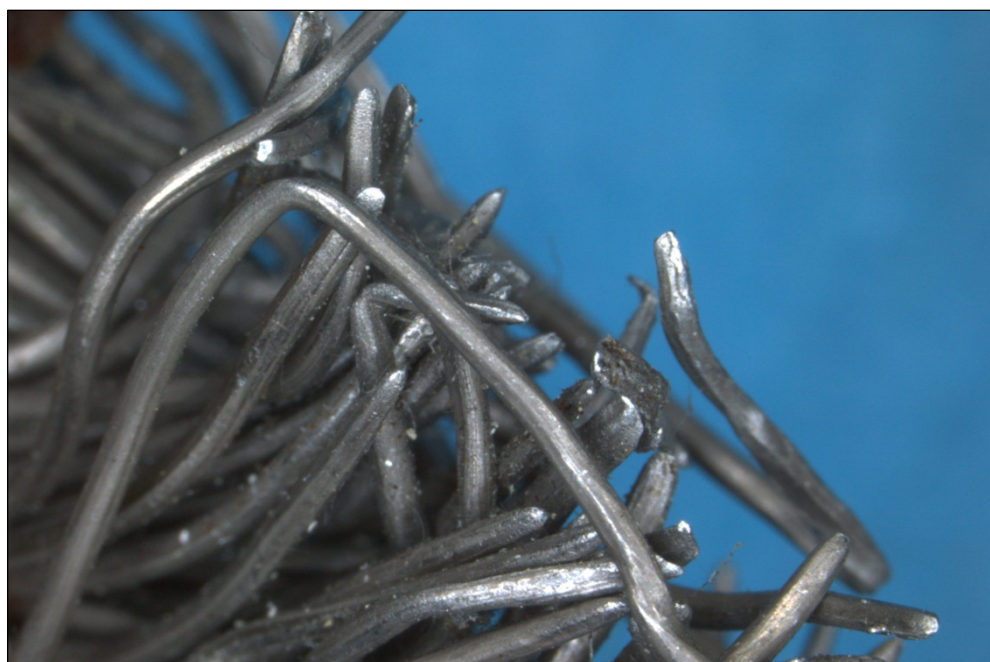
The severed wires exhibited deformation and markings consistent with the mechanical damage that was observed on the FQIS wiring. The fractured strands exhibited 'cup and cone' features that were indicative of an overstress failure (Figure D10).

Figure D10: Magnified view of the severed end of VFG2 wiring

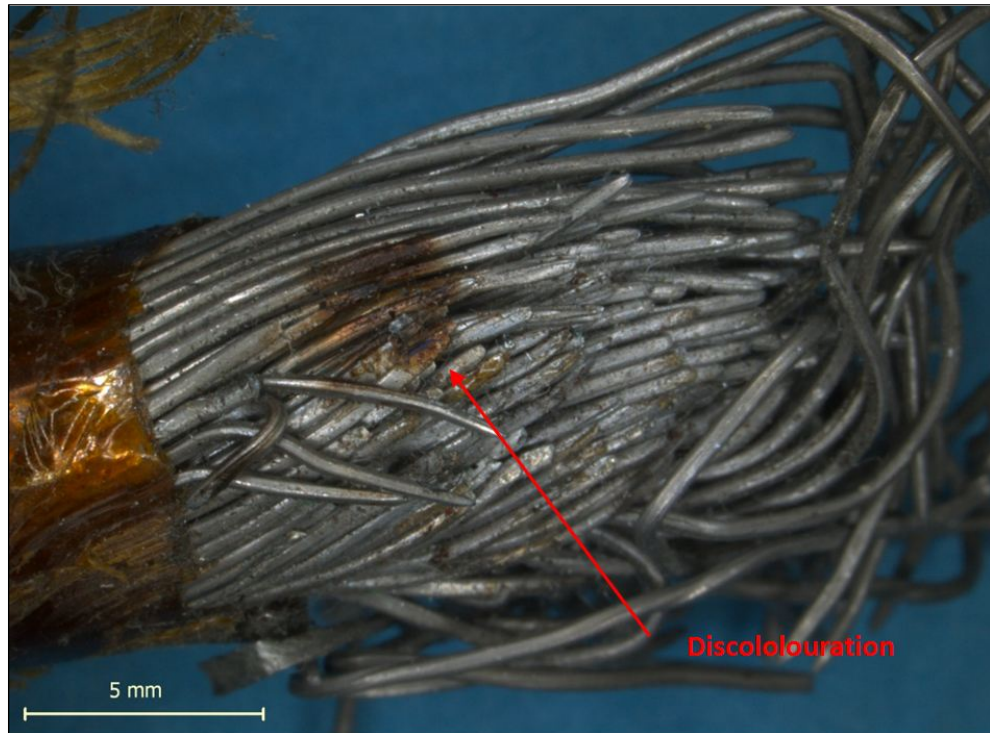
A small discoloured spot was identified on one of the VFG2 cables supplied (Figure D11). While the source of the discolouration was not identified, there did not appear to be any associated melting that would indicate that it was a result of arcing.

Figure D11: VFG2 cable showing small area of discolouration

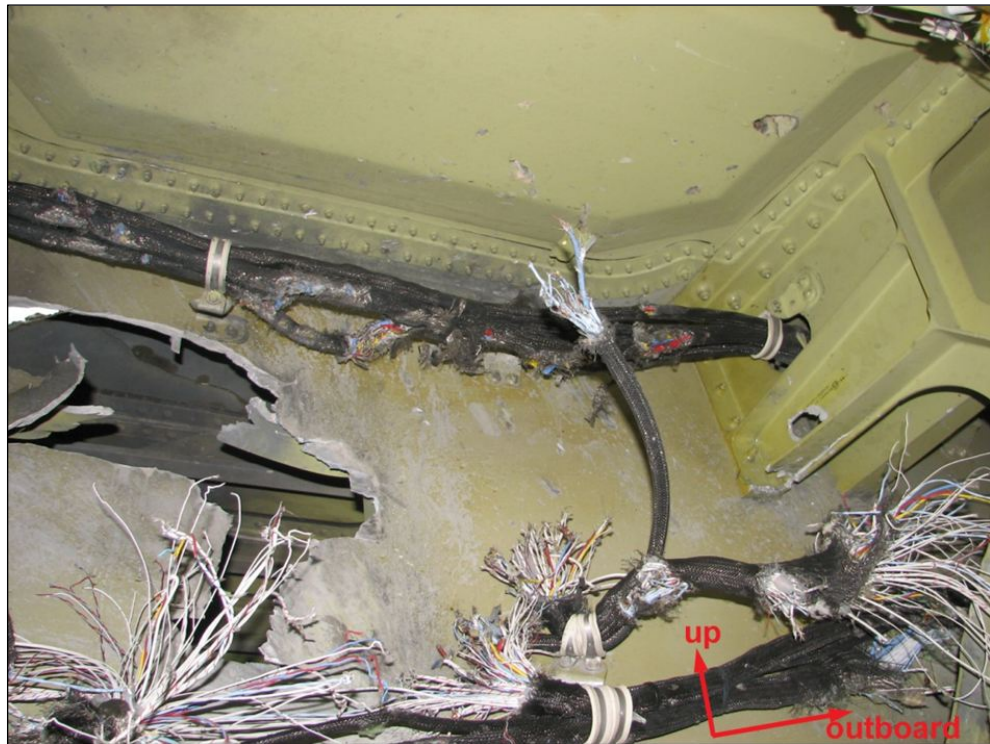
The sections of harness comprised of a number of smaller wires encased in an outer sheath. Damage to the harnesses varied from complete separation to minor damage to the outer sheath and a small number of wires (Figure D12 and Figure D13).

Figure D12: Overview of severed harnesses in-situ, located in the left wing leading edge (also showing the front spar, looking rearward)

All of the exposed severed wires were examined, with no evidence of any arcing noted. The fractured ends of the wires were consistent with overstress failures as a result of localised mechanical impact.

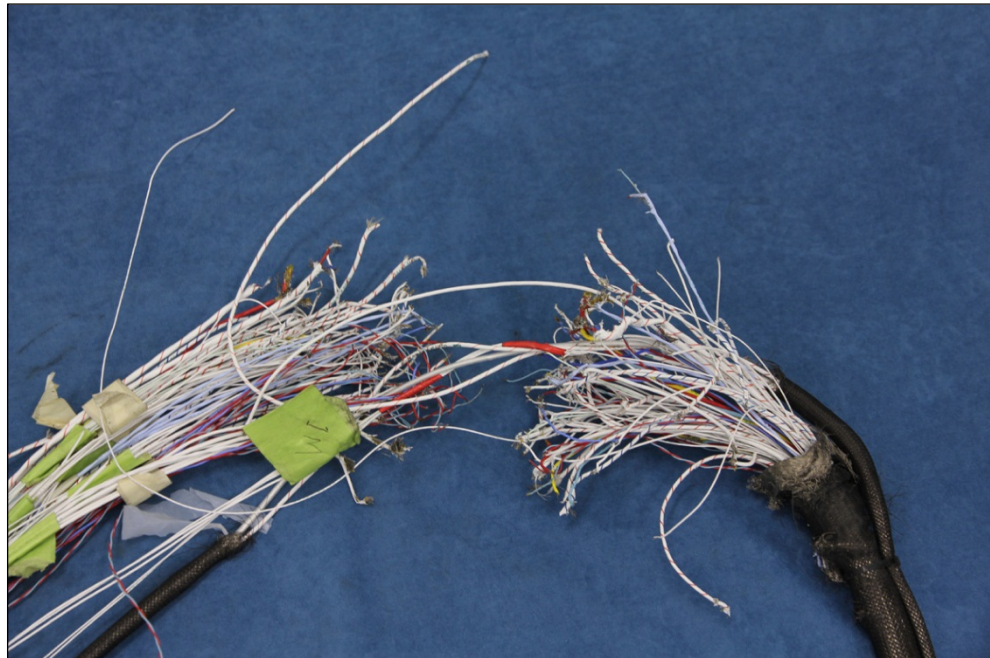
Figure D13: Magnified view of Harness 1M 3001VB
