# Nose landing gear malfunction involving a Hawker Beechcraft G58, VH-OMS

Hervey Bay, Queensland, 3 April 2013

**ATSB Transport Safety Report**  
Aviation Occurrence Investigation  
AO-2013-065  
Final – 7 August 2013

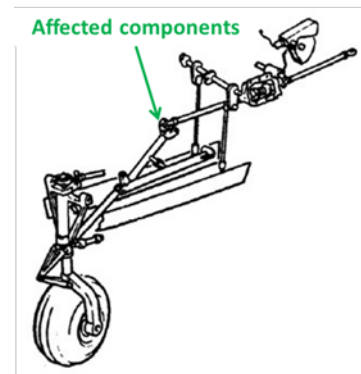
As the aircraft's main landing gear touched down, the copilot selected the fuel and mixture controls to off, while the PIC concurrently reduced the throttle settings to idle and turned the electrical system off. The aircraft's nose then lowered and slid along the runway. The aircraft came to a stop and the crew exited. As a precaution, the aircraft was covered with fire retardant foam, but no fire resulted. A video of the landing can be viewed at:

The maintenance provider conducted an examination of the aircraft and determined that the rod end on the NLG forward retract rod assembly had separated from the plunger tube on the NLG plunger assembly (Figure 2). The initial examination suggested that there may have been a manufacturing issue that resulted in a defective joint between the rod end and plunger tube.

After the accident involving OMS, the NLG of a second Baron aircraft was inspected and it also showed signs of a similar defect (Figure 2). That aircraft was built in 2012 and had 127 hours total time in service.

All new assemblies were required to be 'pull tested' to a 2,200 lb. test load. For the assemblies fitted to OMS, the aircraft manufacturer reported that a pull test had been conducted by the supplier; however, it could not be determined why that test did not reveal the lack of brazing. Two other assemblies manufactured by the supplier were pull tested and failed at about 6,000 lbs; the braze joint did not separate.

An improperly brazed rod end might separate from the plunger assembly during landing gear operation. The plunger assembly is part of the NLG extension/retraction system and a separated push-pull retract rod assembly plunger rod end might result in a NLG disconnect from the retraction system that could allow the nose landing gear to collapse on landing.

- **Mandatory Service Bulletin (MSB):** was released by the aircraft manufacturer on 6 May 2013 as a result of this accident: <http://csobeech.com/files/HBC-SB32-4125.pdf>. It was issued to inspect for, and if necessary, replace the specified nose landing gear plunger assemblies. This must be accomplished no later than 50 flight hours or 9 months from the issuance of the MSB, whichever occurs first.
