Aviation Short Investigation Bulletin

Issue 20

AB-2013-088

Final – 28 June 2013

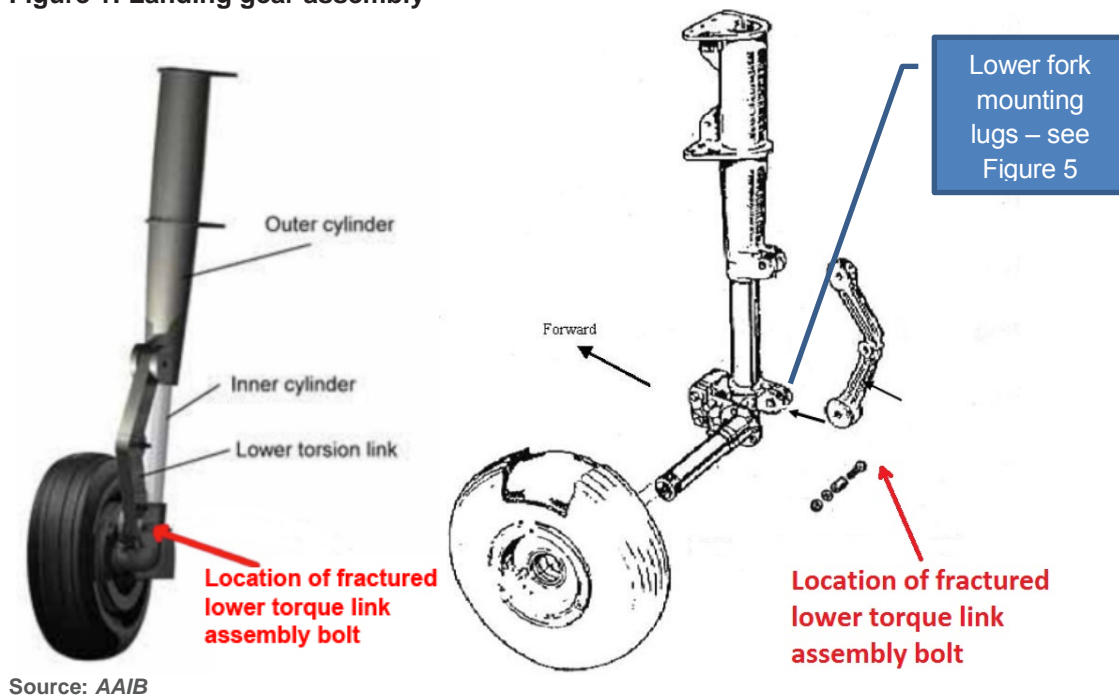
Figure 1: Landing gear assembly

An instructor on the ground watched the aircraft depart and observed an object trailing behind the aircraft. The instructor advised the student via the radio and instructed the student to return and perform a low-level pass so that they could ascertain what the object was. Following the low-level pass, the right main wheel and inner cylinder of the landing gear assembly were observed to have detached from the upper cylinder and to be hanging off the brake line (Figure 1). After a second low-level pass, it was observed that the wheel had completely detached.

The instructor advised the student to hold over the airfield to burn off fuel and allow time for a plan to be formulated. After several hours and with emergency services in attendance, the student was instructed to make a normal approach to runway 36. The aircraft touched down on the runway and slid off to the side coming to rest on the grass. The student was uninjured, however the aircraft was substantially damaged.

The right landing gear assembly and lower torque link bolt were subsequently located and forwarded to the ATSB for examination. The examination of the right landing gear assembly revealed that the lower torque link attachment bolt (Figure 2) had fractured through the final thread. This fracture had allowed the inner cylinder to become detached from the torque link² and to fall from the outer cylinder when the aircraft became airborne.

The examination indicated that the failure of the bolt was due to single-point bending fatigue due to asymmetrical loading (bending from one side) (Figure 3).

Since this incident, the aircraft operator has undertaken to replace all torque link attachment bolts during the next scheduled maintenance on any Piper PA-28 aircraft they operate.

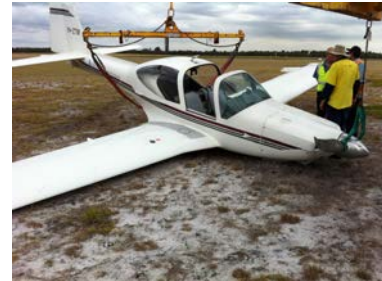
Figure 1: Aircraft damage

At 1135 Western Standard Time,¹ on the student's third solo circuit to runway 06R, ZTM began to drift to the left of the runway centreline. The student elected to go-around and applied full power. Following the application of power, the nose pitched up abruptly and the aircraft then rolled to the left before pitching nose down. The left wing tip contacted the ground and the nose gear and right main gear collapsed before the aircraft came to a stop. The student pilot was able to exit the aircraft without injury, however the aircraft sustained substantial damage.

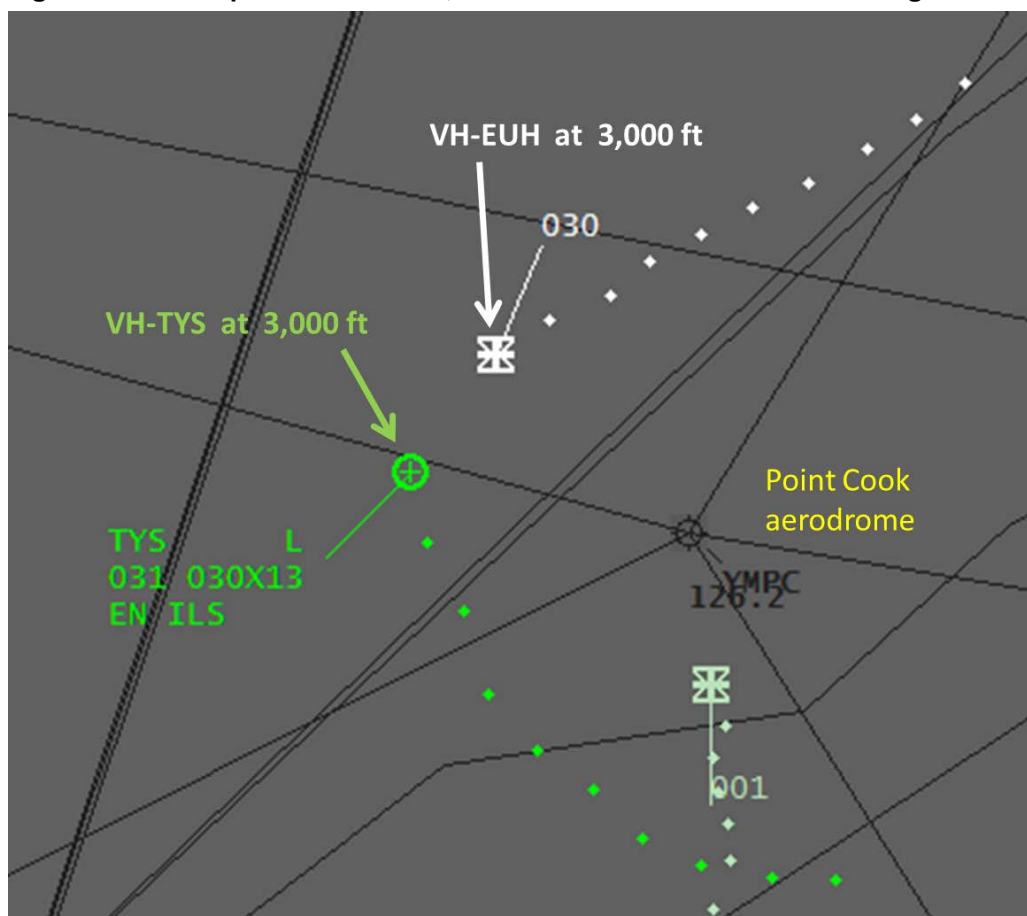
Figure 1: Aircraft positions at 1022, lateral distance 0.4 NM and reducing

At 1022, as TYS was levelling off at 3,000 ft about 1 NM west of Point Cook, the instructing pilot looked to the right and observed a C172 in their 2 o'clock position about 100 m away at the same level (Figure 1). He called 'taking over' and immediately pushed the control column forward to descend below the traffic. The C172 flew about 50 to 100 ft above and about 9 to 12 m behind TYS. The instructing pilot then climbed the aircraft to 3,000 ft and the flight continued with no further incident. While the incident was recorded on Airservices Australia radar system, the incident occurred outside of controlled airspace. The lower limit for controlled airspace was 4,500 ft.

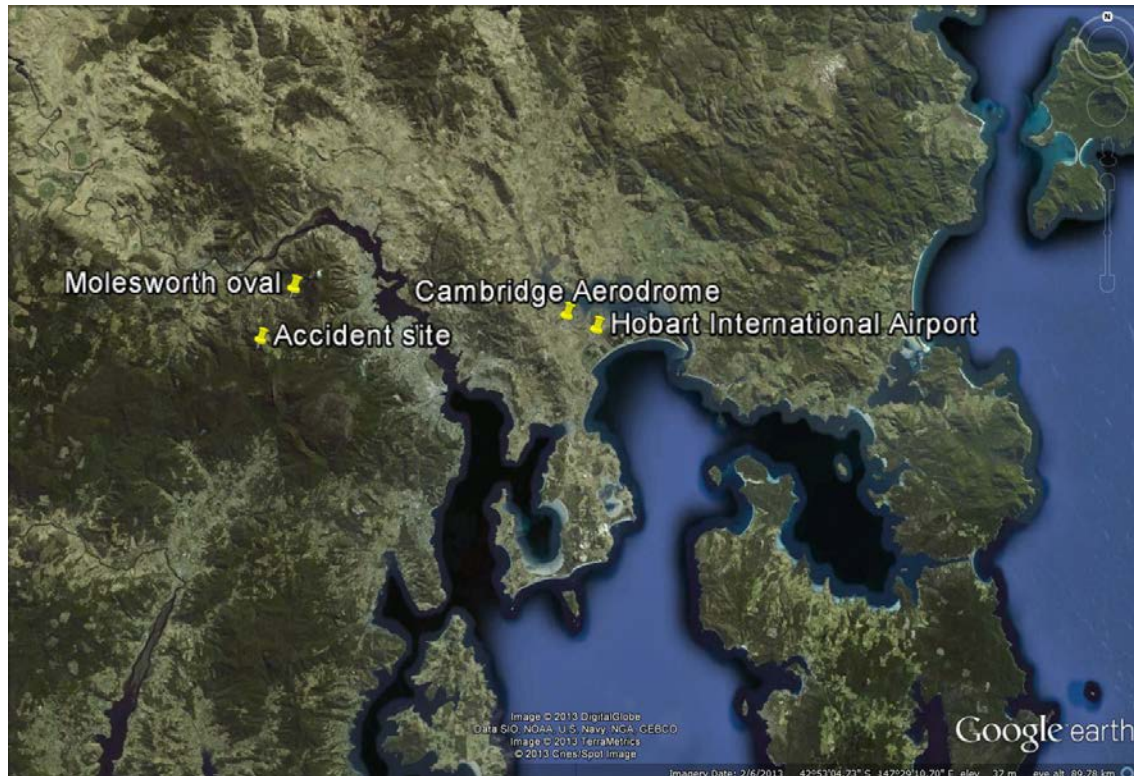
Figure 1: Satellite view of accident site and Cambridge aerodrome

On 7 February, 2013 at about 1655 Eastern Daylight-saving Time¹ a Eurocopter AS350 B2 helicopter², registered VH-EWM (EWM) was conducting water-bombing operations near Hobart, Tasmania, when it collided with terrain (Figures 1 and 2). The pilot, the sole person on board, suffered minor injuries and the helicopter sustained substantial damage.

EWM was one of a group of helicopters involved in mitigation of a large bushfire about 31 km west-south-west of Hobart, Tasmania. At about 1030 that morning, the pilot departed from Cambridge airport to the forward staging area on the Molesworth oval (Figure 1). EWM was one of four helicopters tasked to work on spot fires ahead of the main fire front. The four pilots arranged the spot-fire water-bombing runs between themselves.

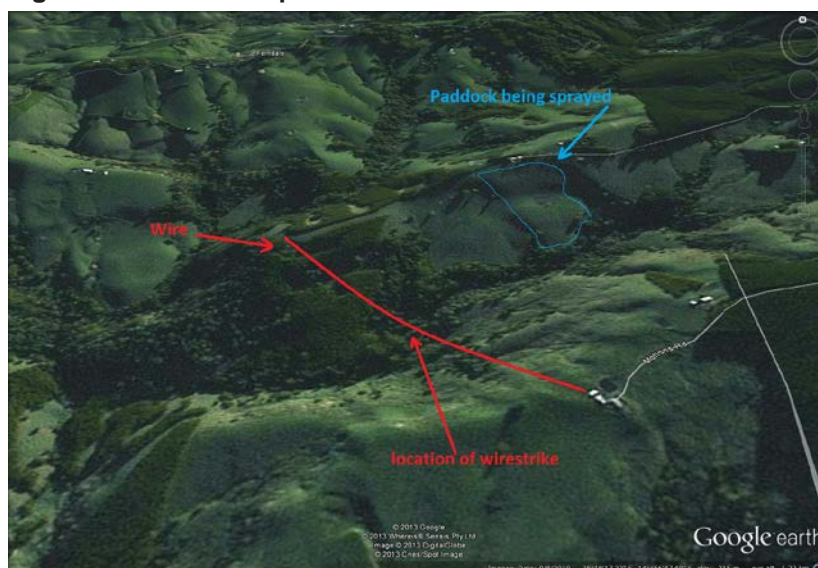
Figure 1: Location of paddock and wire

The pilot performed a run on landing in the nearest clearing, as he had some difficulty in maintaining yaw control, because the tail rotor control cables had lost tension. The pilot was able to exit the helicopter without injury, however, the helicopter was substantially damaged.
