Breakdown and subsequent drift towards danger of the bulk carrier *ID Integrity*

Coral Sea | 18 to 23 May 2012

ATSB Transport Safety Report

Marine Occurrence Investigation 294-MO-2012-005 Final – 22 August 2013 Released in accordance with section 25 of the Transport Safety Investigation Act 2003

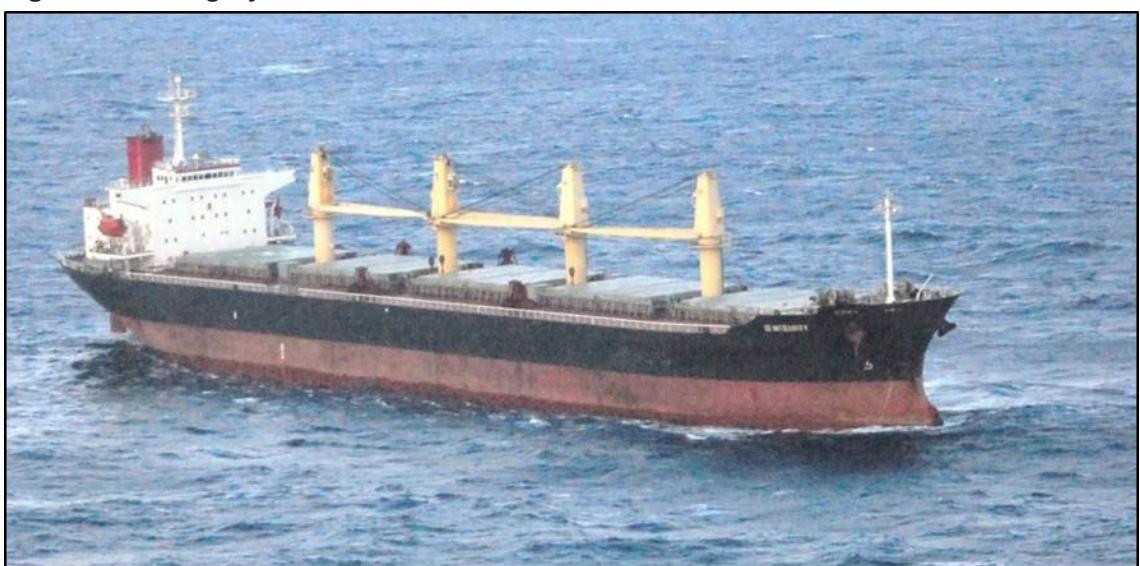
Figure 1: ID Integrity as it drifted across Shark Reef

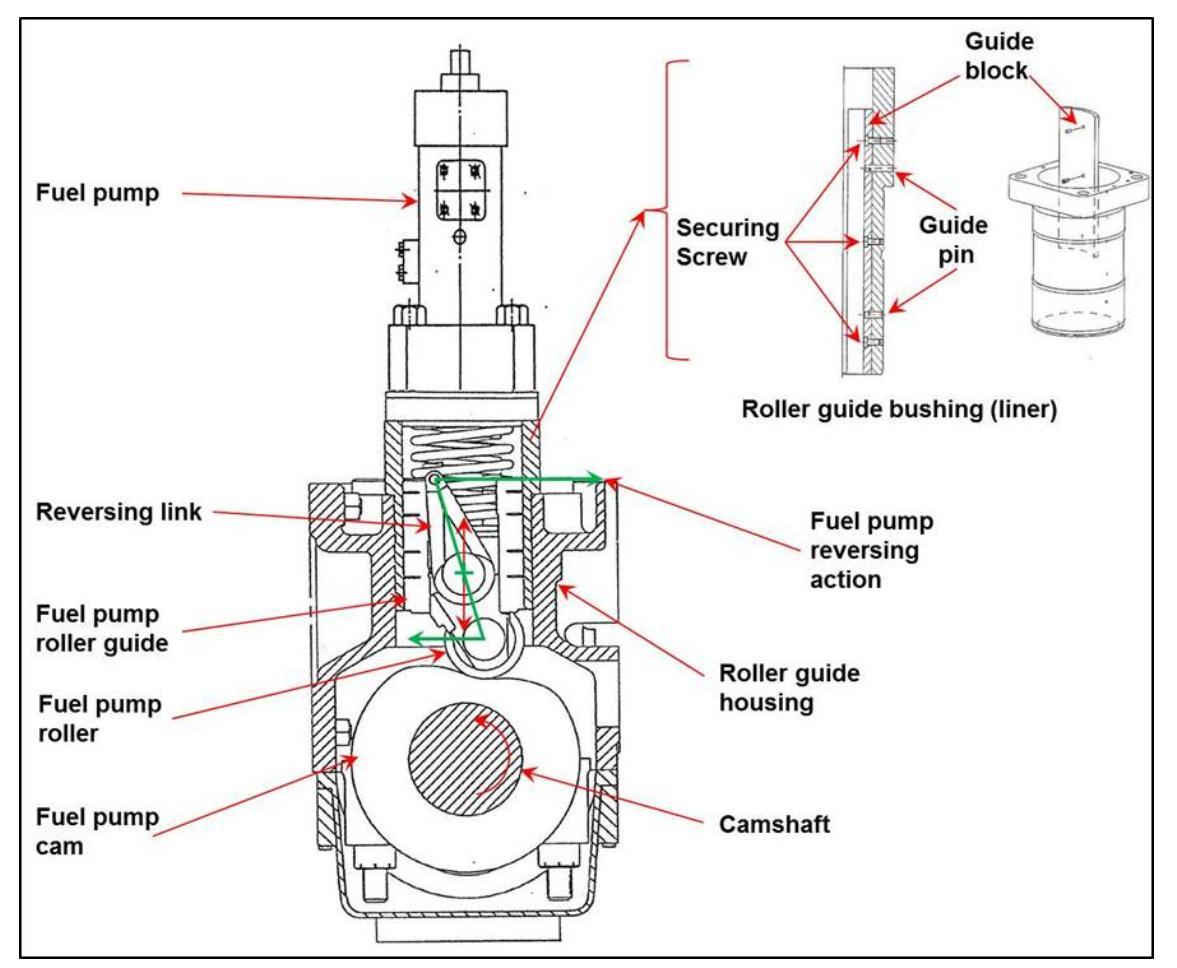
Each main engine cylinder has its own fuel pump mounted on the roller guide housing over the camshaft segment corresponding to that cylinder. Rotating motion of the camshaft is converted to vertical reciprocating motion in the fuel pump through the fuel pump roller and guide (Figure 9).

Figure 9: MAN B&W fuel pump, cam, roller, guide and reversing arrangement
