Australian Government Australian Transport Safety Bureau

# Derailment of freight train 3MC1

Locksley, Victoria | 12 February 2013

ATSB Transport Safety Report Rail Occurrence Investigation RO-2013-006 Final – 11 October 2013 Released in accordance with section 25 of the Transport Safety Investigation Act 2003

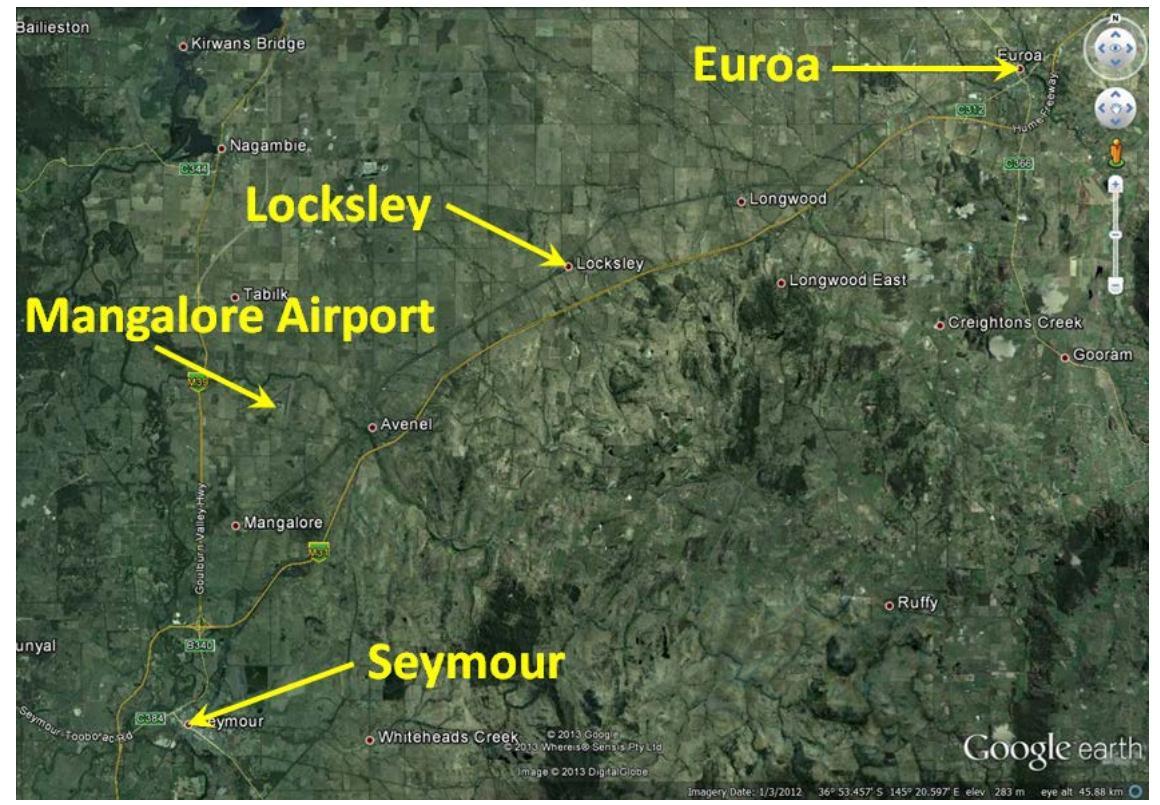
#### Figure 4: Location of Locksley, Victoria

Locksley is the site of a closed railway station adjacent the Defined Interstate Rail Network (DIRN). It is 127.55 km northeast of Melbourne and about 825 km southwest of Sydney (Figure 1 and Figure 4). It is approximately 29 km northeast of Seymour (Victoria) and about 2 km north of the Hume Freeway.
