Engine failure involving Airbus A380, A6-EDA

near Sydney Airport, NSW, | 11 November 2012

ATSB Transport Safety Report
Aviation Occurrence Investigation
AO-2012-150
Final – 9 September 2013

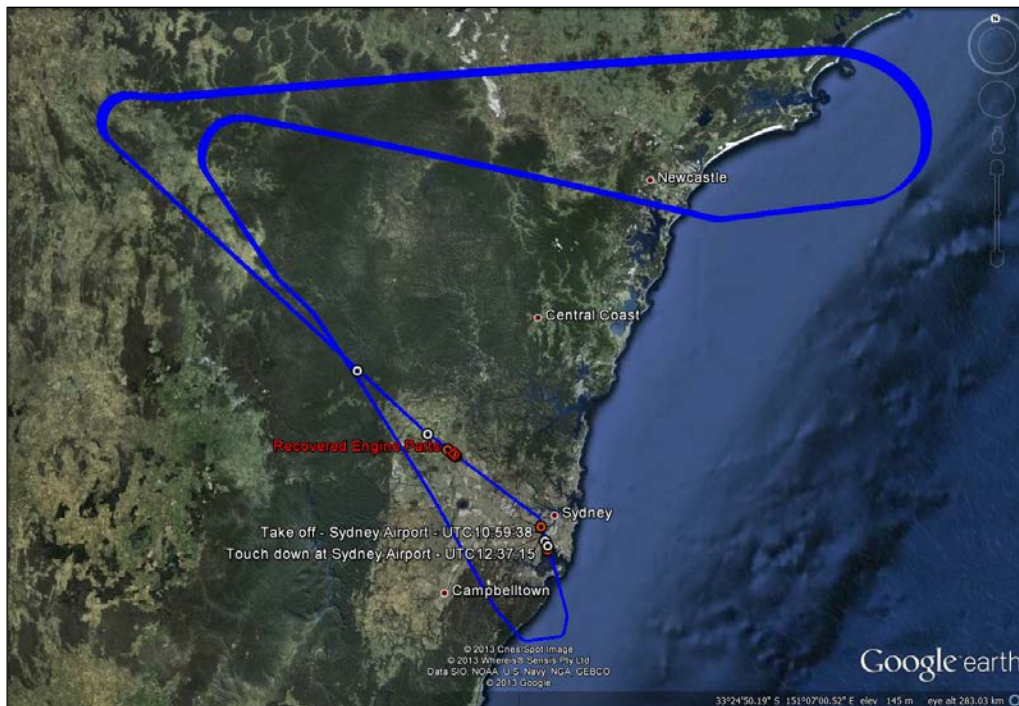
Figure 1: Flight path of A6-EDA following departure from Sydney Airport, NSW

On 11 November 2012, at approximately 2200 EDT¹ an Emirates Airbus A380 aircraft, registered A6-EDA, departed Sydney Airport, New South Wales (NSW) for Dubai, United Arab Emirates. While climbing through an altitude of approximately 9,000 ft, the flight crew reported hearing a loud bang, which was accompanied by an engine exhaust gas temperature over-limit warning. This was followed by an uncommanded shutdown of the No 3 engine (right inboard). The flight crew jettisoned excess fuel and returned the aircraft to Sydney (Figure 1) for a safe landing and disembarkation of the passengers and crew.
