TECHNICAL ANALYSIS REPORT

Report No. 05/04

Occurrence No. 200305447

**Examination of failed Integrated Nozzle Assembly  
and Thrust Reverser components from a  
RB211-524 Turbofan Engine**

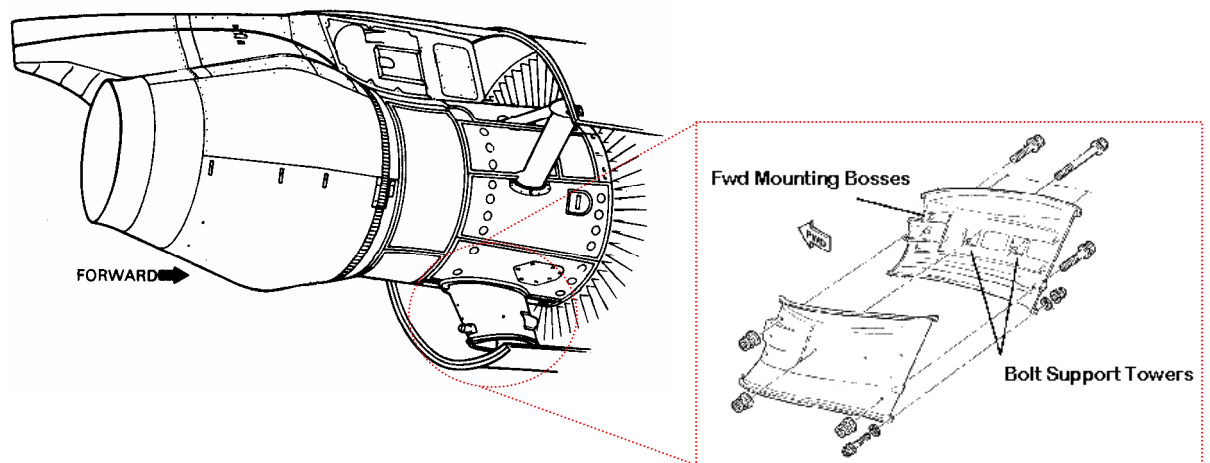
The RB211-524 accessory transfer drive was faired through the INA cold-stream duct by two symmetrical fibre composite shells, adjoined by two central bolt tower fittings and a number of peripheral tie bolts and bosses (figure 9). The part numbers carried by the two fairing halves were *UL23538* and *UL23537* respectively. Both panels also carried stencilled or written information relating to repair operations conducted by the aircraft operator.

**Figure 9.** Basic schematic of the drive fairing shells and bolting arrangement. Enlarged diagram courtesy of the operator's Power Plant Engineering department report S-AB1/1.
