Aviation Short Investigation Bulletin

Issue 23

AB-2013-166

Final – 31 October 2013

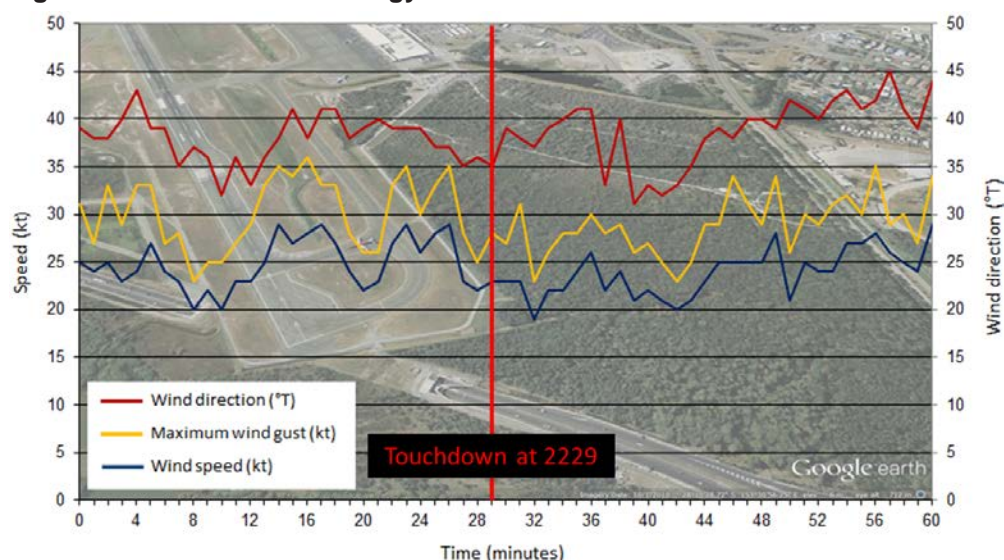
Figure 2: Bureau of Meteorology one-minute data

The BoM subsequently provided the Australian Transport Safety Bureau (ATSB) with one-minute interval data recorded by the AWS. A graphical depiction of the wind speed (kt), maximum wind gust (kt) and wind direction (°True) between 2200 and 2300 is shown in Figure 2.

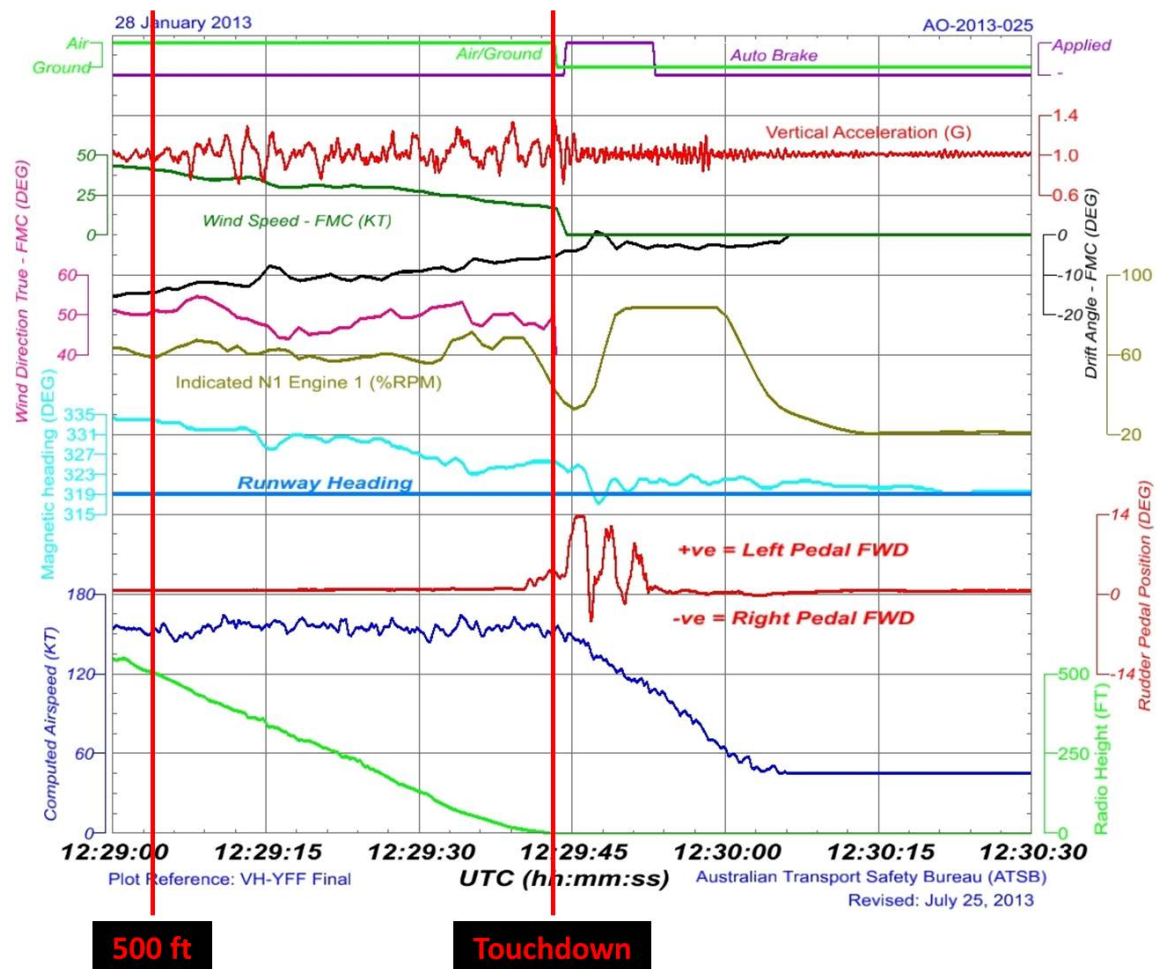
Figure 3: Summary of flight data

The aircraft was fitted with a quick access recorder (QAR) and following the incident, the data was downloaded and provided to the ATSB.⁸ The data showed the following (Figure 3):

- The wind speed and direction recorded by the aircraft's flight management computer was about 41 kt and 51° (True) at 500 ft, 25 kt and 52° (True) at 100 ft, and 17 kt and 50° (True) on the ground.
- The recorded values of the vertical acceleration showed that the aircraft experienced mild turbulence during the descent and at about 500 ft, this increased to moderate turbulence.
- At about 115 ft AMSL, engine thrust was increased.
- The autobrakes activated on touchdown and then about 8 seconds later, manual braking was commenced.
- Prior to landing, left rudder had been applied. This application was continued until several seconds after touchdown when right rudder was applied. Over the following 6 seconds, additional rudder movements were made to align the aircraft with the runway centreline.

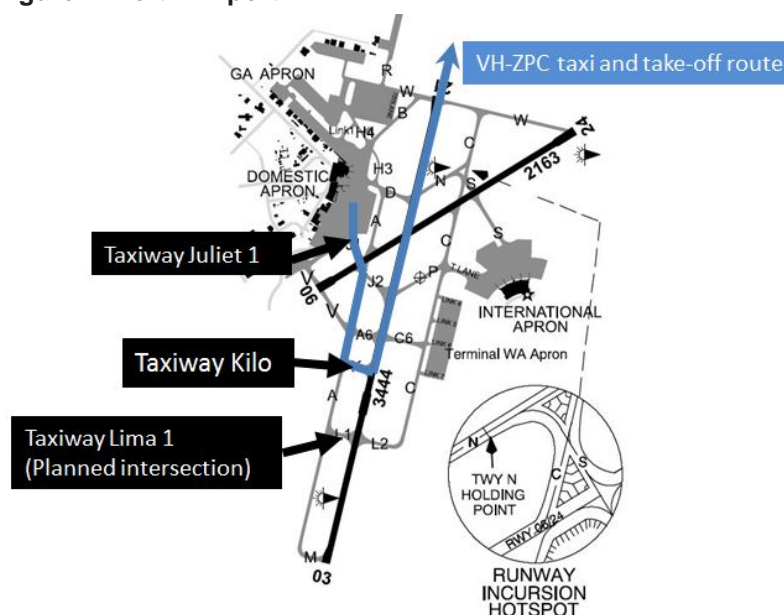
Figure 1: Perth Airport

The FO requested a taxi clearance to the taxiway 'Kilo' intersection of runway 03, and that clearance was given by air traffic control (ATC). The crew did not recall performing the usual taxi route briefing at that time. The captain then taxied the aircraft as per the ATC clearance, across runway 06 via taxiway 'Juliet 1', then via taxiway 'Alpha' to 'Kilo' from where they were cleared to take off on runway 03 (Figure 1). The FO conducted the standard take-off review, which included checking that the departure runway was correct, but did not have a requirement to verify the intersection.

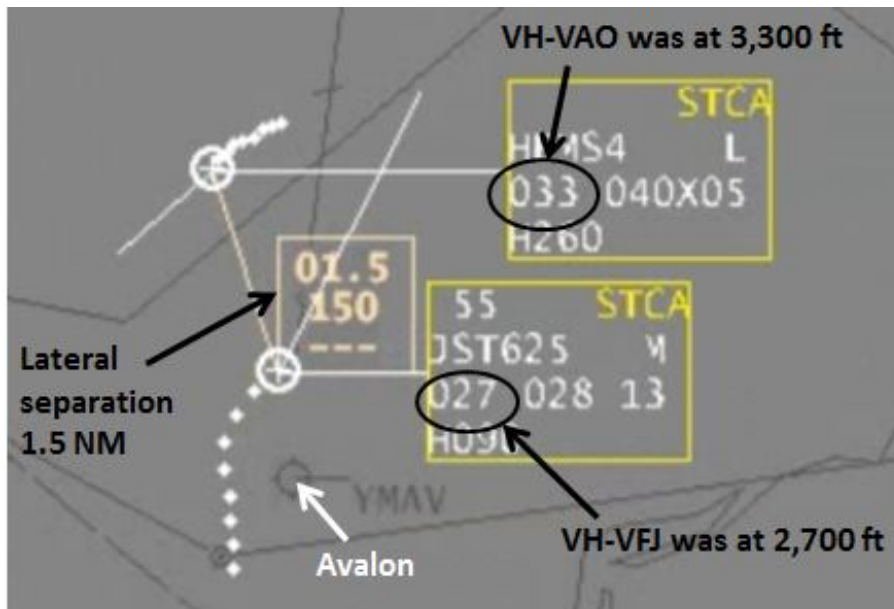
Figure 1: The positions of VH-VAO and VH-VFJ at 2040

The controller then instructed the crew of VFJ to make an immediate right turn and advised them of the location of VAO, 500 ft above and 2.3 NM ahead. As VFJ turned right, vertical separation reduced to 600 ft and lateral separation to 1.5 NM (Figure 1). The crew of VFJ continued the right turn and subsequently landed at Avalon without further incident. The pilot of VAO continued tracking west for his destination.

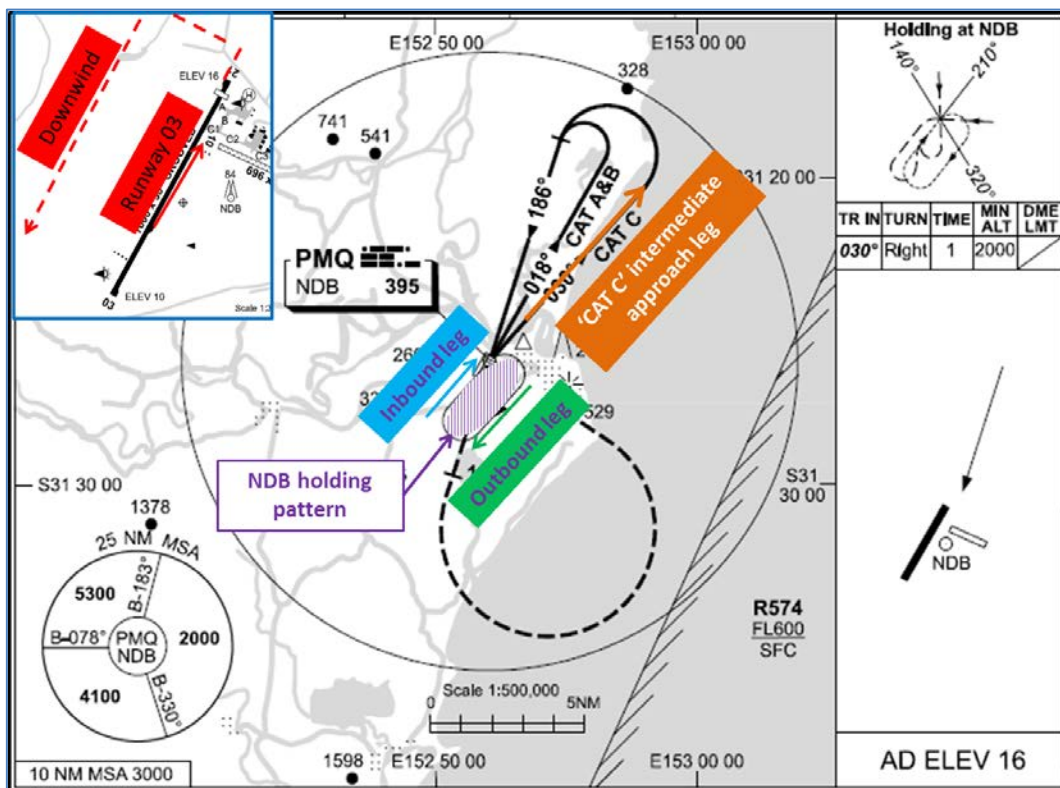
Figure 1: Port Macquarie NDB approach

The crew planned to enter the Port Macquarie non-directional (radio) beacon (NDB)¹ holding pattern at 3,600 ft and then conduct an NDB approach to runway 21 (Figure 1 and Figure 2).

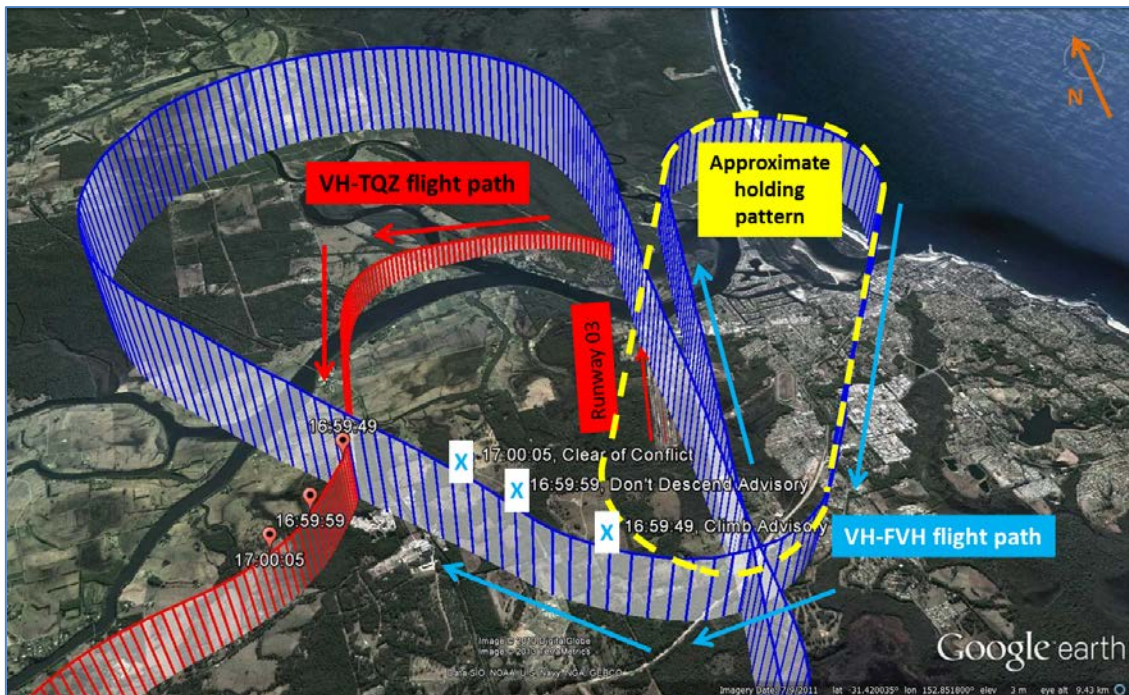
Figure 2: Summary of flight data

The flight data recorders (FDR) were downloaded from TQZ⁹ and FVH and the data provided to the ATSB. The data showed the following (Figure 2):

- At 1659:49, while at 3,536 ft, the crew of FVH received a TCAS RA to climb.
- At 1659:53, FVH commenced a climb.
- At 1659:52, separation between FVH and TQZ reduced to about 290 ft vertically and 1.6 NM horizontally.
- At 1659:55, TQZ was observed commencing a descent.
- At 1659:59, the crew of FVH received a 'do not descend' TCAS RA.
- At 1700:05, the crew of FVH received a 'clear of conflict' TCAS message.
