Wirestrike involving Cessna 172 VH-TKI

13 km NE of Bendigo, Victoria | 29 October 2012

ATSB Transport Safety Report
Aviation Occurrence Investigation
AO-2012-142
Final – 7 November 2013

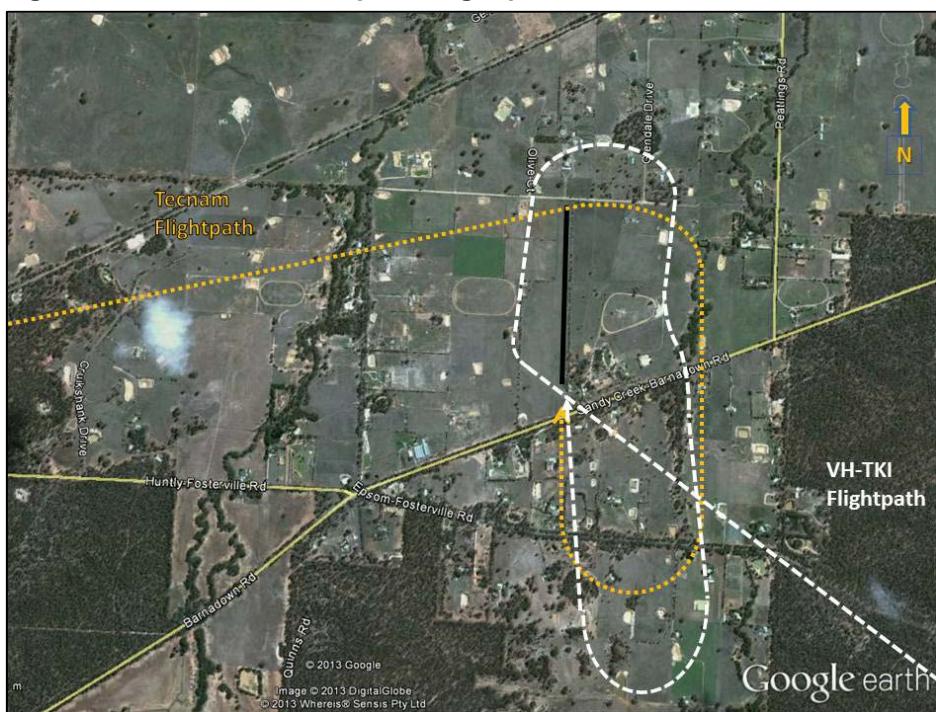
Figure 1: Overview of airstrip and flight paths

TKI arrived overhead the ALA at approximately 1254 Eastern Daylight-saving Time.¹ The PIC and passengers reported observing a Tecnam Eaglet (Tecnam) aircraft conduct a right circuit and landing from the south at the ALA. The pilot of TKI then overflew the airstrip and also carried out a right circuit in preparation for a landing from the south. The rear-seat passenger of TKI described a shortened circuit to land in the northerly direction. Figure 1 shows the estimated circuits of the two aircraft based on the recollections of the occupants of the Tecnam, an observer at the ALA and the rear-seat passenger in TKI.

The PIC of TKI could not recall conducting a right-hand circuit.

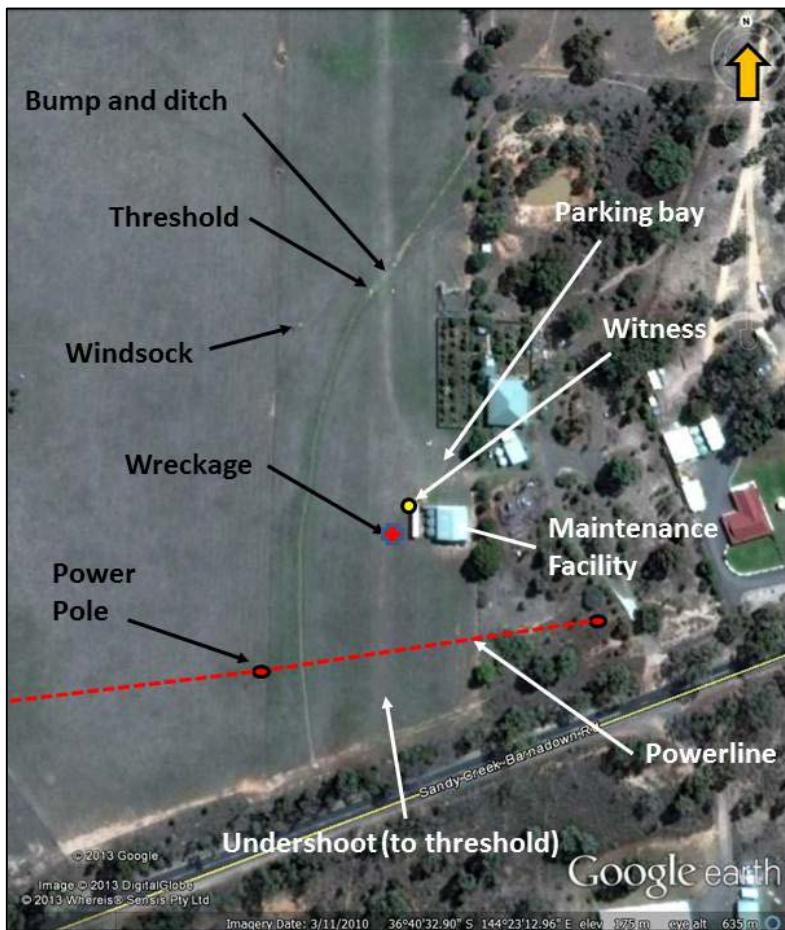
Figure 3: The ALA with witness location

The privately-owned, grass ALA was primarily used by aircraft undergoing maintenance at the property (Figure 3). The maintenance facility was operated by the ALA owner and was located at the southern end of the airstrip, adjacent to the parking bay.

The airstrip was oriented approximately north-south on a magnetic bearing of 355°, with a useable length from the permanently-displaced threshold to its northern end of about 900 m. Two threshold markers were located adjacent to the airstrip to indicate the threshold (Figures 3 and 4). These markers were the only markings on the airstrip, apart from one road verge-like post with a reflector that was abeam the threshold. The airstrip was otherwise defined by a 10 m wide mown area (Figure 4).

The owner of the ALA reported that the threshold was permanently displaced to the north due to the proximity of the maintenance facility, the position of the powerline and trees and the location of a culvert and associated bump in the surface of the airstrip. Although easily distinguished from directly above, the threshold markers were partially obscured by grass when viewed from the final approach perspective (Figure 4).

South of the threshold markers, the undershoot area was mown for a further 180 m back to the fence line, giving the undershoot the same appearance as the airstrip. This mown area provided extra take-off length to the north but was not intended to be used for landing from the south. A wind sock was located close to the threshold markers (Figure 3).

The 125 m span crossed the airstrip undershoot area 47 m to the north of the tree line and 136 m south of the permanently displaced threshold, and was orientated from the south-west to the north-east at an angle of 75° to the airstrip centreline (Figure 3). The eastern power pole was situated amongst the garden and established trees associated with the dwellings. This pole was about 75 m east of the centreline of the airstrip. The western power pole was situated in an open paddock about 50 m west of the airstrip centreline.

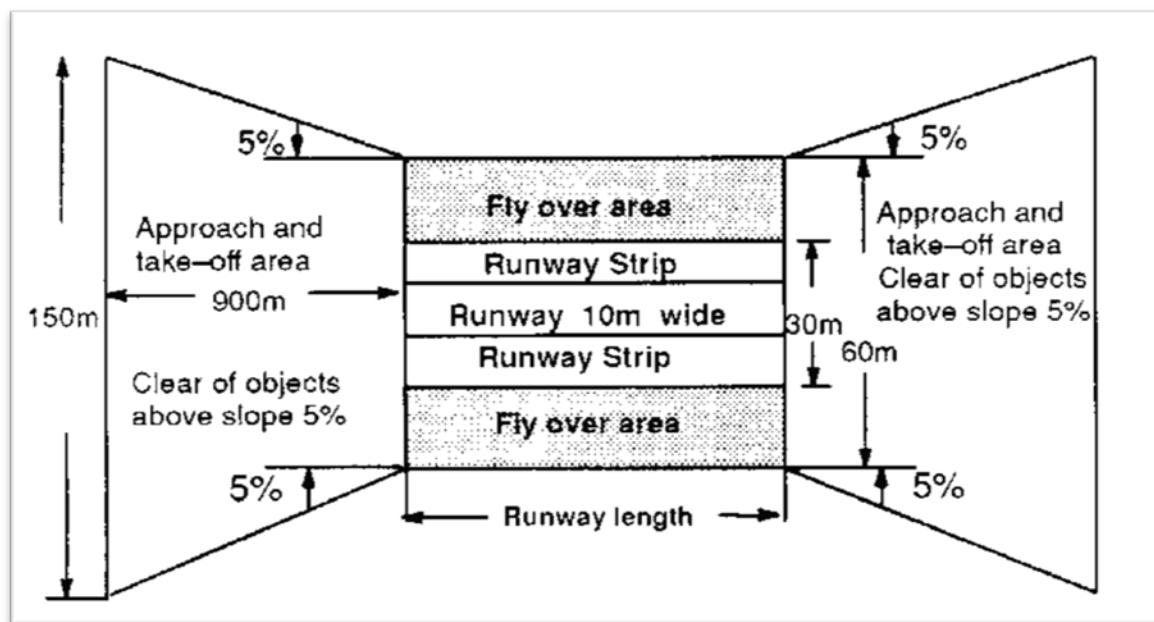
Figure 10: Recommended obstacle area

The ATSB assessed the obstacle area to the south of the ALA in accordance with the guidelines in CAAP 92-1(1). This assessment found that the approach and take-off area to the south of the airstrip complied with the guidelines.

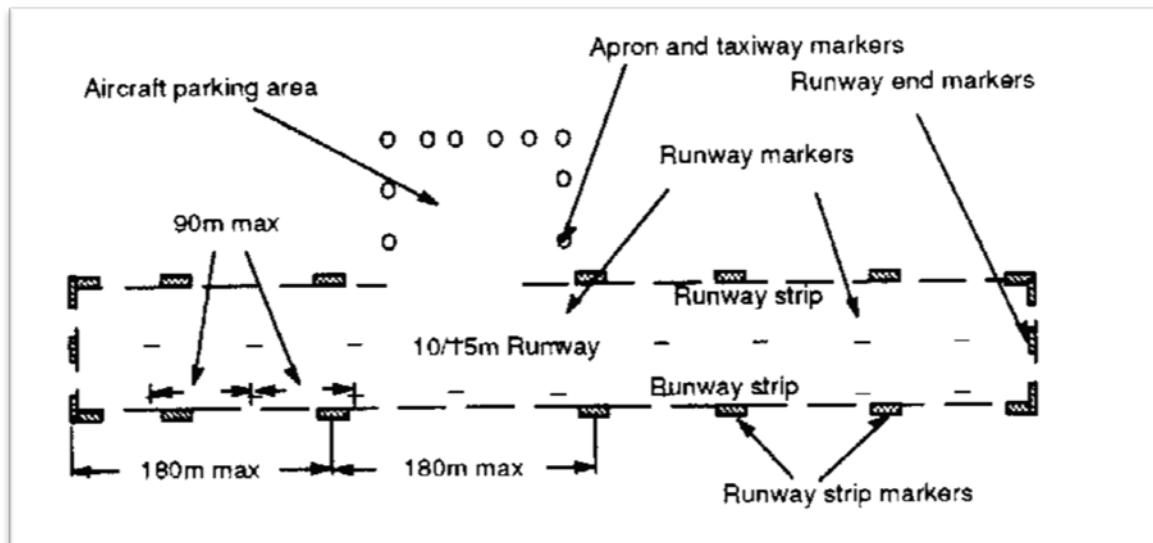
Figure 11: Typical ALA layout and marking

The ATSB found that the ALA markings did not conform to the CAAP 92-1(1) guidelines. However, the requirements of the CAAP represented guidelines only; there was no mandatory requirement for the ALA to conform to this guidance material.

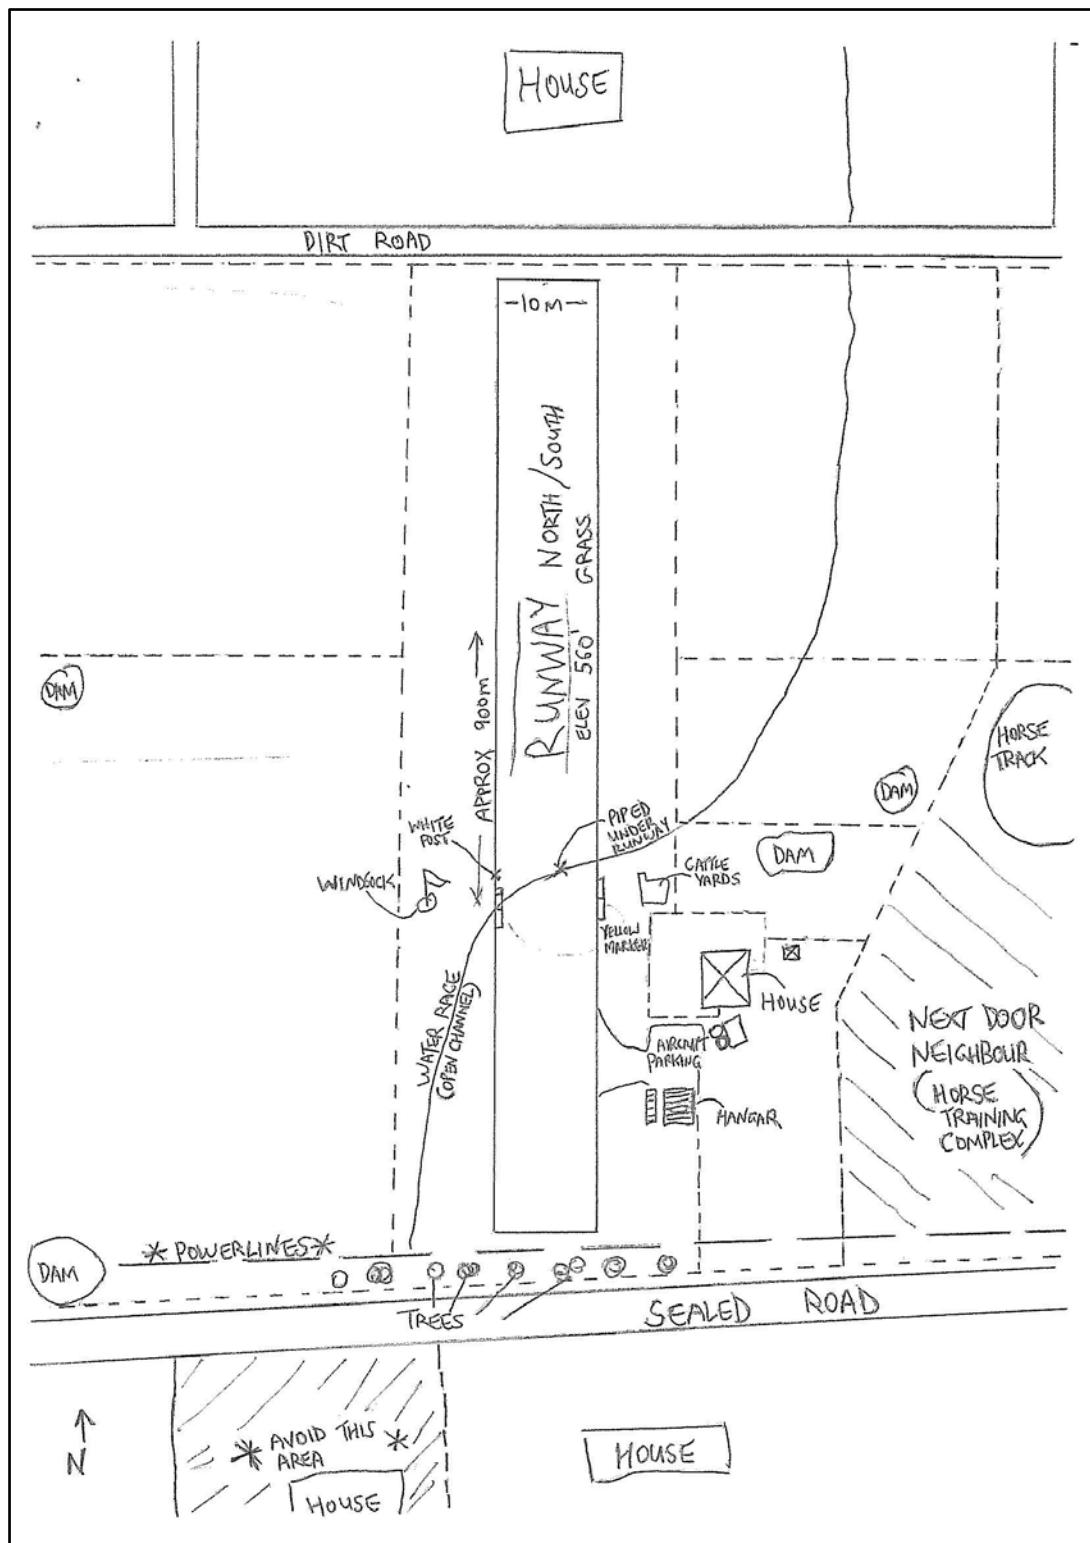
Appendix A – Aircraft landing area owner's diagram as provided to pilots

The owner of the ALA supplied pilots with a hand drawn diagram of the ALA (Appendix A), depicting the location of hazards and operational procedures. The ALA diagram was not drawn to scale and showed the powerlines close and parallel to the road. A note on the diagram stated 'If landing from the south, touch down after [the] windsock to avoid trees, powerlines and [a] bump where pipes go under [the] runway'.
