Multiple SPAD by freight train 9837

Hurlstone Park, New South Wales | 30 January 2013

ATSB Transport Safety Report

RO-2013-003

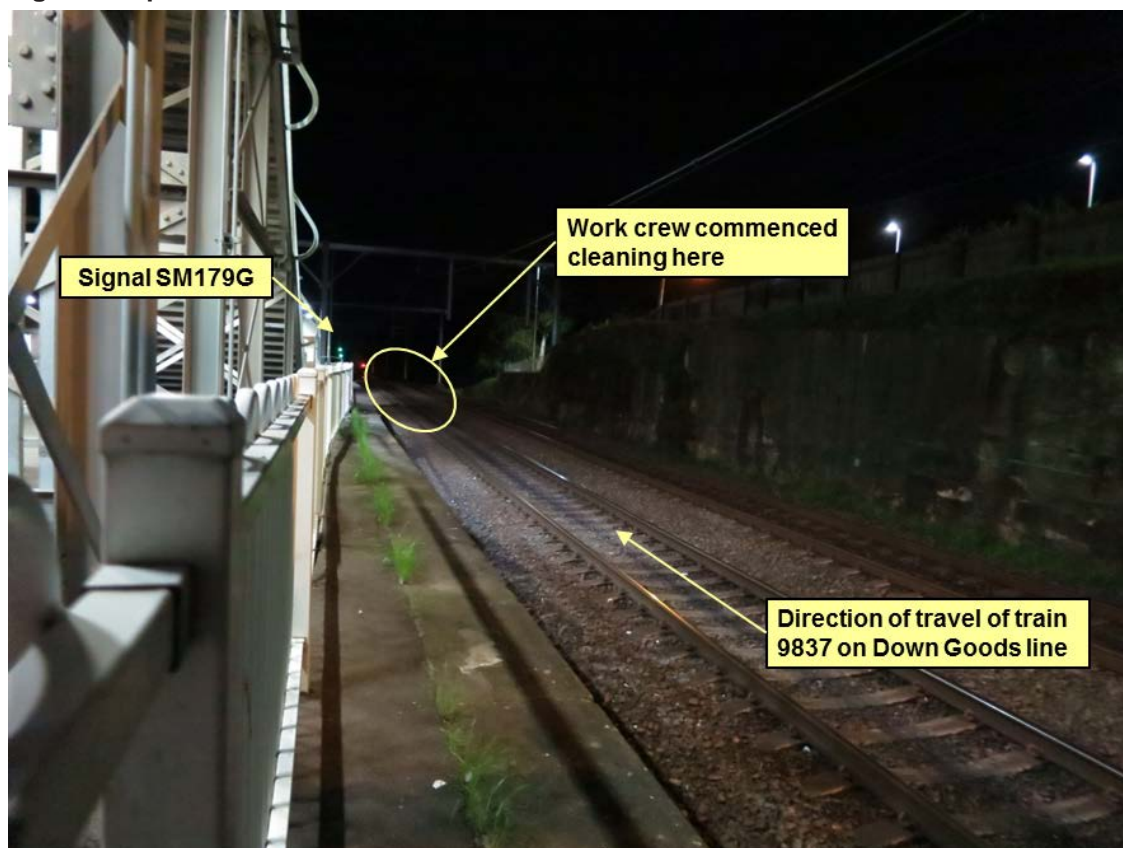
Figure 1: Up and Down Goods lines at Hurlstone Park station

The protection officer for the work crew called the area controller, located at Sydenham signal complex, at 0203 and requested authority to work on the Up and Down Goods lines adjacent to Hurlstone Park station platform 1 (Figure 1). The protection method used was Absolute Signal Blocking (ASB) whereby the area controller placed signals at stop to prevent rail traffic from entering the affected section. Due to the amount of rail traffic on the Goods lines at that time, the request was initially refused.

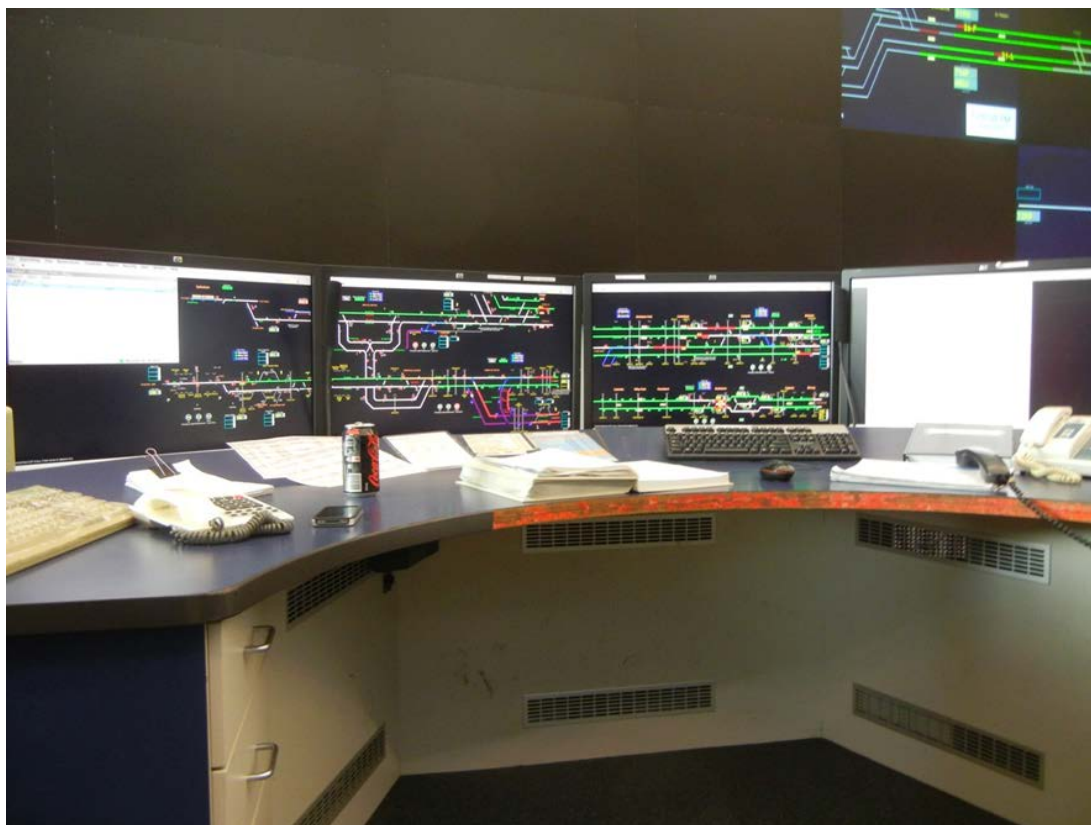
Figure 5: Sydenham signal complex – Meeks Rd-Campsie control panel

vital¹⁰ centralised traffic control system which enables real time monitoring and control of the signals and points. The area controller's area of responsibility is displayed over multiple LCD monitors. The Meeks Road–Campsie control panel is shown in Figure 5.

Examination of the ATRICS replay revealed that, when the area controller utilised a command in ATRICS to block signals SM109G and SM115G, the track beyond those signals, in the usual direction of travel, changed from white to blue, indicating a block on the section. The colour changes demonstrate there is recognition of physical changes to the track conditions at the software level.

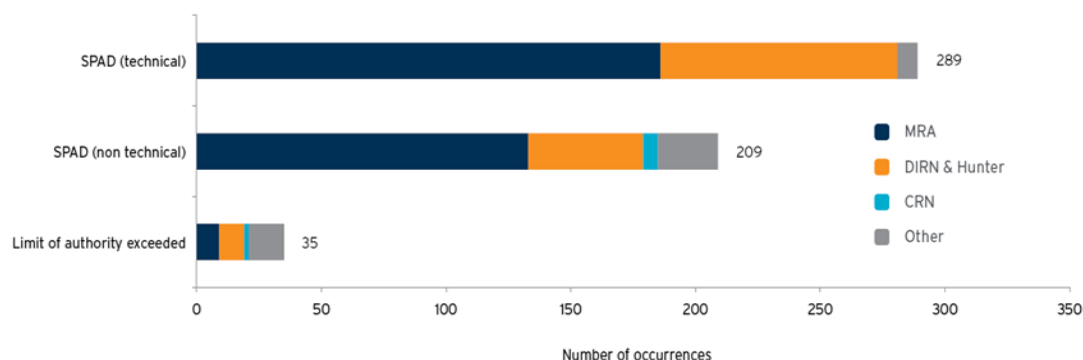
Figure 8: SPADs on the NSW rail network, 2011–2012

The Independent Transport Safety Regulator of NSW (ITSR) published an annual summary of SPAD occurrences in NSW which summarised the safety performance of the NSW rail network and considered historical trends. Figure 8 below shows the number of SPAD events in 2011–2012. For analysis purposes, SPADs are categorised into a technical SPAD, non-technical SPAD or limit of authority exceeded events. The most common type is technical SPAD with 289 occurrences. Technical SPADs involve a signal changing its indication from proceed to stop as the train is approaching the signal giving the driver insufficient time to stop the train. The SPAD event where train 9837 passed two signals at stop approaching Hurlstone Park falls under the category of a non-technical SPAD. In 2011–2012 there were 209 of these occurrences. The third type is the limit of authority exceeded occurrence. This is an event such as when a train passes a stop board in a yard. In 2011–2012 there were 35 of these occurrences.

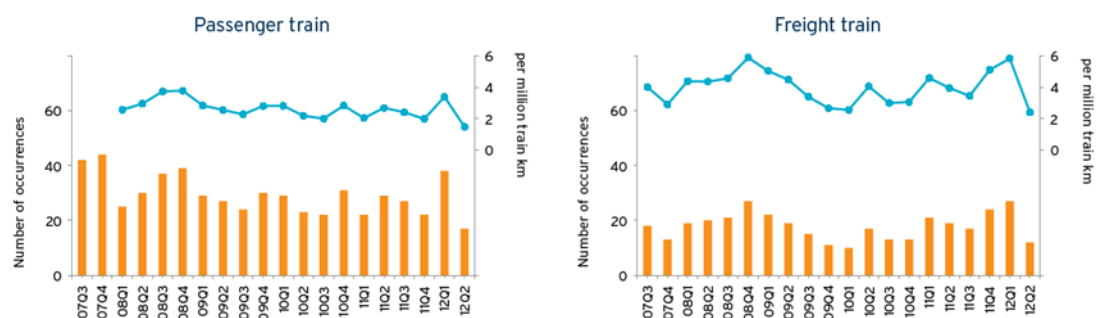
Figure 9: Signal passed at danger (non-technical) on the NSW rail network, 2007–08 to 2011–2012

SPAD data presented in Figure 9 summarise occurrences that involved non-technical SPADs on the NSW rail network for the five years from 2007–2008 to 2011–2012. The rate of SPADs for

freight trains over the period (3.9 per million train km travelled) was much greater than that for passenger trains (2.3 per million train km travelled) despite freight trains travelling over track with a greater proportion of unsignalled track.

The ITSR found that the number of crew performance SPADs on the metropolitan rail area had decreased over the five-year period despite an increase in train movements. ITSR analysed the rates of non-technical SPAD events per million kilometres for the three years to December 2010 and found that the SPAD rate for freight trains in NSW was around 30% higher than that of passenger trains.¹⁶ Some potential contributing factors to a higher rate of freight train SPAD events include increased mass and velocity of freight trains and differing mental workload conditions associated with the freight and passenger train driving task.
