Collision between a truck and passenger train 8205

Pettavel Road Level Crossing, Mount Moriac, Vic | 7 September 2013

ATSB Transport Safety Report Rail Occurrence Investigation RO-2013-024 Final – 11 February 2014 This investigation was conducted under the *Transport Safety Investigation Act 2003* by the Chief Investigator, Transport Safety (Victoria) on behalf of the Australian Transport Safety Bureau in accordance with the Collaboration Agreement entered into on 18 January 2013.

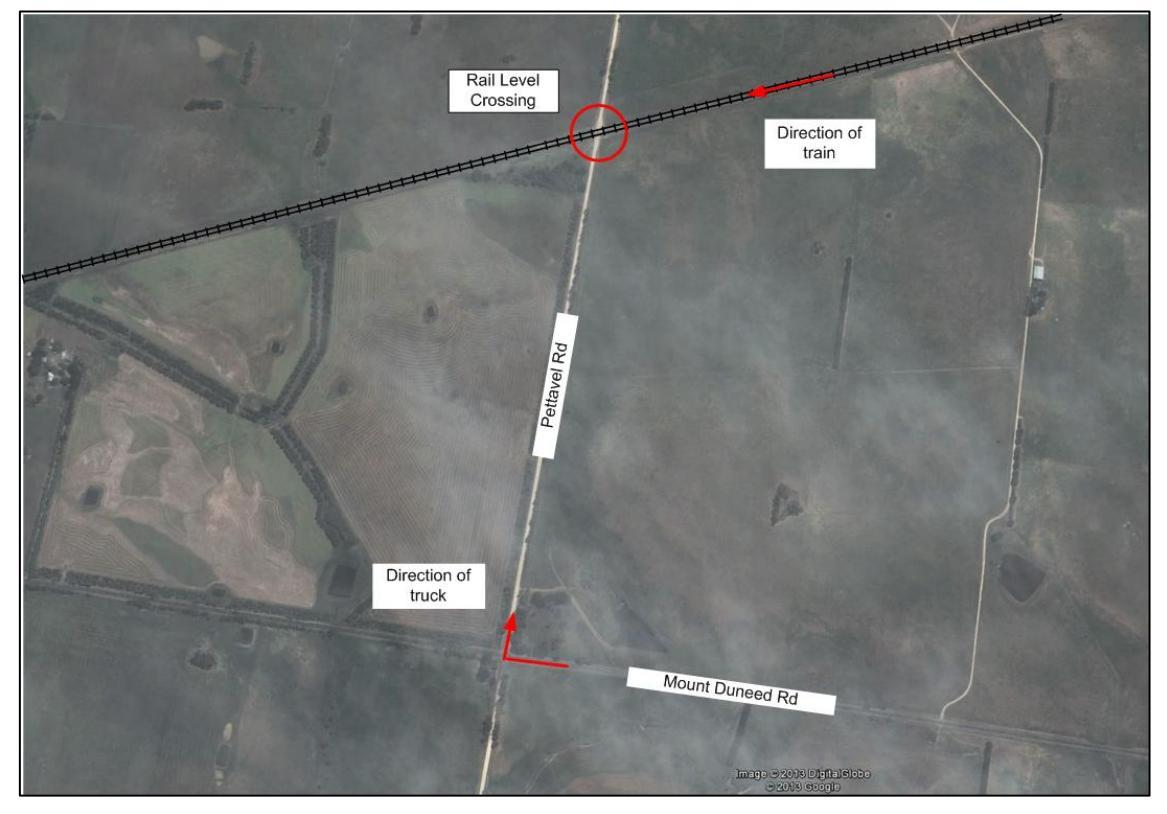
As train 8205 approached the Pettavel Road level crossing from the northeast, a rigid truck and dog trailer combination that was employed in transporting soil from a development site turned onto Pettavel Road from Mount Duneed Road (Figure 1). The truck had completed one trip through this level crossing that morning, and was on the second trip. The truck was loaded with about 10 m³ of soil and the trailer was carrying about 12 m³ of soil.

When the train was about 615 m from the crossing the trucks were observed by the train driver who sounded the whistle for about 3 seconds. The train whistle was again sounded, this time for about 7 seconds, commencing 407 m (whistle board location) from the level crossing. The train driver considered that the trucks had not been alerted to the train so, when the train was about 230 m from the crossing, he made an emergency brake application. About 182 m from the crossing, he sounded the horn for a further 5 seconds and when the train was about 100 m from the crossing, he concluded that the trucks were not going to stop and braced for the collision. The leading truck was observed to go through the level crossing and the second truck followed. As the second truck proceeded through the crossing, the locomotive, which had decelerated to a speed of about 101 km/h, collided with the truck's dog trailer. The locomotive came to a stand about 315 m past the level crossing.

Figure 1 - Overview of truck and train 8205 approach to the Pettavel Road level crossing
