# VFR flight into dark night conditions and loss of control involving Piper PA-28-180, VH-POJ

31 km north of Horsham Airport, Victoria | 15 August 2011

## ATSB Transport Safety Report

AO-2011-100

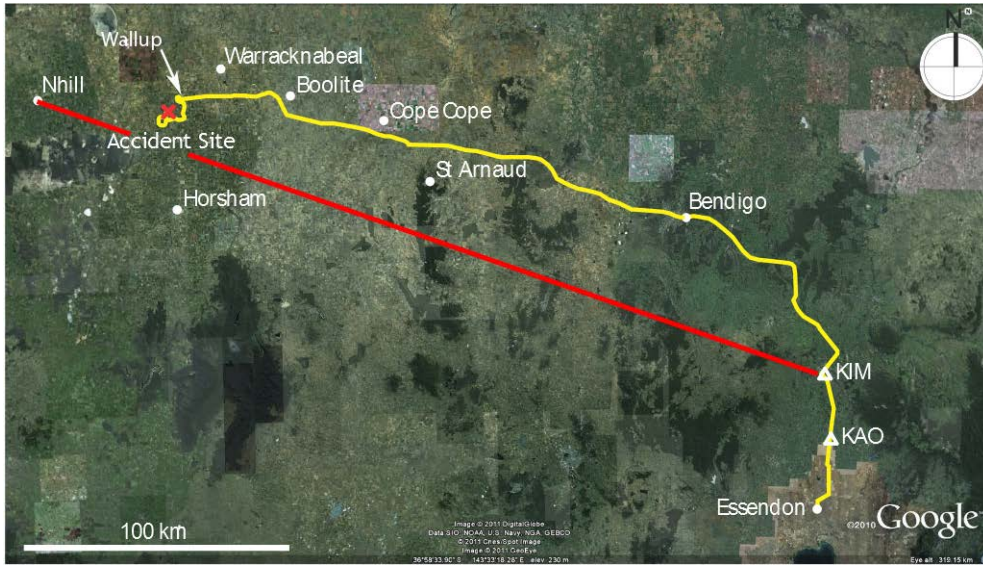
**Figure 1: VH-POJ track in yellow and planned track from KIM in red**

The aircraft departed Essendon at about 1600, which was approximately 1 hour later than the intended departure time. The pilot had initially planned to fly to the VFR waypoints Kalkallo (KAO) and Kilmore (KIM), then direct to Nhill (Figure 1). Given the forecast winds and aircraft performance, that route would have resulted in the aircraft arriving at Nhill at about 1753. However, after passing KIM the aircraft was flown to Bendigo Airport, Vic. landing there at 1649.

Information from a tablet computer that was recovered from the accident site showed POJ departed Bendigo for Nhill at 1711 (Figure 1). At 1748, the aircraft flew approximately 1 km south of Cope Cope. A witness at that location later reported an aircraft flying low with the engine sounding normal and that it had been raining, although not heavily. At about 1801, POJ passed to the west of Boolite, and a witness at that location reported hearing an aircraft that was described as flying low from the south-east to the north-west. That witness reported that it had been raining and had been 'a terrible day'.

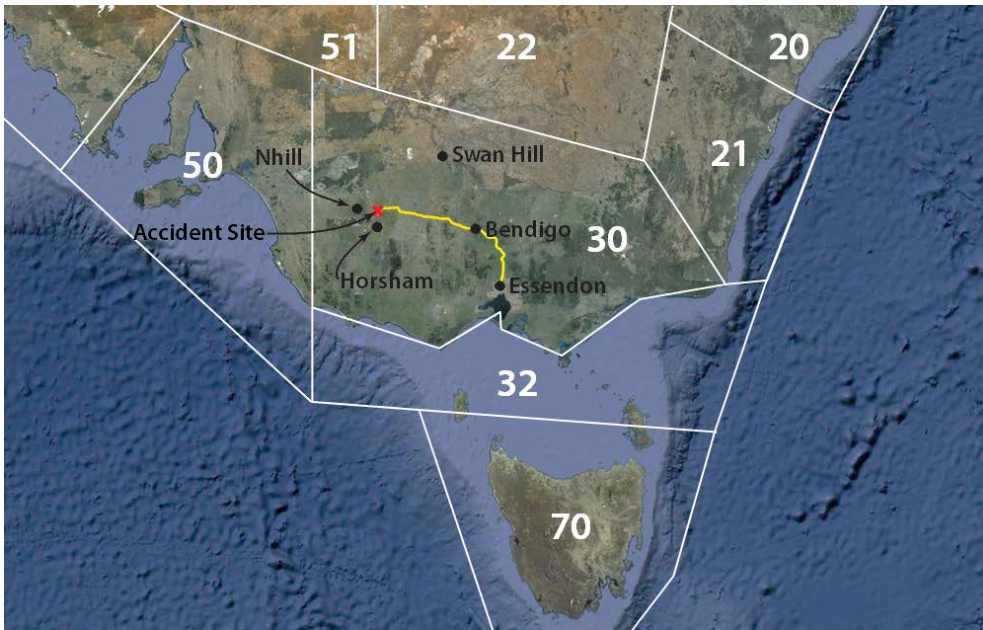
**Figure 2: Area 30**

While on the ground at Bendigo, the pilot logged on to the National Aeronautical Information Processing System (NAIPS)<sup>5</sup> and accessed the latest Area 30 aviation weather forecast<sup>6</sup> and associated reports for the remainder of the flight (Figure 2 - the weather affecting the flight is discussed more fully at the section titled *Operational Information*). It was reported that, while on the ground, a passenger telephoned a family member in Nhill and advised they might have to stay in Bendigo, indicating the pilot may have considered terminating the flight due to the weather conditions. During that telephone call the passenger reportedly received a favourable assessment of the local weather at Nhill.
