Engine flame-out and ditching involving Bell LongRanger helicopter, VH-RHF

Cone Bay, approximately 98 km north of Derby, WA | 8 June 2013

ATSB Transport Safety Report
Aviation Occurrence Investigation
AO-2013-097
Final – 11 December 2013

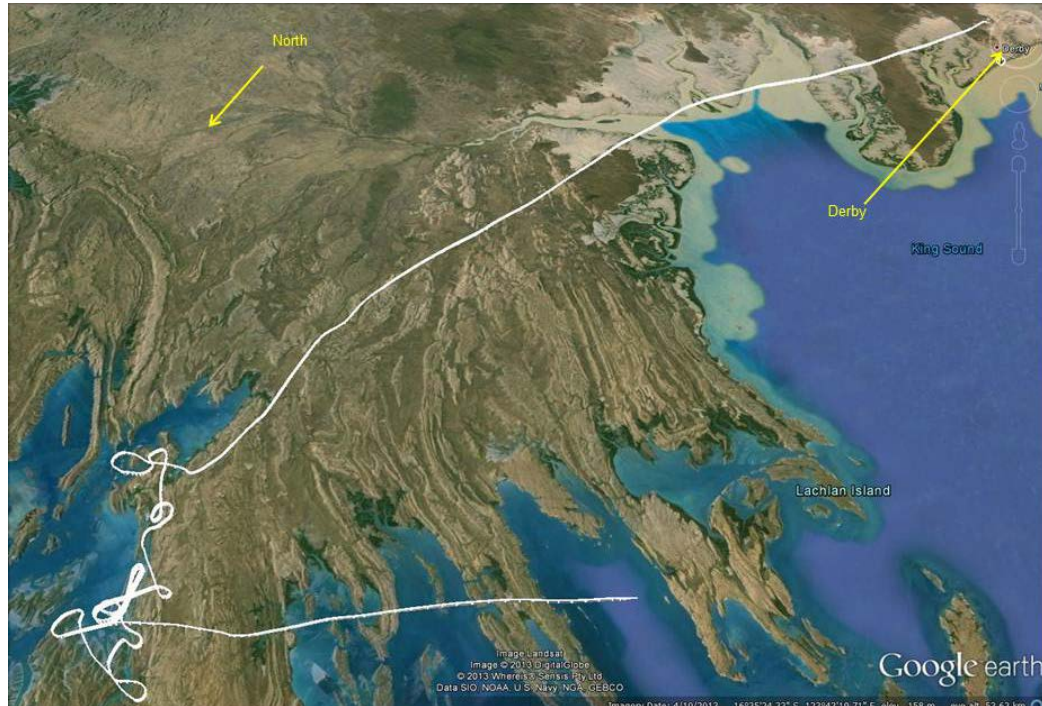
Figure 1: VH-RHF flight track as derived from data from the on-board GPS

A global positioning system (GPS) unit that the pilot was using as a supplemental navigation aid was mounted to the instrument panel. This unit routinely recorded time-based positional data, which was later used by the Australian Transport Safety Bureau (ATSB) for defining tracks, speeds and heights during the flight (Figure 1).

explained that his original intent was to keep in close proximity to land, but as a precaution he altered track to minimise the fuel required to complete the flight. Another consideration for the pilot was the unsuitability of the rough terrain on the overland route in case of a forced landing.

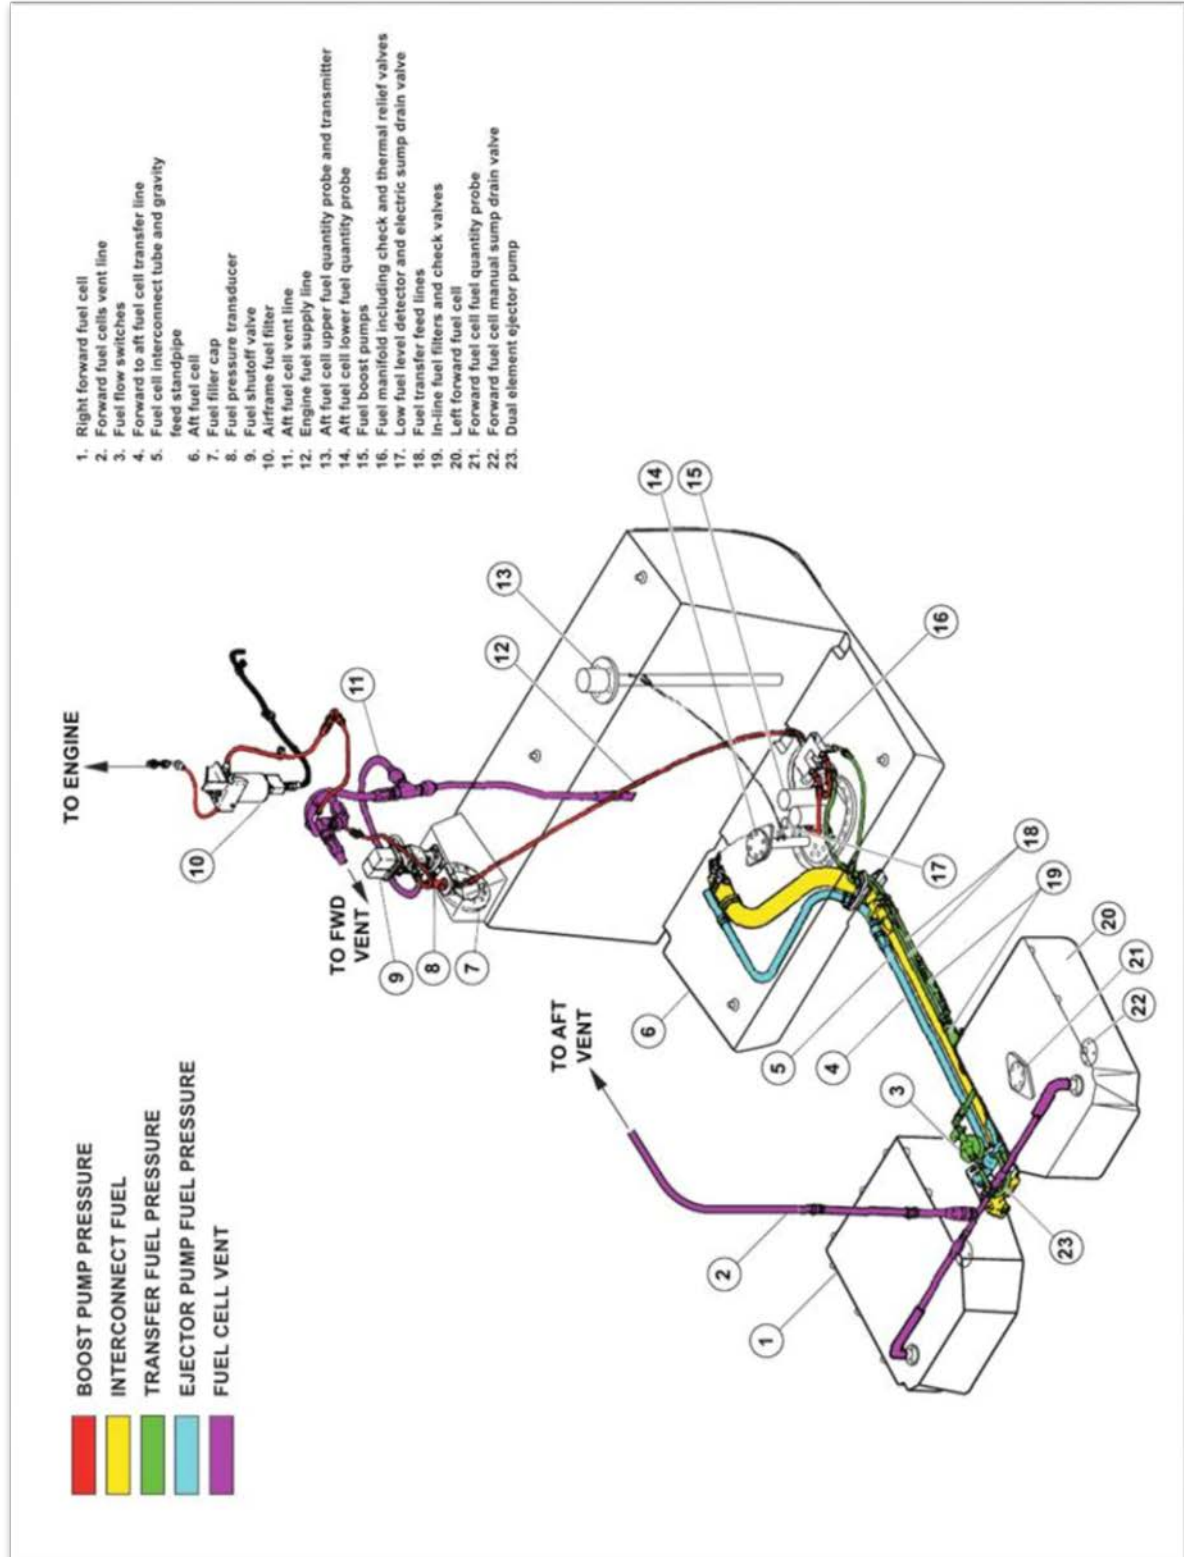
A - Bell 206L3 LongRanger fuel system

When the engine was operating, the inter-tank transfer process was automatic and continuous. If one of the boost pumps failed or a supply line to the ejector pump blocked, the other pump could provide sufficient fuel flow to maintain the inter-tank transfer. Any loss of flow to the ejector pump would be detected by the left or right flow switch and activate the applicable annunciator on the instrument panel. If both boost pumps failed, or both supply lines to the ejector pump blocked, as much as 87 L might remain in the forward tanks and be unusable.

The LongRanger was fitted with an electrically-powered Fuel Quantity Indicating System (FQIS) as standard equipment. In this model helicopter, a probe in the left forward tank and two probes in the main tank were electrically connected to a fuel quantity transmitter incorporated into one of the probes. The transmitter processed the output of each probe and produced an electrical signal to drive the panel-mounted indicator to represent total fuel weight in pounds. Contamination of the fuel probes was known to cause false readings.

The helicopter was also fitted with an electrically-powered low fuel caution system as standard equipment that operated independently of the FQIS. When the fuel quantity in the main tank reduced to somewhere between 28 and 42 L, a float switch in the tank was designed to activate a light on the cockpit caution panel. The helicopter manufacturer warned in the flight manual that uncoordinated flight in this low fuel condition could lead to fuel starvation and sudden power loss.
