Level crossing collision between train 3PW4 and a motor vehicle

Werribee, Vic | 25 May 2012

ATSB Transport Safety Report
Rail Occurrence Investigation
RO-2012-007
Final – 18 December 2013

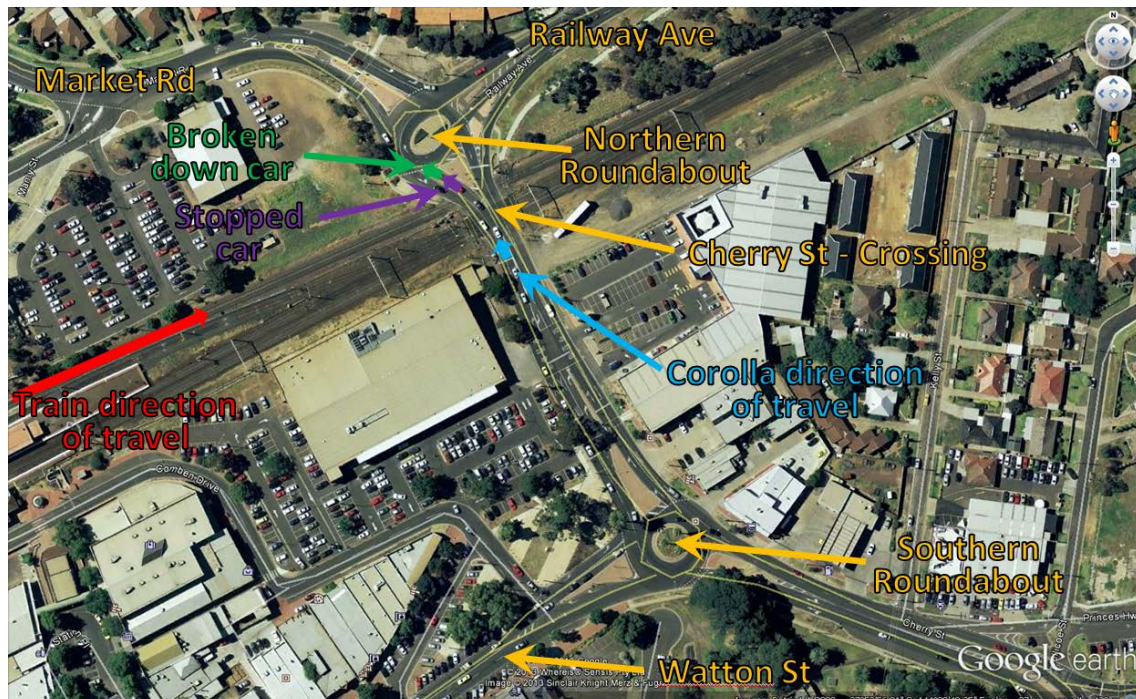
Figure 1: Aerial view of Cherry Street level crossing

At about 1730, a motor vehicle (Holden Barina) was travelling in a northerly direction along Cherry Street. As the Barina traversed the level crossing (Figure 1) its engine stopped. It came to a stand, clear of the crossing, but obstructing the right-hand lane of Cherry Street just before the northern roundabout. The driver attempted to restart the Barina but was unsuccessful. He then switched on the vehicle's hazard lights and made a telephone call to a friend in order to get help.

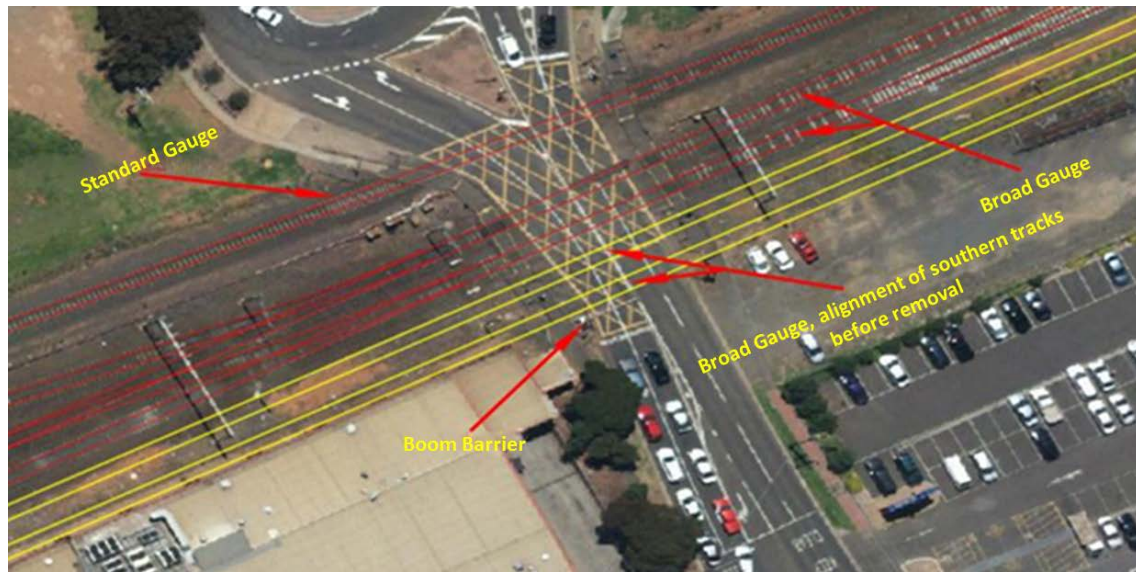
Figure 5: Aerial view with decommissioned and removed tracks shown

The Cherry Street level crossing protection equipment was commissioned in October 1973 and comprised half-boom barriers, flashing lights, bells and associated road signage. At the time of commissioning, there were four broad gauge tracks that crossed Cherry Street (Figure 5).

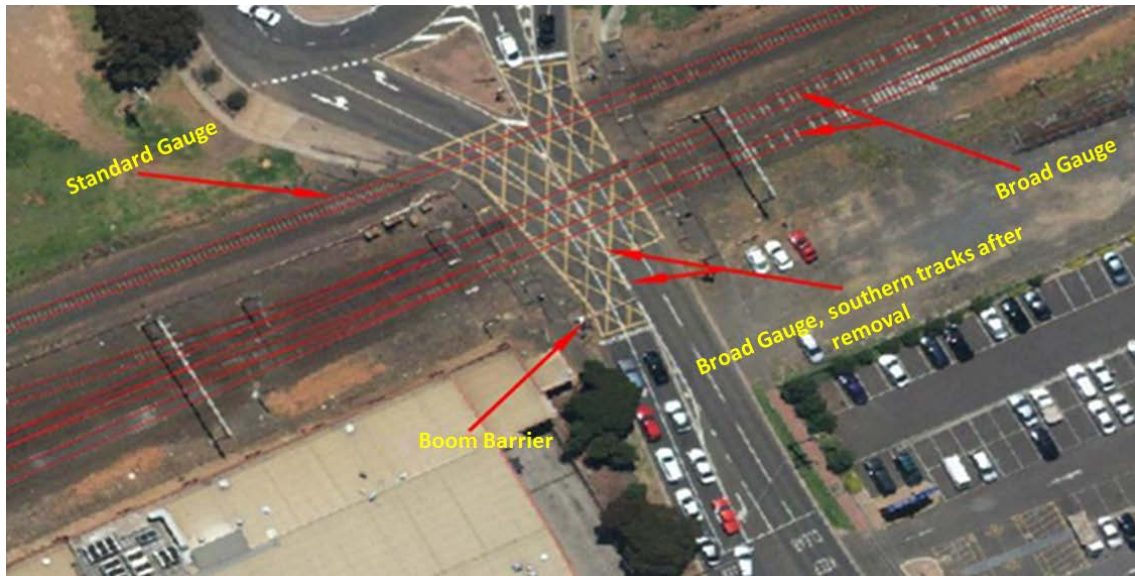
Figure 6: Aerial view of the current standard and broad gauge tracks and the area where two redundant broad gauge tracks were removed

Since then, two of the broad gauge tracks located on the southern side of the crossing had been decommissioned and removed (Figure 6). At this time, the southern boom barrier, flashing lights and bells were not relocated towards the remaining tracks. This resulted in the stop line and level crossing equipment being about 10 m from the nearest running rail on the southern side of the crossing.

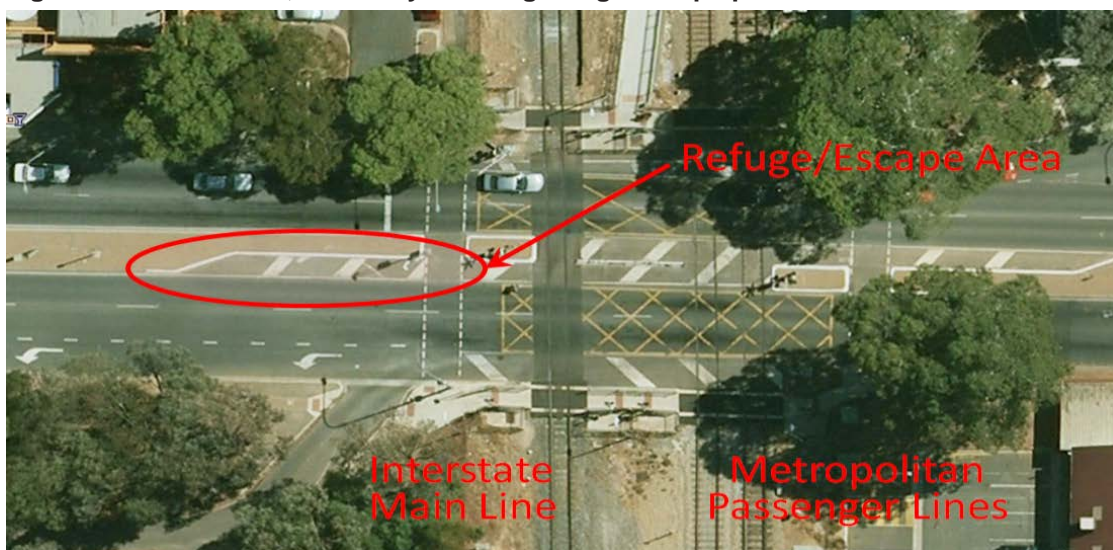
Figure 8: Park Terrace, Salisbury showing refuge/escape post 24 October 2002

- Provision of escape/refuge areas (Figure 8).

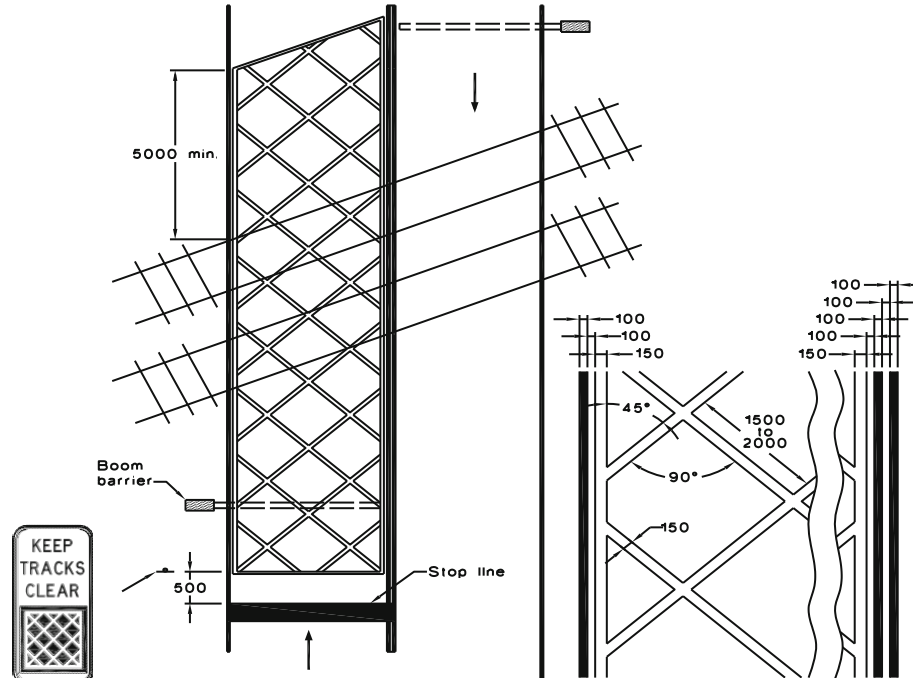
Figure 10: Australian Standard 1742.7-2007 layout of Yellow box pavement markings

The standard states that box markings shall only be used to discourage traffic queuing on a crossing. Where they are used, they should conform to the standard (Figure 10).

The pavement markings at the Cherry Street level crossing were generally consistent with the requirements of AS 1742.7–2007. However, the yellow box markings at the northern end of Cherry Street, immediately before the roundabout, finished about 2 m beyond the nearest running rail rather than 5 m as set out in the standard.
