Total power loss involving a Robinson R22, VH-STK

155 km SSW of Normanton aerodrome, Queensland, 13 November 2013

ATSB Transport Safety Report
Aviation Occurrence Investigation
AO-2013-211
Final – 20 January 2014

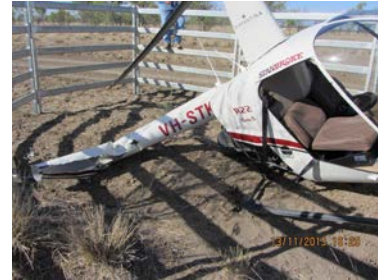
Figure 1: Damage to VH-STK

At about 20 ft above ground level, the engine stopped. The pilot lowered the collective² and flared³ the helicopter for landing. On impact, the helicopter spun around 180° (Figure 1). The helicopter was substantially damaged and the pilot was uninjured.
