Australian Government
Australian Transport Safety Bureau

Aviation Short Investigation Bulletin

Issue 25

AB-2013-215

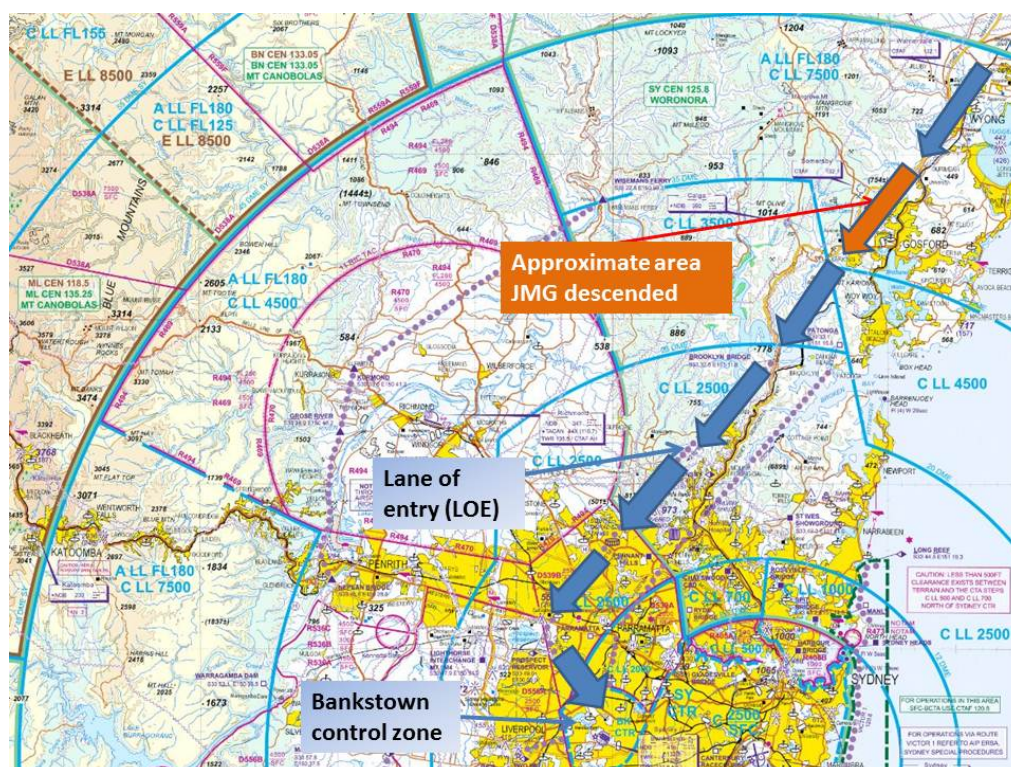
Figure 2: Flight path of VH-JMG

About 20 minutes after entering Williamtown airspace, the pilot recalled waking up. Realising he must have fallen asleep, he gathered his thoughts, checked the aircraft's instruments and then realised that he was now in Class C airspace, about 12-15 NM north of Brooklyn Bridge (Figure 2).

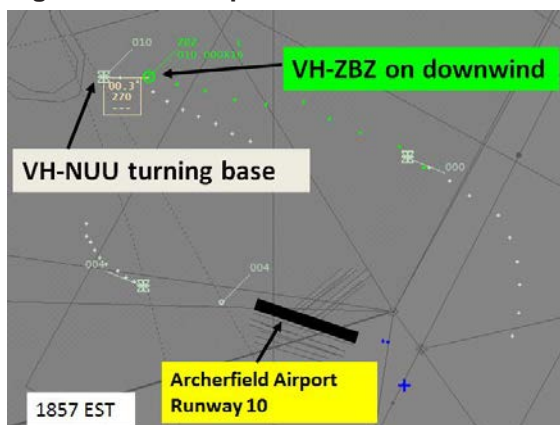
Figure 2: Aircraft positions at 1857

At about 1857 (Figure 2), the pilot of NUU broadcast that he was turning onto base and about 20 seconds later the pilot of ZBZ also broadcast that he was turning onto base for runway 10.

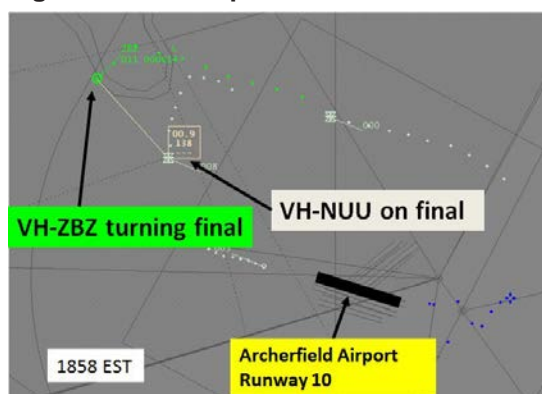
Figure 3: Aircraft positions at 1858

At about 1858 (Figure 3), the pilot of ZBZ commenced turning onto final and then broadcast that he was established on final. He reported that, at that time, he had sighted an aircraft well ahead on late final and believed it was NUU. The pilot of NUU immediately broadcast that he was also on final.

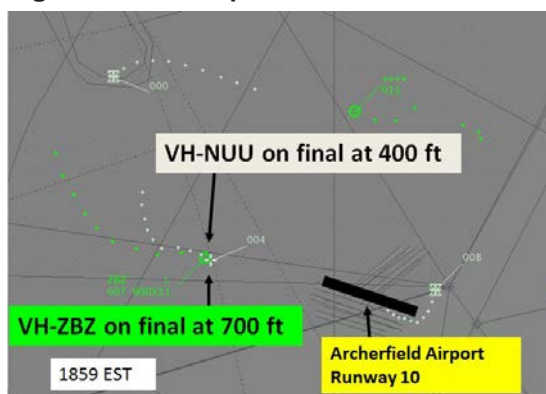
Figure 4: Aircraft positions at 1859

At about 1859 (Figure 4), the pilot of ZBZ saw NUU below his aircraft. The pilot of ZBZ conducted a go-around and NUU continued the approach.

Airservices Australia surveillance data indicated that the vertical separation reduced to 300 ft.

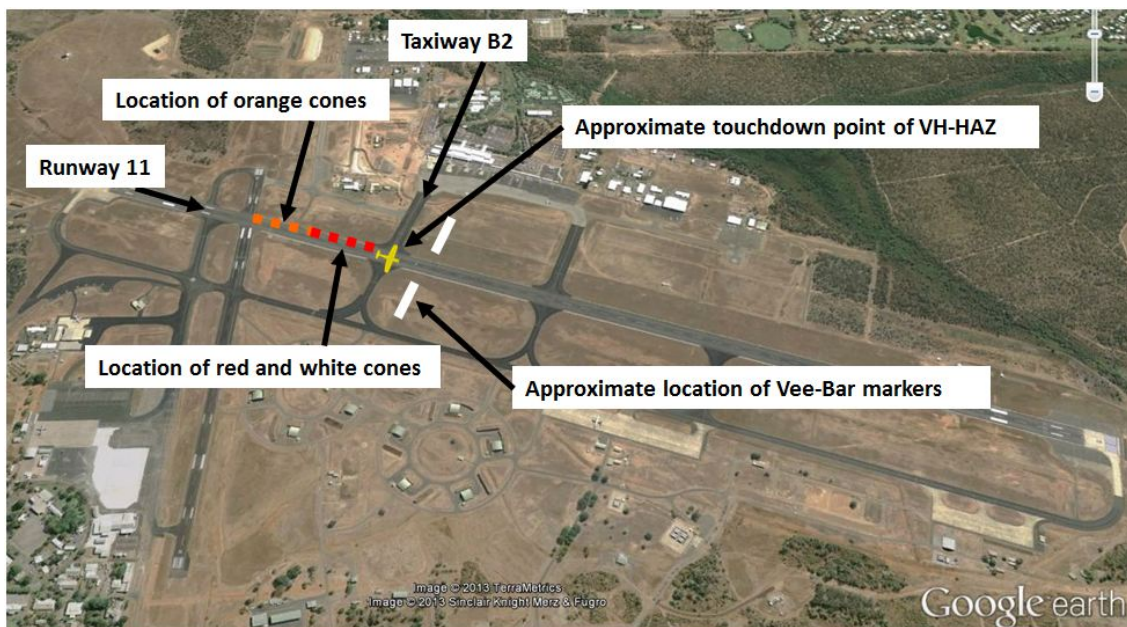
Figure 1: Location of runway works markings

The pilot reported that, after completing his flying duties at about 1830, he was notified by his company that ATC had advised that the aircraft had landed before the displaced threshold.

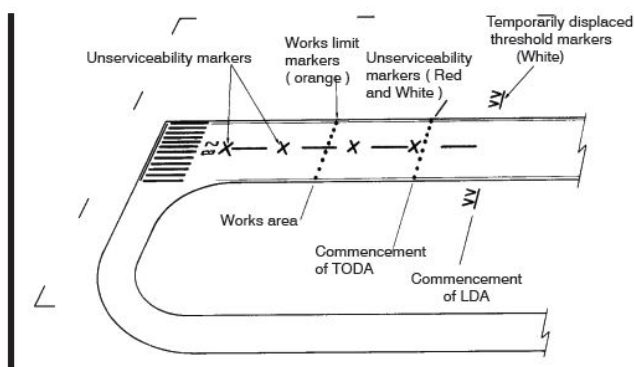
Figure 2: Displaced threshold markings

- a series of inverted 'V' markings (white) painted across the runway; or
- one or two white Vee-Bar markings located on both sides of the runway (Figure 2); or
- at military controlled aerodromes (such as Darwin), for short periods and dependent on military operational requirements, four white cones situated on both sides of the runway.

Figure 9 – Markings for a temporarily displaced threshold due to works on the runway for a period of 30 days or less.
