# Embrittled nut and related failures Robinson R22 Beta helicopter, VH-JNP

22 km N of Saxby Downs, Qld | 12 October 2011

**ATSB Transport Safety Report**  
Aviation Occurrence Investigation  
AO-2011-135  
Final – 22 January 2014

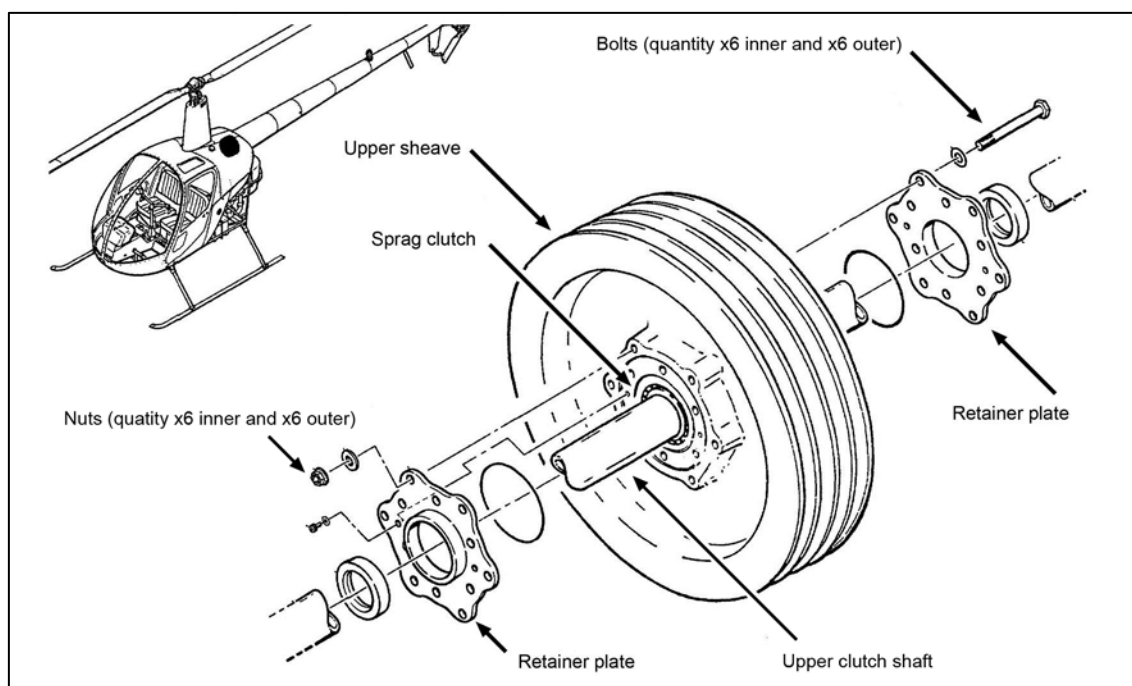
**Figure 2: R22 clutch assembly location and exploded view**

Figure 2 illustrates the R22 helicopter clutch assembly. Along with the clutch shaft, a free-running sprag clutch and two oil seals were secured centrally to the upper sheave by opposing retainers, using an array of six outer and six inner bolts and nuts.

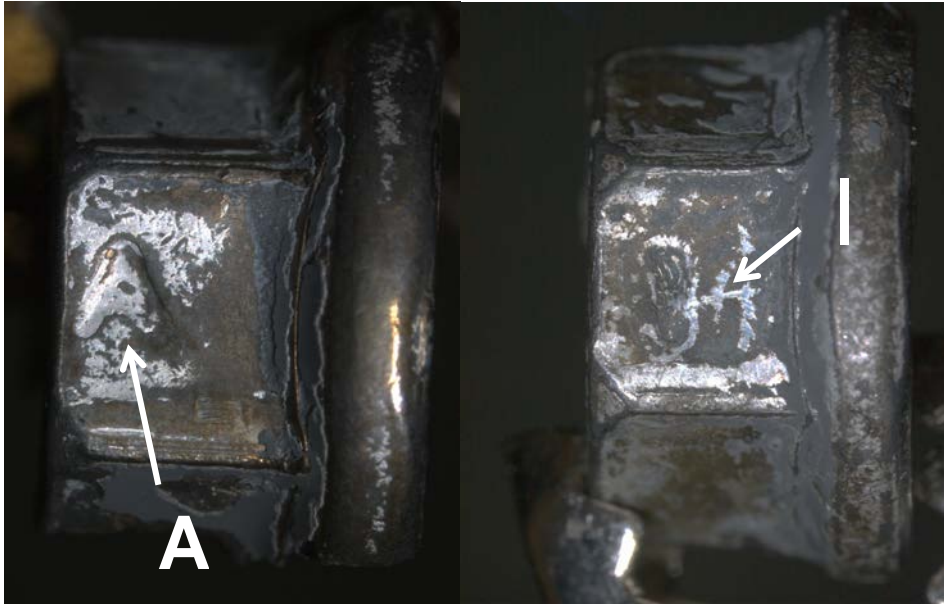
All of the retainer's outer nuts showed hallmark features comprising either an 'A' and/or or an 'I' on their lateral faces. Referring to the US Department of Defence Handbook MIL-HDBK-57F(IS) - 2011, this combination of identifiers was attributed to Airfasco Industries Fastener Group of Canton, Ohio, USA (Figures 15 and 16).

**Figure 15:** Manufacturer's hallmark on the flanks of two MS21042L-4 nuts from the clutch assembly/retainer outer fasteners.

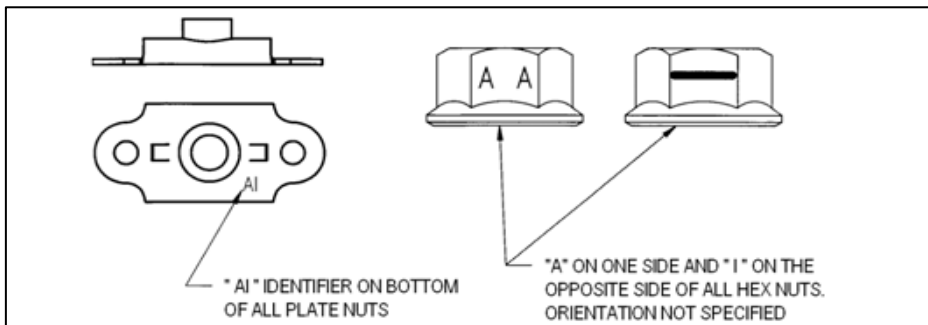
**Figure 16:** Manufacturer's hallmark attributed to Airfasco Industries Fastener Group.
