Australian Government
Australian Transport Safety Bureau

Aviation Short Investigation Bulletin

Issue 27

AB-2014-024

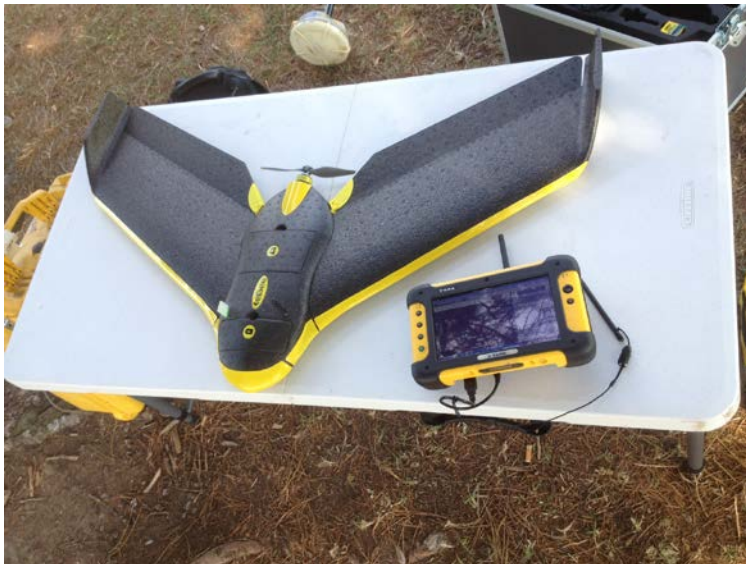
Figure 1: Sensefly eBee 178

At about the same time, the operator of an unmanned aerial vehicle (UAV), Sensefly eBee 178 (Figure 1), arrived at the 'Iluka Echo' (Echo) mine site to conduct an aerial photography survey of the site. After having completed his pre-flight preparations and a risk assessment of the operation, the operator heard an aircraft operating about 1-1.5 km away on a neighbouring property to the north-east of the UAV launch site (Figure 2).

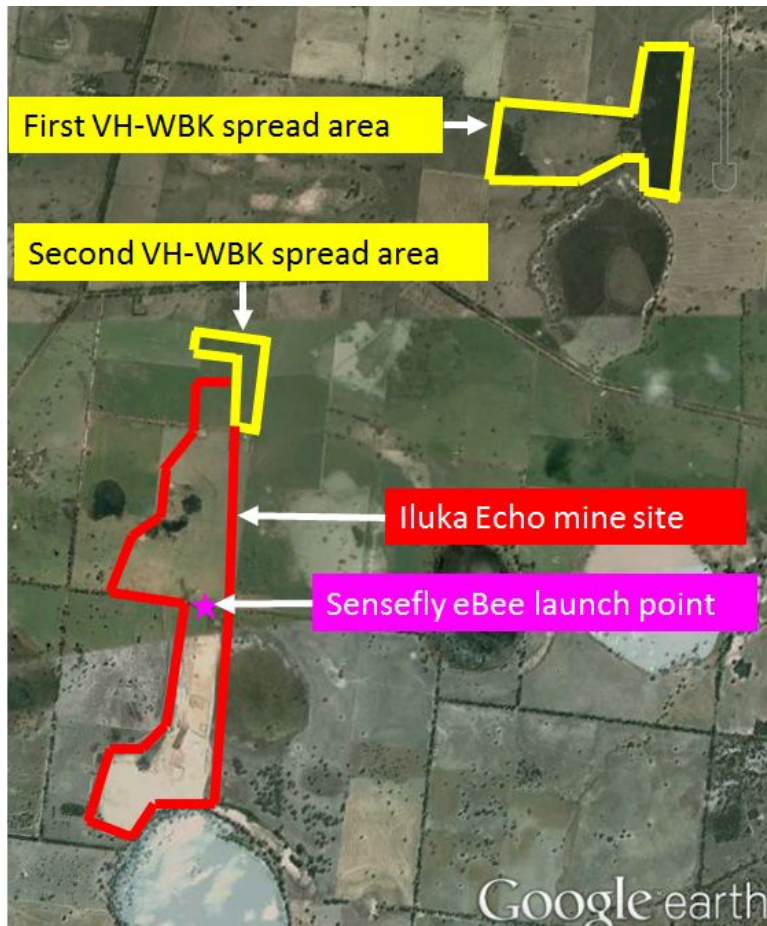
Figure 2: Operating areas for VH-WBK and the UAV

At about 1000, the UAV operator heard increasing noise from WBK and observed the aircraft cross the site boundary from the north, conduct a 180° turn about 150 m north of the UAV, then complete one full 360° turn before it departed again to the north. At the time, the UAV was on approach to land, at about 380 ft AGL. The operator immediately put the UAV into a holding pattern to maintain its current position. He estimated WBK was at about 100-150 ft AGL and came within about 100 m horizontally of the UAV. He attempted to contact the pilot of WBK on the radio but did not receive a response.

The pilot of WBK reported that, after completing spreading on the first paddock, he then returned to the airstrip about 3 NM to the north-east, where the aircraft was re-loaded with fertilizer. He subsequently spread the fertilizer on the second block, about 2 NM south-west of the first area, operating at about 50-100 ft AGL. He finished operating in the area by about 1200. He reported sighting a white vehicle on the road on the mine site, but did not see the UAV at any time. The next day the UAV operator contacted the pilot of WBK and advised him of the incident.

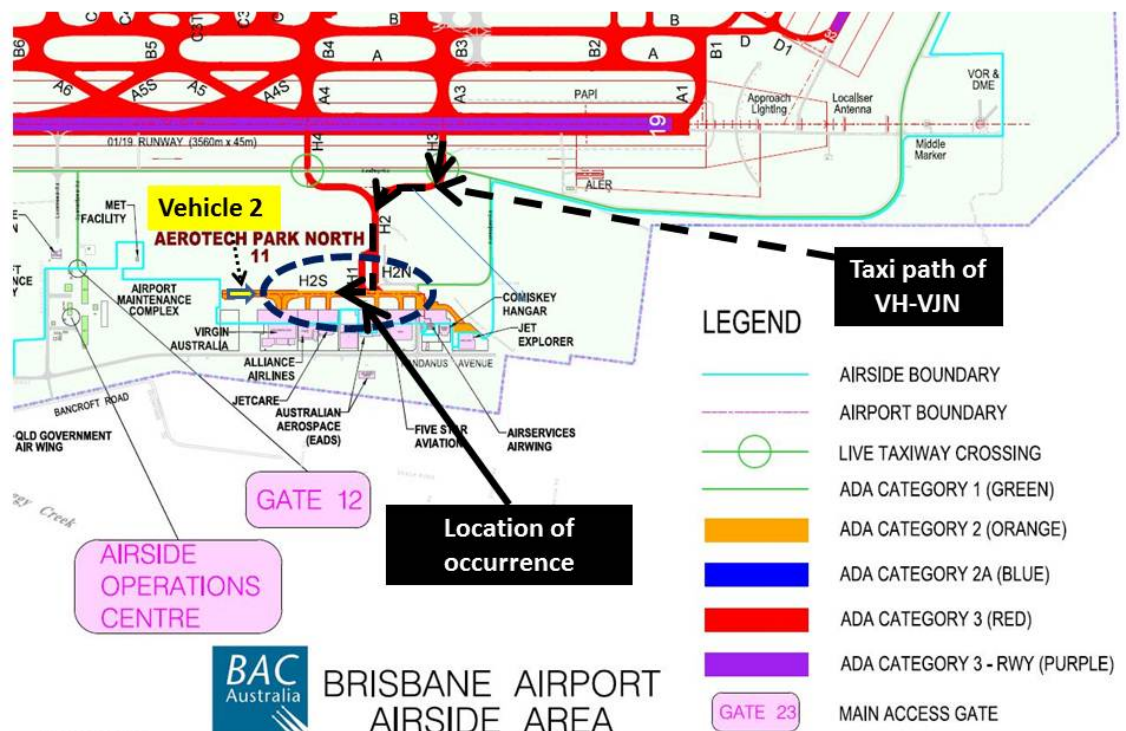
Figure 1: Brisbane Airport

The crew taxied VJN via taxiway 'Hotel 3' (H3), 'Hotel 2' (H2), and then via a right turn onto 'Hotel 2 South' (H2S) (Figure 1). As per company policy, the aircraft was taxied at a maximum speed of 9 kt during turns. During the 90° turn from H2 to H2S the pilot saw a vehicle approaching from the opposite direction along H2S. The vehicle had headlights on, but no flashing light. The captain reported he manoeuvred the aircraft to the right by 2-3 m and braked firmly. During this manoeuvre the captain observed the vehicle brake, and turn right onto the grass. The vehicle passed close to the aircraft's left wingtip.

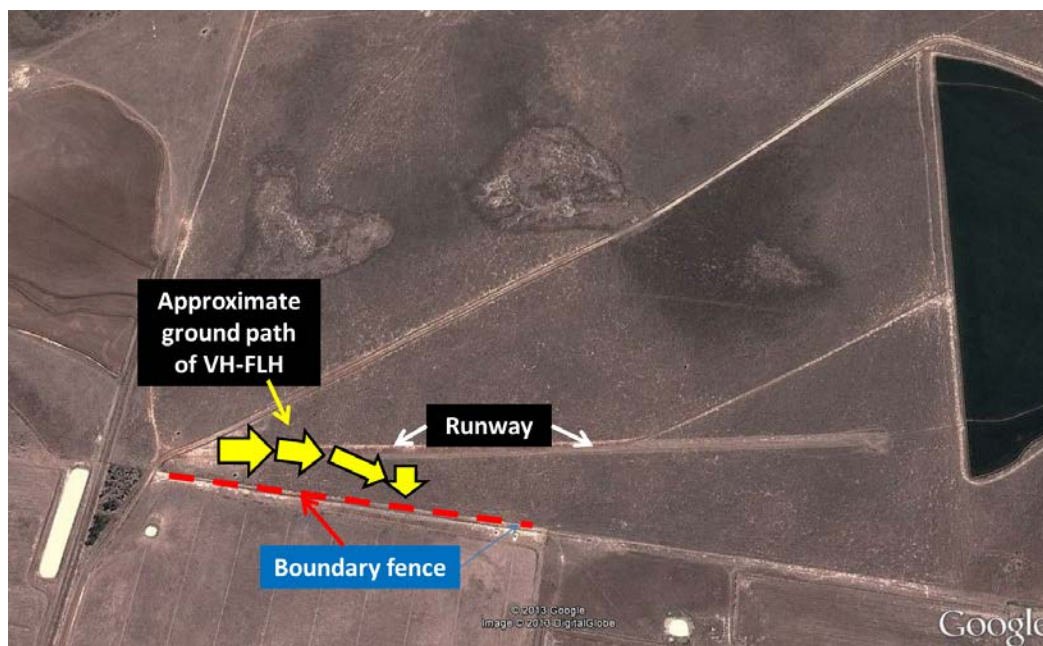
Figure 1: Accident site

During the landing, the main wheels touched down first, followed by the tail, which was locked into place. Shortly after, the aircraft suddenly veered right about 45°. The pilot considered a go-around, but was concerned that the aircraft would not clear the boundary fence (Figure 1). Consequently, he elected to continue the landing and selected reverse thrust, applied left brake, left rudder and left aileron in an attempt to re-align the aircraft with the runway. The aircraft did not slow down as the pilot expected. The wheels began to 'grab' and the left undercarriage leg became detached which caused the aircraft to rotate facing about 90° away from the runway. The left wingtip and propeller subsequently contacted the ground. The pilot shut down the aircraft and exited. The pilot was not injured, but the aircraft was substantially damaged (Figure 2).

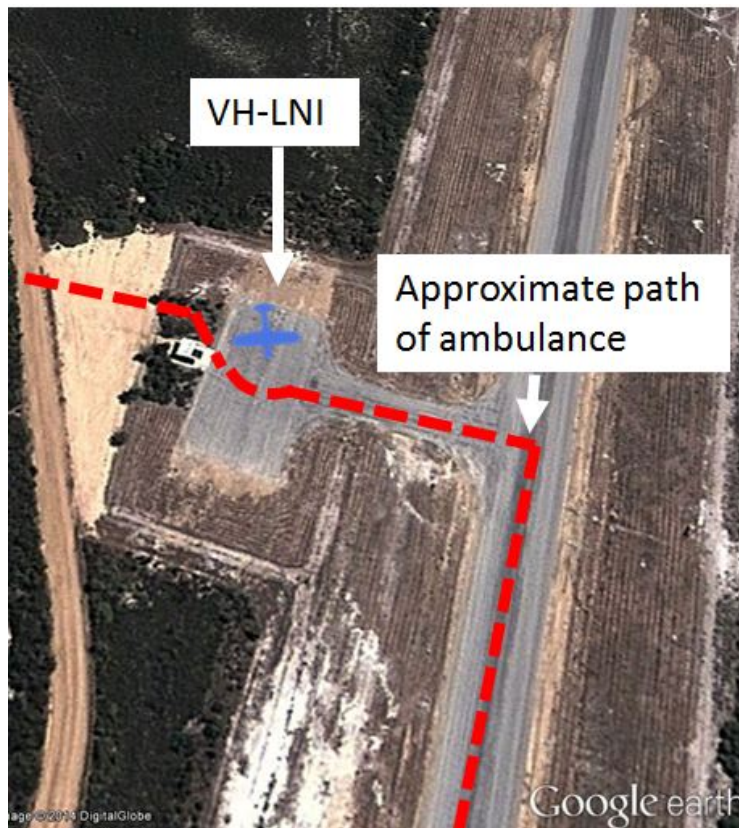
Figure 2: Jurien Bay (ALA)

The ambulance driver then proceeded to the runway and stopped prior to entering the runway. The driver reported that he and his ambulance partner conducted a thorough visual inspection for aircraft approaching and on the runway. The ambulance then entered the runway and drove towards the helipad, about 300 m south of the RFDS apron (Figure 2).

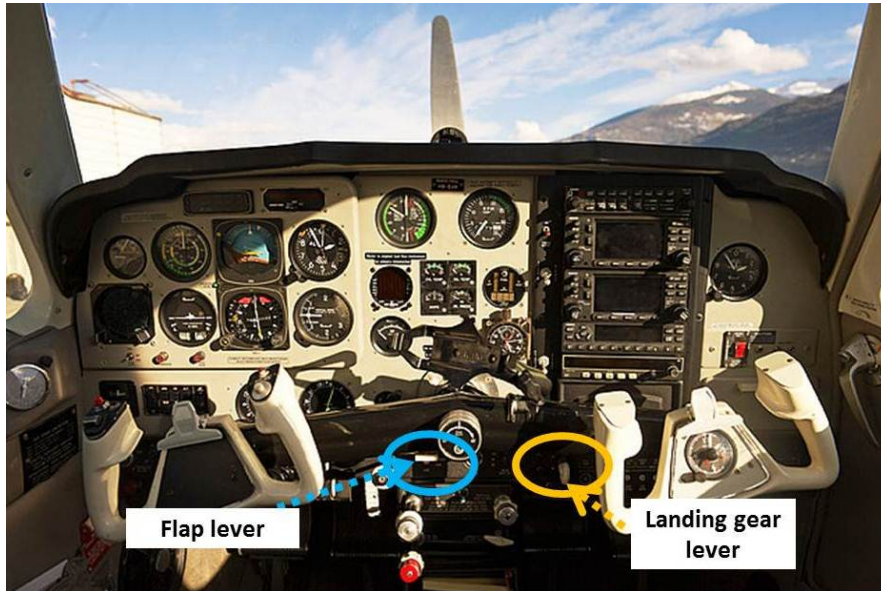
Figure 1: Cockpit of a Beech Bonanza similar to VH-YEN

The student had completed his recent training in a Cessna 182 aircraft, which had the flap lever located in a position similar to that of the landing gear lever in the Bonanza (Figure 1 and Figure 2).
