# Engine power loss and departure from controlled flight involving Piper Seneca, VH-LCK

Near Broome Airport, Western Australia | 11 July 2012

**ATSB Transport Safety Report**  
Aviation Occurrence Investigation  
AO-2012-093  
Final – 3 June 2014

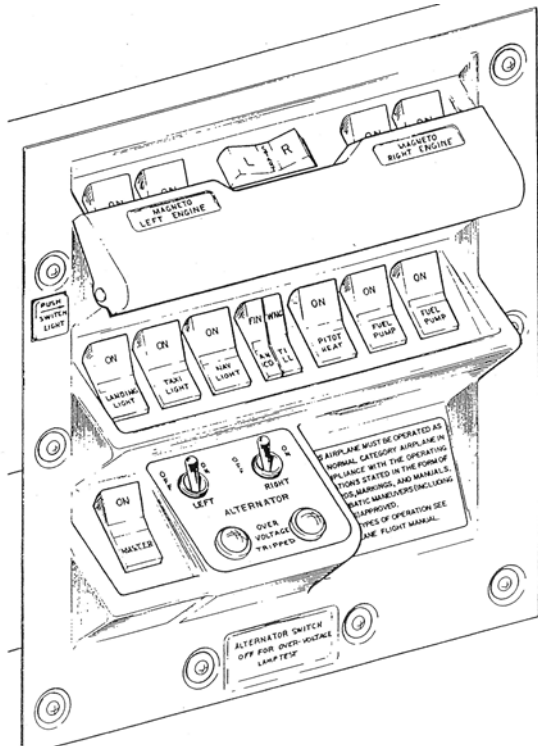
**Figure 3: Electrical switch panel**

Power for the aircraft electrical system was provided by an alternator mounted on each engine and a 12 volt battery. Most of the switches for the aircraft's electrical system were fitted to a panel on the left cockpit sidewall (Figures 3 and 4). This included the electrical master switch and switches for the engine magnetos, electric fuel pumps, starter motors, alternators, external aircraft lighting and pitot heat.

Each engine was equipped with two magnetos, providing a duplicated ignition source to the cylinders of each engine and independently of the aircraft's electrical system. The switches for each engine's left and right magnetos were located on the top row of the switch panel. A hinged, spring-loaded cover closed over the front half of the magneto switches, guarding against inadvertent operation of the magnetos during flight. The top-row centre switch operated each engine's starter motor.

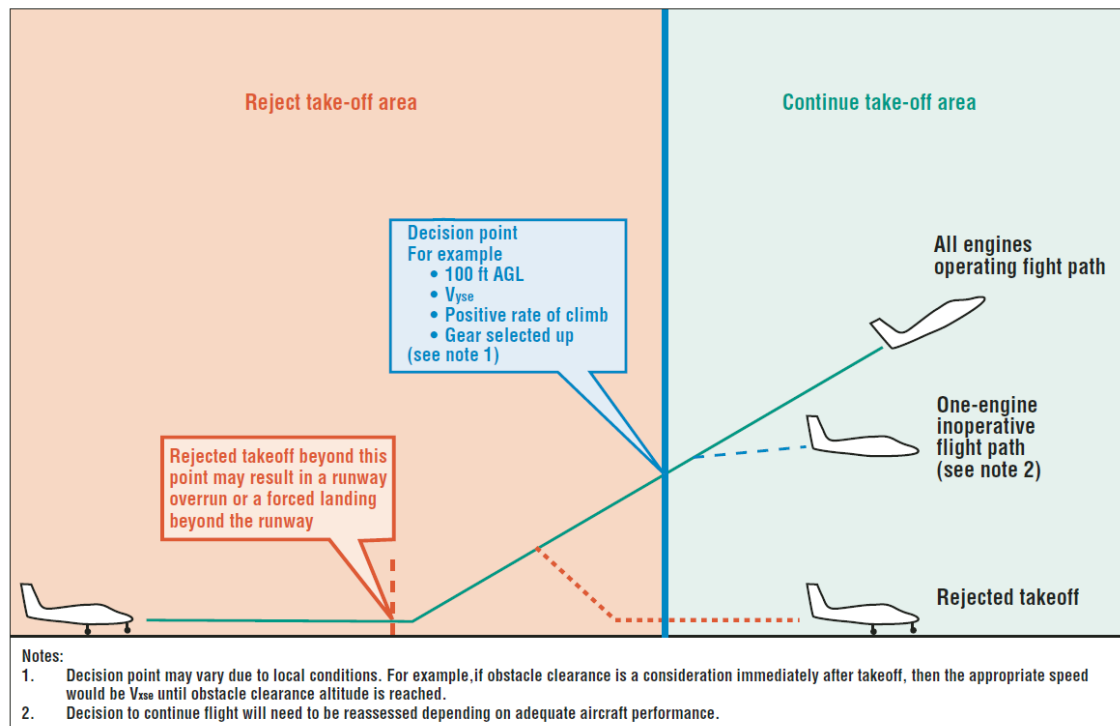
**Figure 6: Typical considerations for take-off performance, multi-engine aircraft below 5,700 kg MTOW**

The operator's standard procedure during take-off was consistent with the information contained in the aircraft manufacturer's aircraft flight manual. That procedure required the pilot to rotate<sup>8</sup> at an airspeed not less than 70 kt and establish the aircraft in the initial climb before retracting the landing gear when a safe landing could no longer be made on the remaining runway. The action of retracting the landing gear was used as a decision point to continue the take-off in event of a subsequent emergency (Figure 6). In the event of an emergency before this decision point, the operator's procedure was to discontinue the take-off and land on the remaining runway.

At Broome, where the runway is about 2,400 m long, the decision point to continue/discontinue the take-off in the Seneca was typically reached about halfway along the runway. At this point, the aircraft would be accelerating towards the initial climb speed of 110 kt. After reaching this speed and being safely clear of obstacles or terrain, the operator's procedures called for engine power to be reduced to the climb setting and completion of the climb checklist.

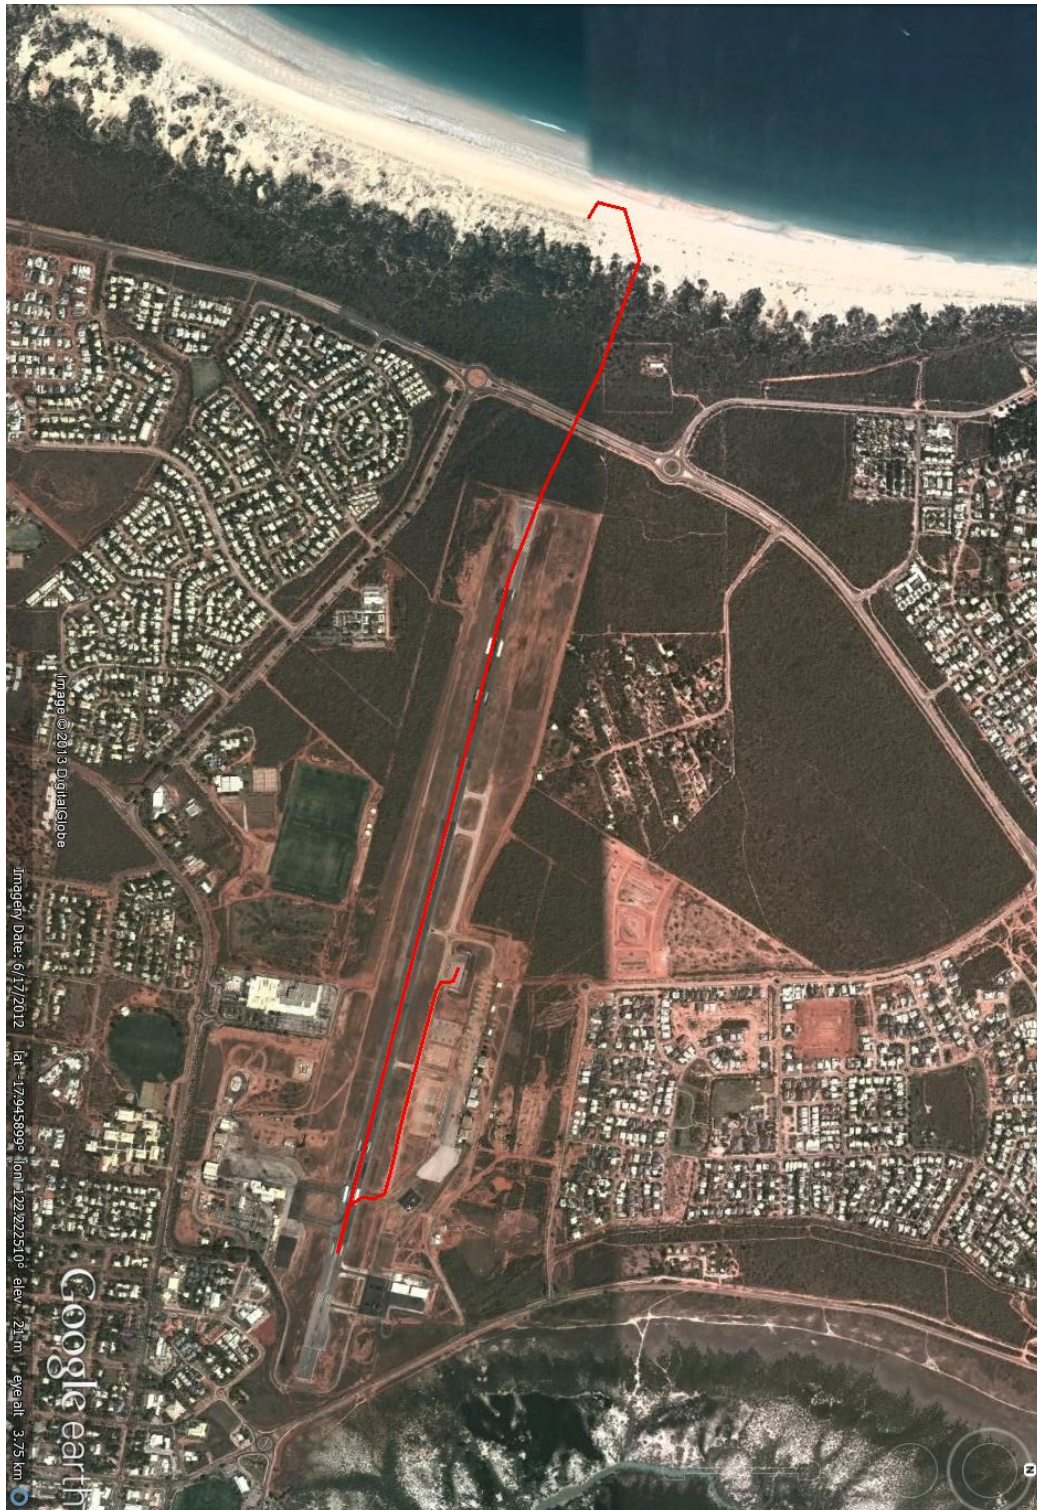
**Figure A-1: Plan view**

Plan and side views of the aircraft's point-to-point global positioning system-recorded flight path are at figures A-1, A-2 and A-3.
