Wirestrike involving Cessna 182A VH-SGB

Burrum River, Queensland | 17 December 2012

ATSB Transport Safety Report
Aviation Occurrence Investigation
AO-2012-170
Final – 5 June 2014

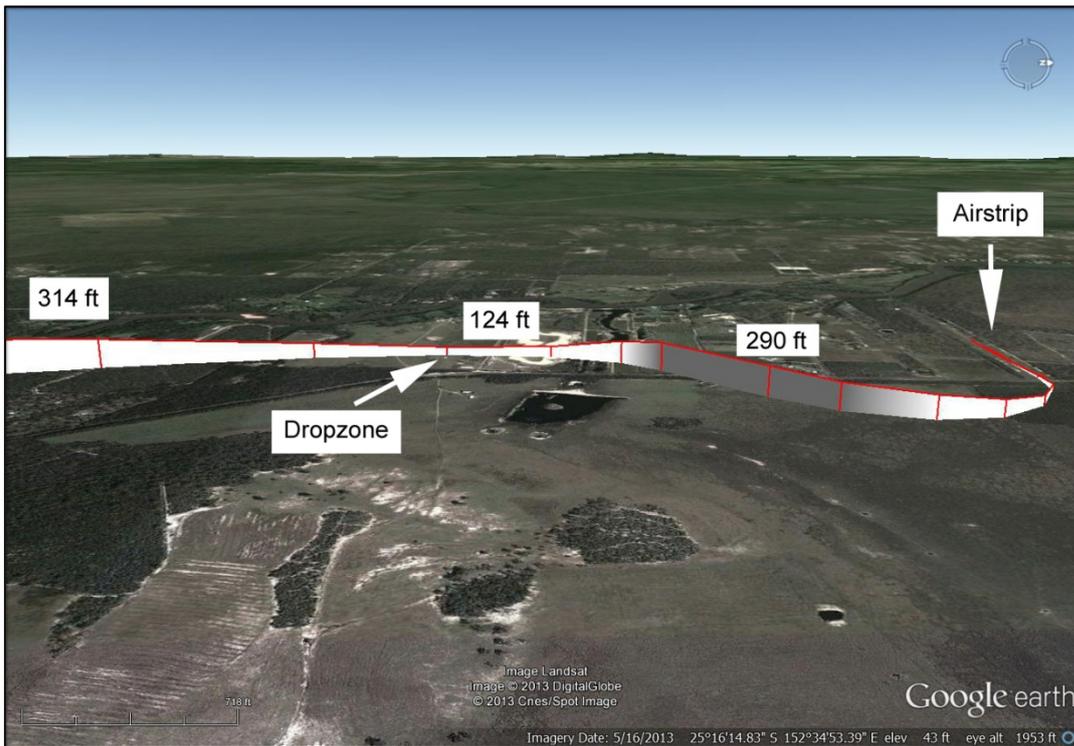
Figure 7 – 11 November 2012 low level pass over drop zone and arrival at airstrip⁸

The GPS data showed that the pilot had previously conducted low level passes at a number of locations, including the parachute drop zone. The flight recorded on the GPS on 11 November 2012⁷ involved two low passes, one from the south to the north and another from the west to the east. These flights are reproduced from the GPS data at Figures 7 and 8.
