ATSB TRANSPORT SAFETY INVESTIGATION REPORT

Aviation Occurrence Report –200404085

**Collision with terrain
20 km SW St George, Qld
19 October 2004
VH-ZXZ
Gyroflug Speed Canard**

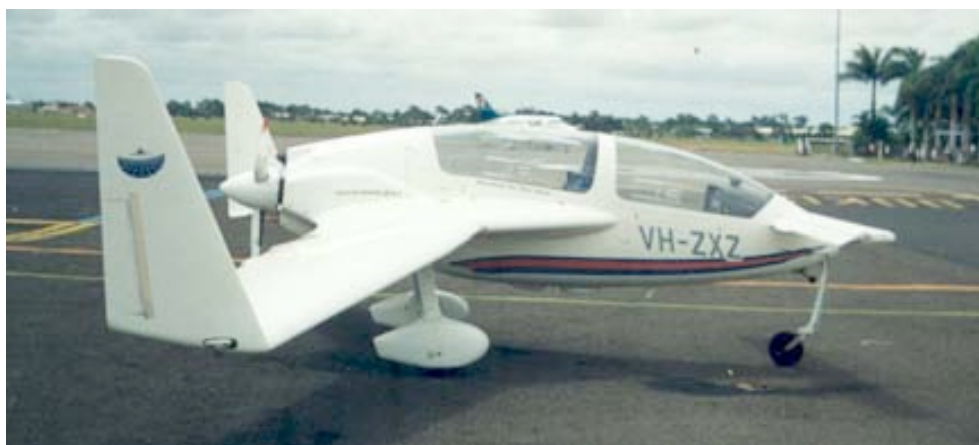
Figure 1: Gyroflug Speed Canard VH-ZXZ

The Gyroflug Speed Canard was a factory-built, two-seat (tandem), canard configured light aircraft constructed primarily of composite fibre (Figure 1). The engine was mounted at the rear and fitted with a pusher propeller. The cockpit canopies were clear plexiglass.
