ATSB TRANSPORT SAFETY REPORT

Aviation Occurrence Investigation AO-2008-005 Final

Engine failure 15 km west of Townsville Airport, Qld 14 January 2008 VH-PSQ Cessna Aircraft Company 208

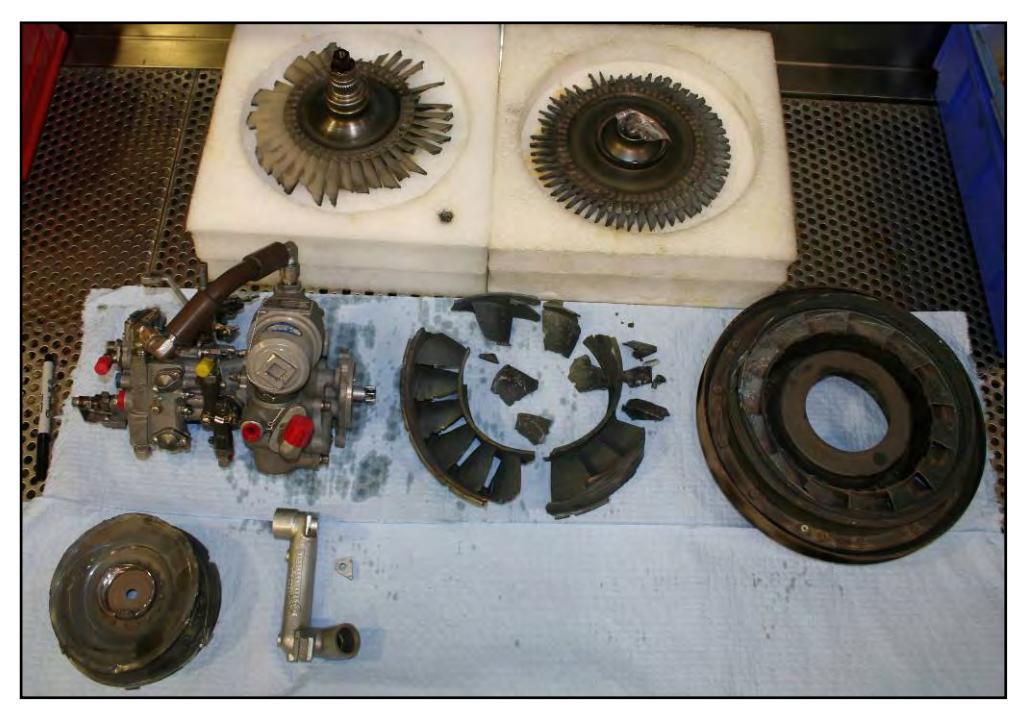
Figure 1. Components received for examination

To assist in the analysis of the damage sustained by the engine and the identification of factors that had contributed to the in-flight failure, the following engine components (Figure 1) were received at the ATSB's Canberra laboratories after completion of the engine disassembly.

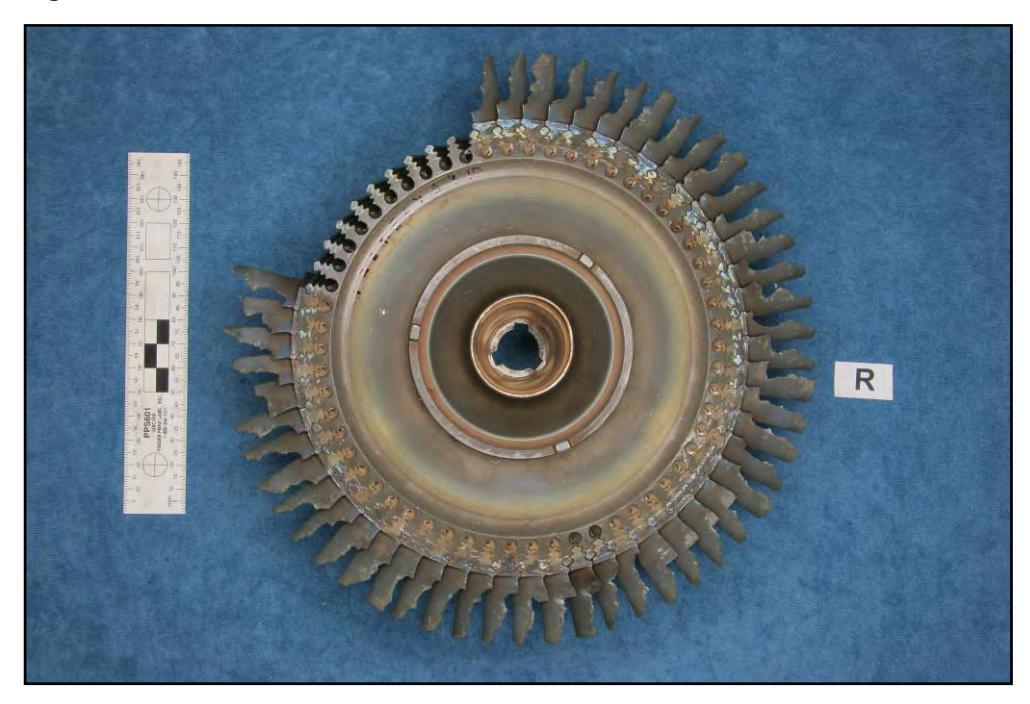
Figure 4. Power turbine disc and blade set

The engine power turbine (PT) disc (Figures 11, 12) carried 41 solid-section removable blades, affixed with a fir-tree arrangement as-per the CT disc. The blades had sustained a varying degree of mechanical damage – the majority having fractured transversely or diagonally backward through the outer airfoil section. Several blades however, had fractured at or near to the root transition, although the uniform dendritic fracture morphology was similar to the other blades and typical of forced fracture under conditions of impact-induced overstress (Figure 13). The trailing edges of all PT blades showed little visual evidence of service-related cracking or other progressive degradation mechanism.

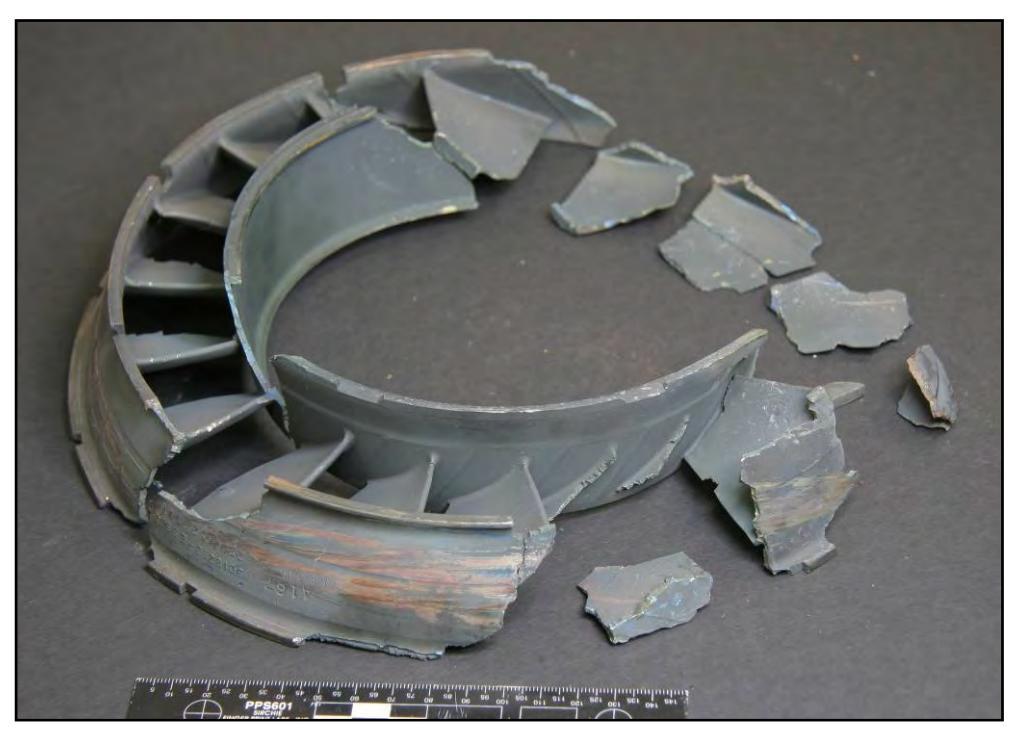
Figure 9. Interstage baffle assembly

The interstage baffle plate that is normally secured within the centre of the vane ring was recovered separately from the engine and had sustained extensive damage and loss of material from the outer periphery, particularly on the rear-facing plate (Figure 9). Of the three riveted tabs that retain the upstream plate against the vane ring face, one had been lost and one had partially pulled away from the baffle plate, with one of the two rivets missing. Several of the locating lugs around the periphery of the upstream baffle plate, showed cracking running diagonally inward from one corner, with one lug having evidently torn away from the plate through a similar area. The areas of normal seating between the baffle plates and the vane ring core showed evidence of fretting and repeated movement between the surfaces in contact. Similar areas of contact and some wear were also noted on the edges of the locating lugs and on the underside of the retaining tabs (Figure 10).

The central raised bosses on both sides of the baffle assembly showed crushing, scoring and deformation that attested to the baffle moving laterally out of position between the compressor and power turbine discs. The rivets retaining the bosses and baffle plates were all present and secure.

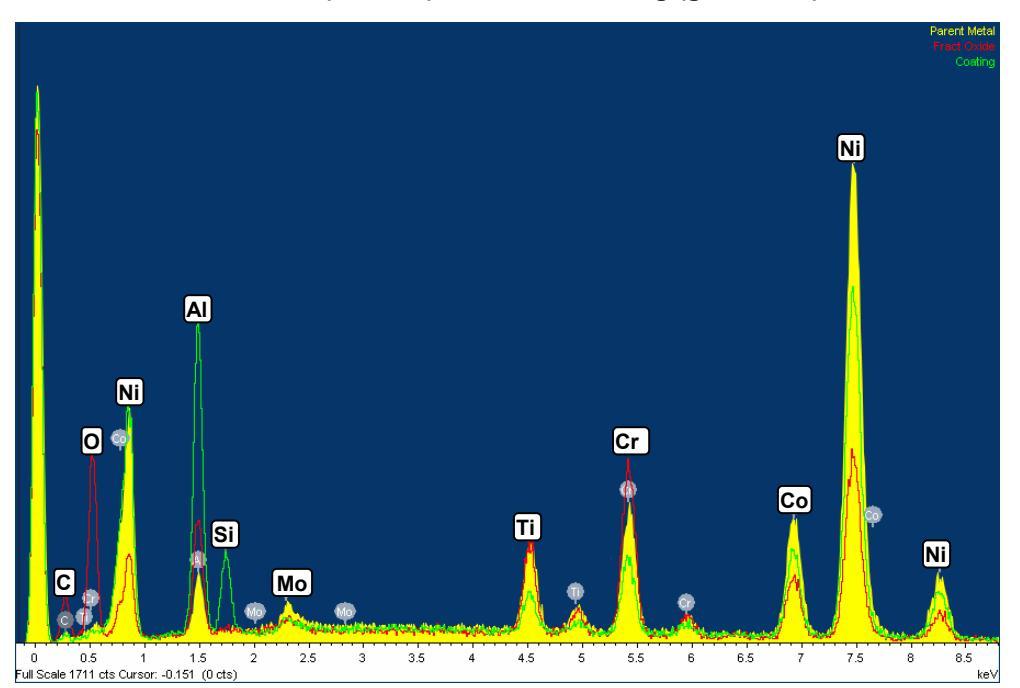
Figure 24. EDS elemental spectrum of parent metal (yellow base), fracture surface oxide (red line) and blade coating (green line)

Energy-dispersive x-ray spectroscopic analysis (EDS) provided confirmation of the presence of Calcium, Magnesium, Aluminium and Silicon based oxides and deposits across the fracture – typical of materials originating from dusts and environmental products entering the engine. EDS also confirmed the coating to be a conventional silicon-aluminide diffusion coating, above a substrate typical of an IN-100 Nickel-based superalloy (Figure 24).

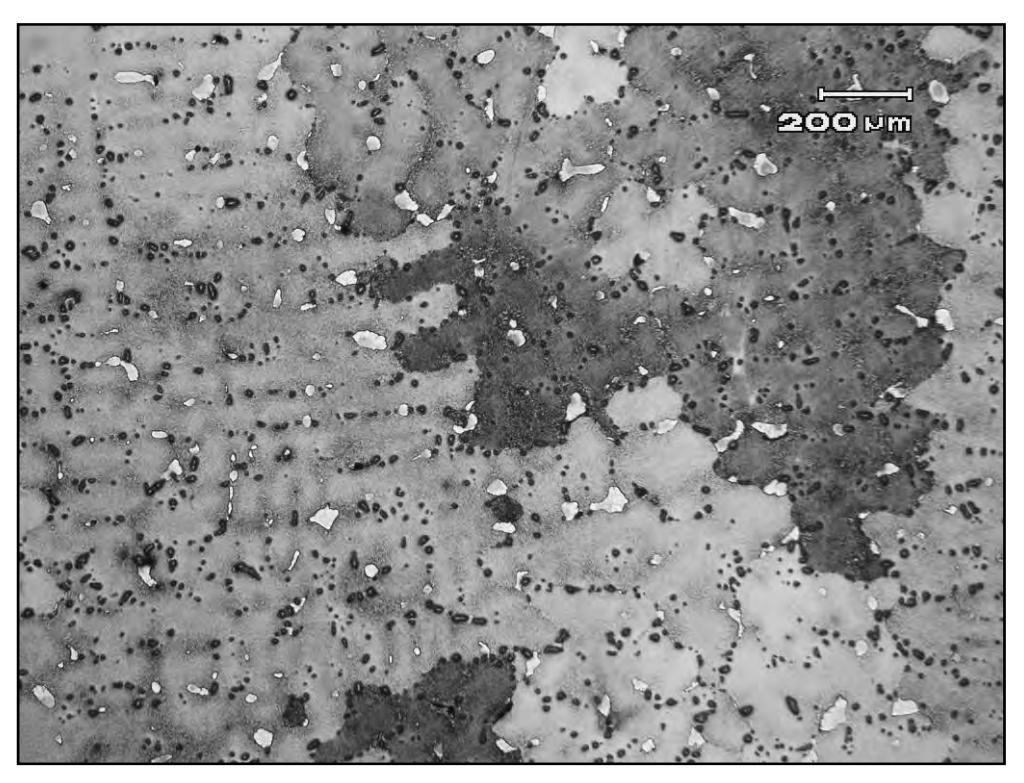
Figure 27. Typical blade bulk microstructure – dendritic γ ` matrix with carbides (dark particles) and islands of γ - γ ` eutectic (light areas)

Microstructurally (after etching), the blade material presented a distribution of angular massive carbides and gamma-gamma prime eutectic (γ - γ `), within a matrix of gamma-prime (γ `) precipitate (Figure 27). A comparison of the γ ` morphology between the fir-tree root and aerofoil material showed moderate levels of spheroidisation and some agglomeration of the γ ` within the aerofoil (Figure 28). Remnants of sigma-phase (σ) remained within the material immediately beneath the coating diffusion zone.
