Aviation Occurrence Investigation – AO-2008-007 Preliminary

# Hard landing – Darwin Airport, NT 7 February 2008 VH-NXE Boeing Company 717 - 200

Hard landing - Darwin Airport, NT, 7 February 2008, VH-NXE, Boeing Company 717 - 200

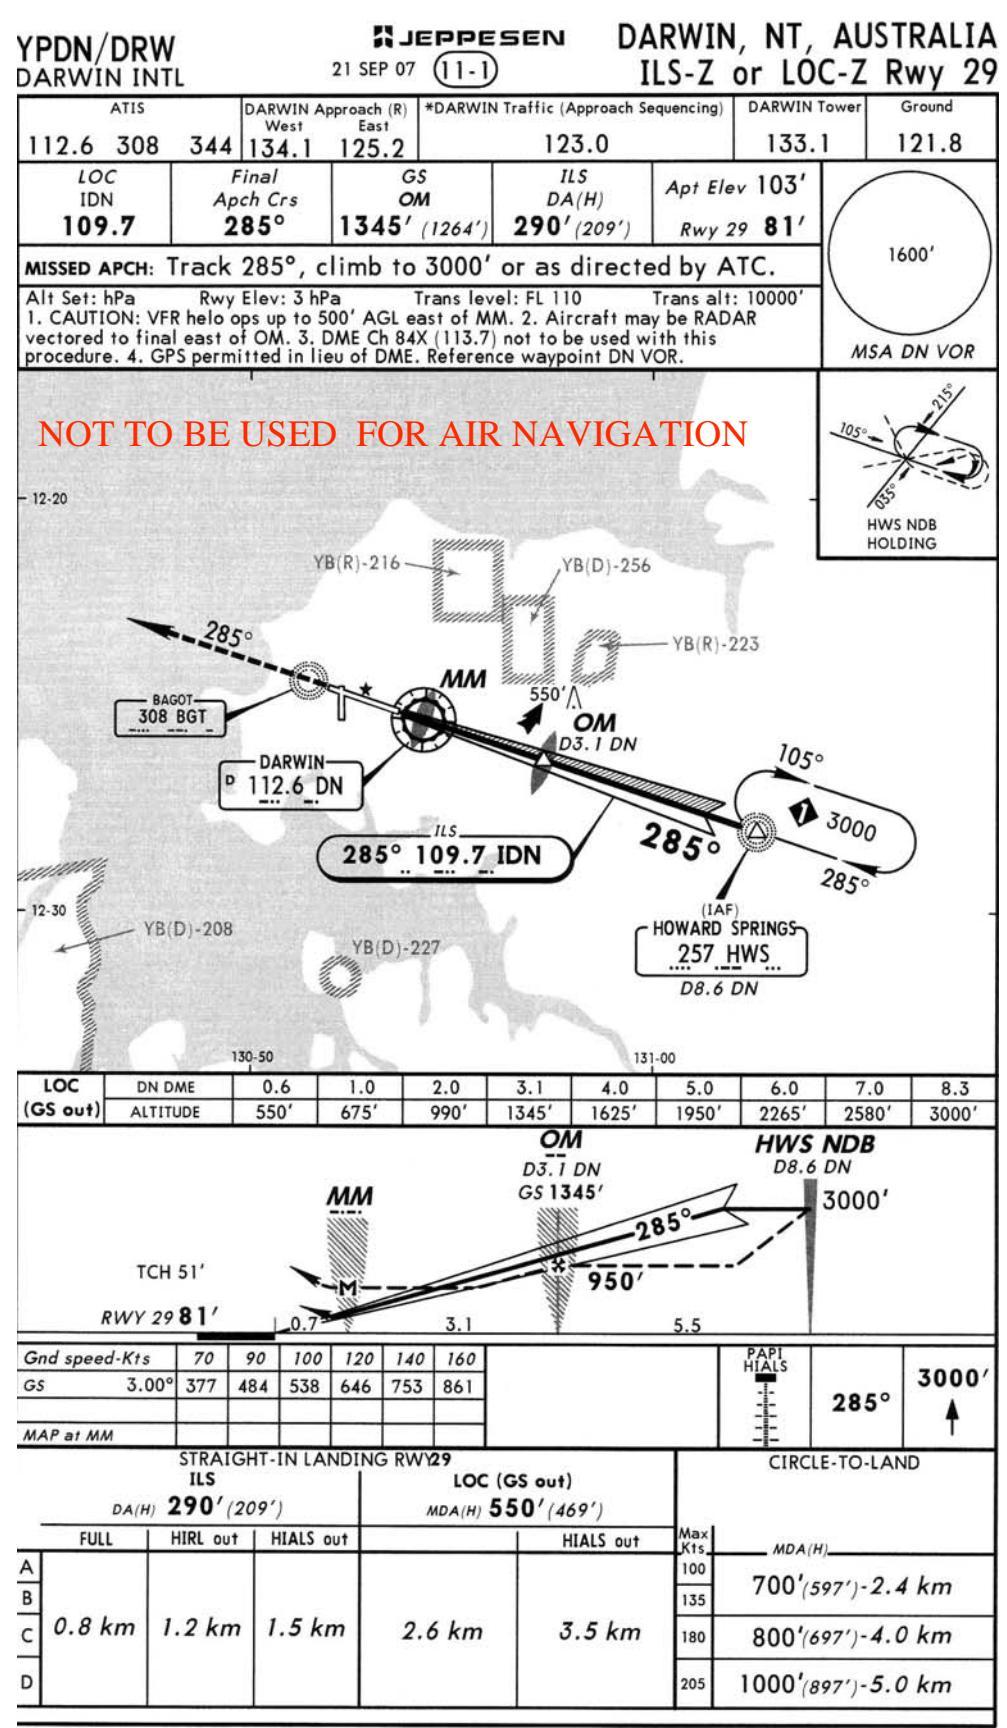
#### Figure 1: Darwin Runway 29 ILS approach chart

On 7 February 2008, a Boeing Company 717–200 (717) aircraft, registered VH-NXE, was being operated on a scheduled passenger service from Cairns, Qld, via Nhulunbuy (Gove) to Darwin, NT, with six crew and 88 passengers. During an ILS<sup>1</sup> approach (Figure 1) and visual landing to runway 29 at Darwin Airport, the aircraft was subject to a hard landing. The aircraft then bounced before the crew were able to complete the landing roll and taxi the aircraft to the terminal.

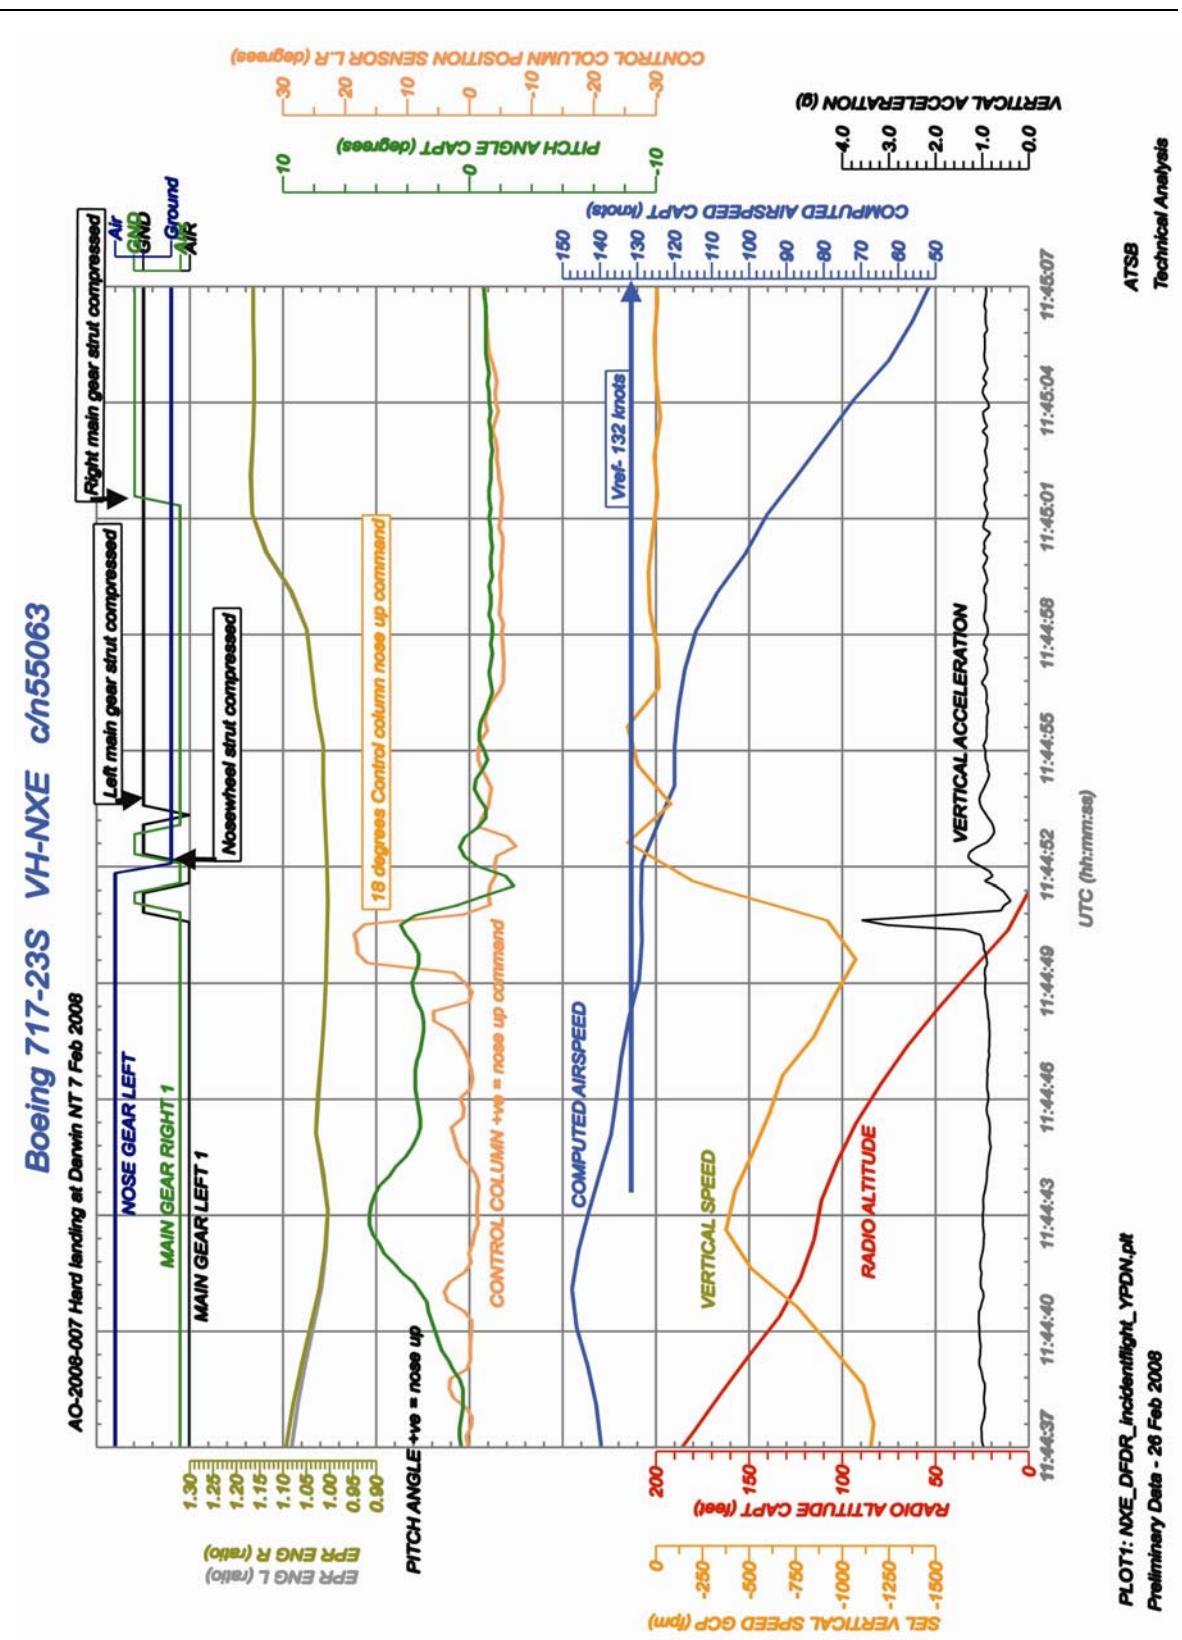
# **APPENDIX A : FLIGHT RECORDER DATA**

The FDR information at Appendix A displays the aircraft's flight path parameters from a radio altitude of 180 ft to after touchdown.

At approximately 30 ft radio altitude, the FDR recorded a rate of descent of approximately 1,000 ft/min at the same time as an abrupt control column nose up command was applied. The copilot recalled hearing the synthesised calls of radio altitude from the aircraft's radar altimeter.

At 2114:50, the aircraft touched down with a rate of descent of about 1,000 ft/min, which resulted in a hard impact with the runway prior to the 300 m runway markings (Figure 2). The aircraft then bounced before settling onto the runway. The crew completed the landing rollout and taxied the aircraft to the terminal.
