ATSB TRANSPORT SAFETY INVESTIGATION REPORT Marine Occurrence Investigation No. 249 Final

Independent investigation into the collision between the Australian registered fishing vessel

Allena

Northern Fortune

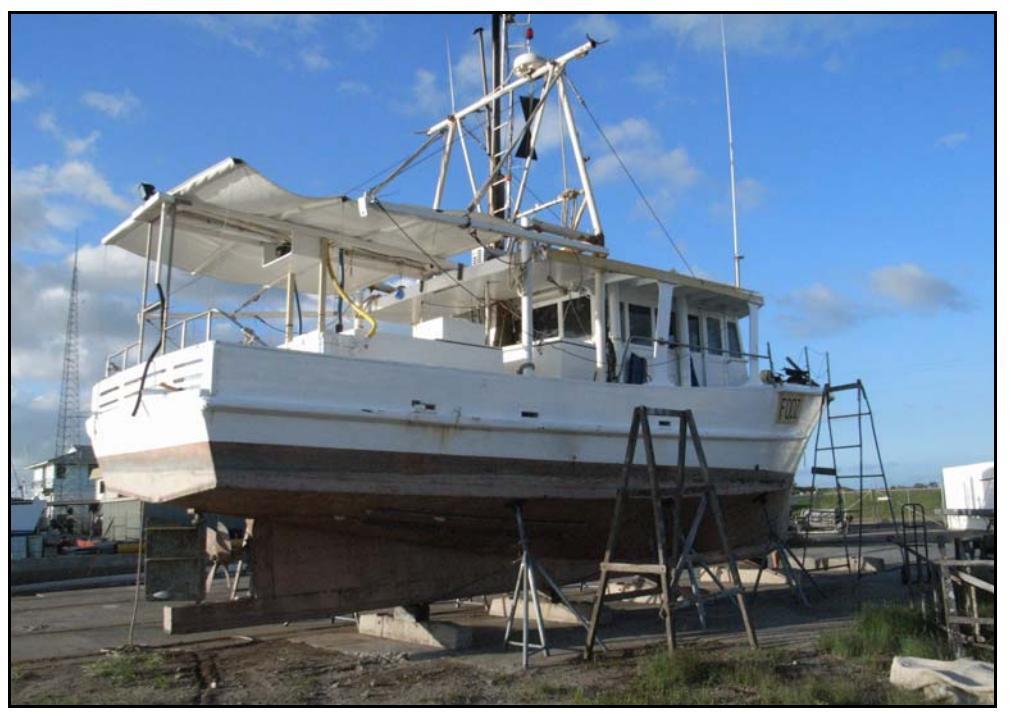
Figure 1: Allena

The Australian fishing vessel *Allena* (Figure 1) was owned by its skipper and registered with Maritime Safety Queensland as a class 3B vessel³.

The vessel was built in Gladstone, Queensland, in 1974. It was constructed of hardwood planks over hardwood frames. It is 13.54 m long, has a beam of 4.34 m and a gross tonnage of 20.22. At the time of the incident, the hull and wheelhouse were painted white with beige trim.

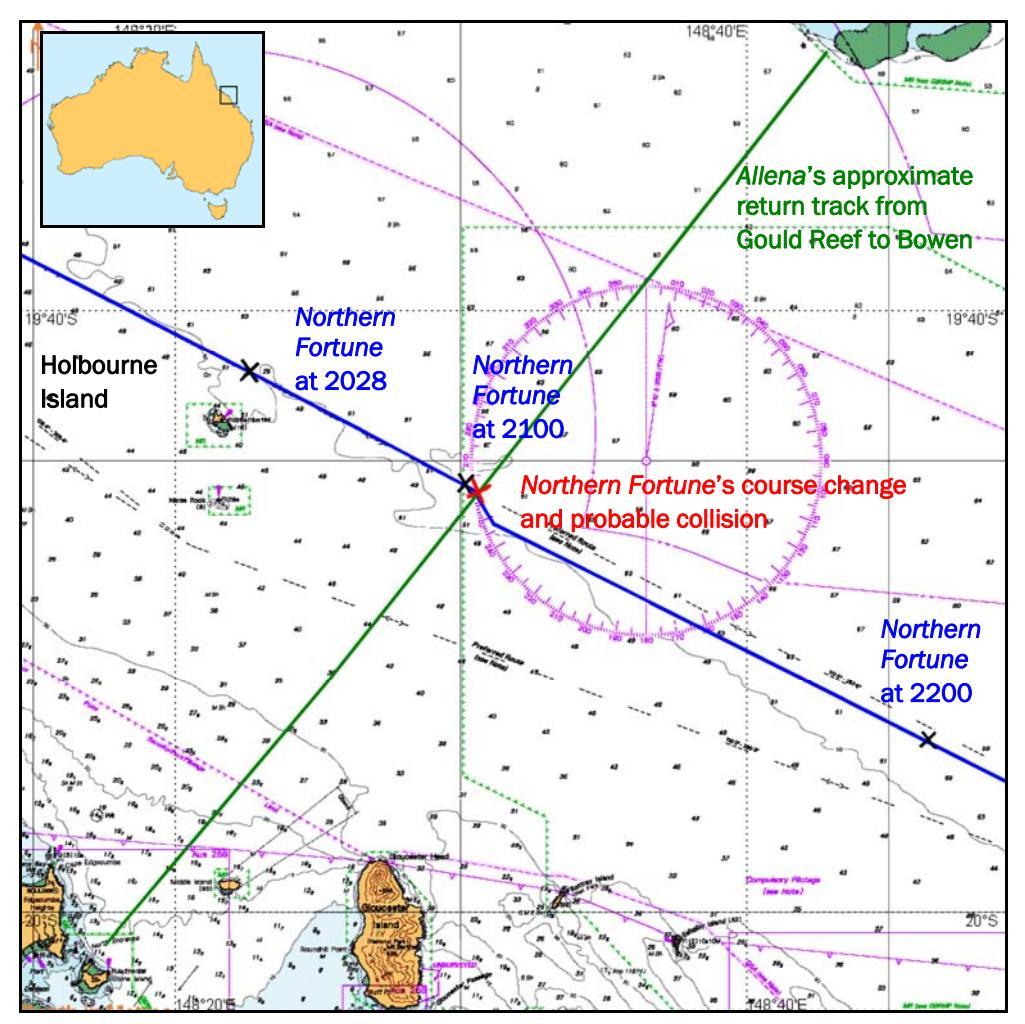
Figure 3: Section of navigational chart Aus 825

At about 2028, Northern Fortune passed Holbourne Island (Figure 3).

By about 2030, the last of *Allena*'s fishermen had gone to bed, leaving the skipper alone in the wheelhouse. Even though he believed that he had passed the main shipping route, the skipper looked out of the wheelhouse through the portside door to see if there was any traffic in the area. At this time, *Northern Fortune* was 10.4 miles and about 56°, or five points⁹, to starboard of *Allena*. The two vessels were approaching each other on a constant relative bearing, a collision course (Figure 3).

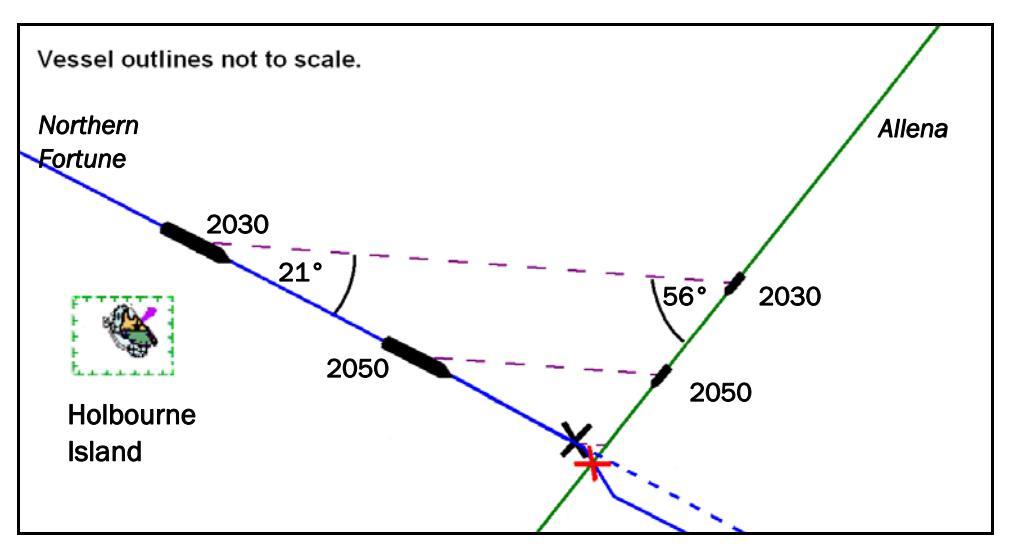
Figure 7: Recreation of the relative positions of Allena and Northern Fortune

On 21 January, a crossing situation existed between *Allena* and *Northern Fortune*. *Northern Fortune* was about five points, or 56°, to *Allena*'s starboard side at about 2030 (Figure 7) and the vessels maintained a constant relative bearing to each other until the collision. *Allena* was not engaged in fishing and, thus, was a power driven vessel for the purposes of the COLREGS. According to Rule 15 of the COLREGS,

Allena was approaching Northern Fortune on a constant relative bearing. Allena was about 21° on Northern Fortune's port bow (Figure 7). The fishing vessel had its aft deck lights illuminated but the reflectors in those lights were pointing away from Northern Fortune. From Northern Fortune's bridge, the loom of Allena's lights should have been visible even though the lights themselves would not have been directly visible. The third mate and the seaman on watch should have seen Allena, before the seaman left the bridge at 2045 to conduct his ship safety rounds, when it was about 4.5 miles away.
