Landing gear failure and runway excursion involving Cessna 441 VH-XBC

Coonawarra Airport, South Australia | 31 March 2013

ATSB Transport Safety Report
Aviation Occurrence Investigation
AO-2013-072
Final – 8 September 2014

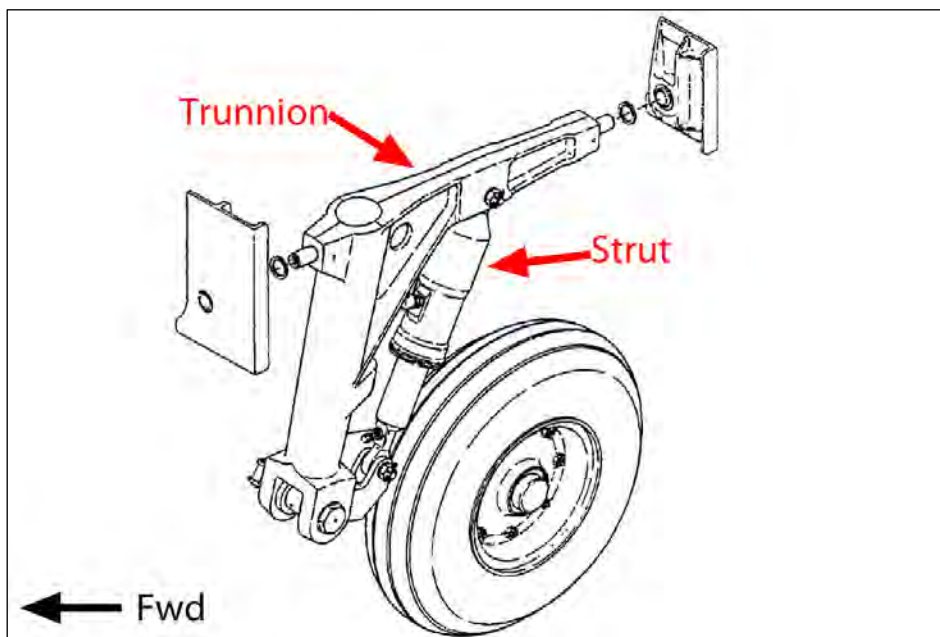
Figure 4: Cessna 441 main landing gear configuration

The main gear assembly consisted of a trunnion (part number 5741115), shock strut and fork/axle assembly (Figure 4). The gear was mounted within the inner wing structure and pivoted longitudinally between front and rear trunnion pins. The shock strut supported the landing gear static and dynamic loads and acted to dampen transient loads during landing, take-off and taxiing.
