Wheels-up landing involving Fairchild SA227-AT Metro III, VH-UZA

Brisbane Airport, Queensland | 15 February 2012

ATSB Transport Safety Report
Aviation Occurrence Investigation
AO-2012-024
Final – 29 September 2014

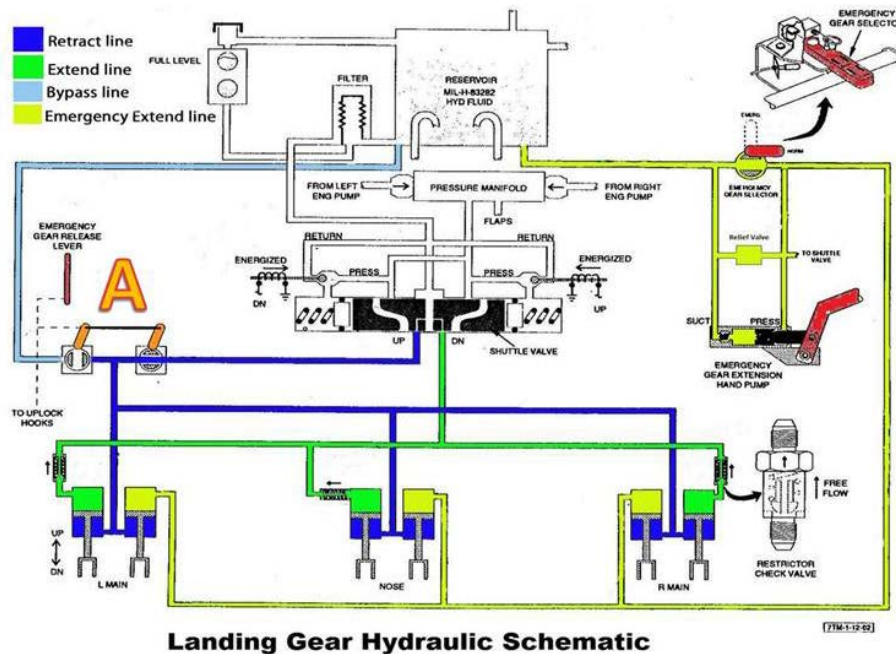
Figure 2: Landing gear hydraulic system

Rotation of the emergency release lever mechanically released the landing gear up-locks and positioned the shut-off and bypass valves (item 'A' Figures 2 and 3). This isolated the normal selector valve and allowed hydraulic fluid within the retract side of the system to return to the reservoir (Figure 3). Completion of that action should allow the landing gear to gravity freefall. The emergency gear selector, when rotated to the 'emergency gear' position, directed reservoir fluid to the emergency hand pump, which could then be used to increase pressure on the extend side of the landing gear actuators to assist in moving the gear to the fully locked down condition.
