# Locomotive fire

Awaba, New South Wales | 5 June 2014

RO-2014-010

Final – 31 October 2014

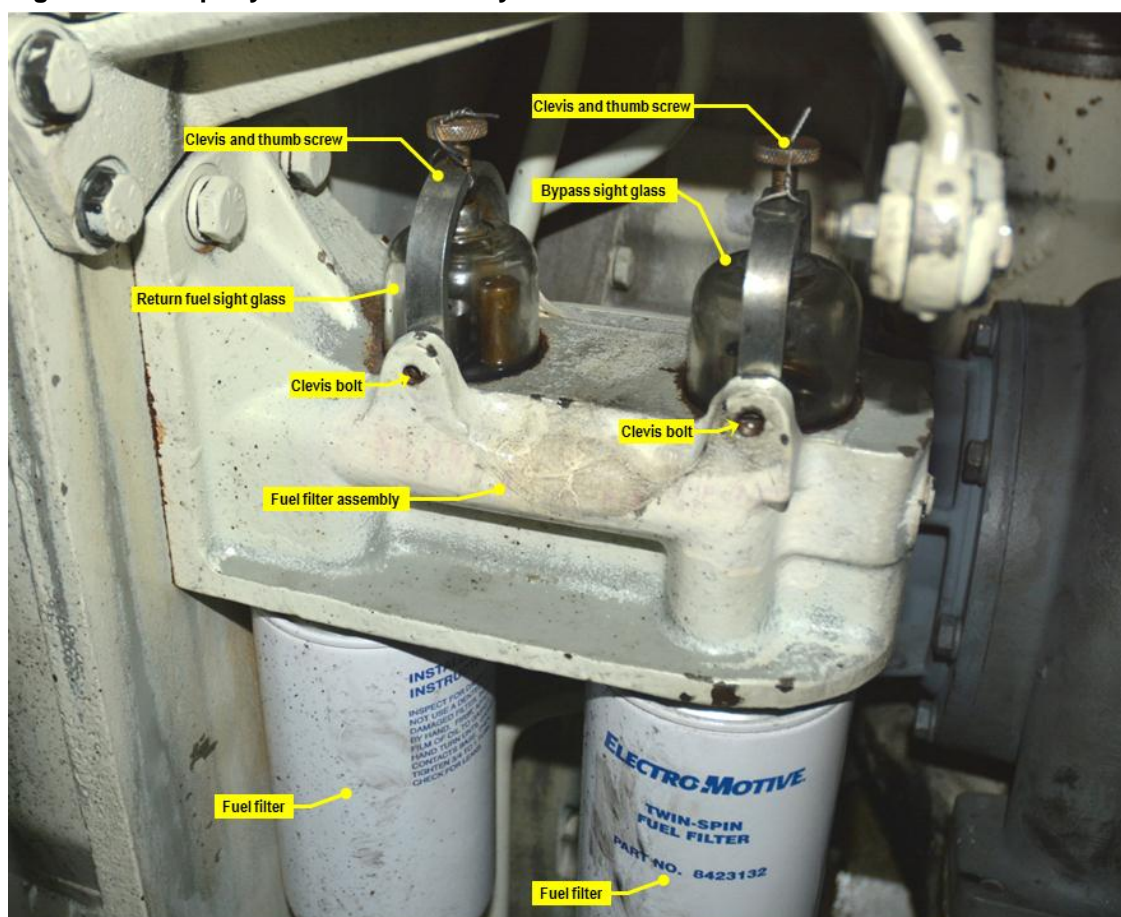
**Figure 2: Exemplary fuel filter assembly**

To maintain engine power, fuel is circulated throughout the engine at the rate of approximately 1500 litres per hour (25 litres per minute) by a conventional diesel fuel injection system. Operating pressures in the system vary up to 410 kPa (60 psi). The fuel is filtered by dual filters located on an assembly inside the engine bay at the front of the engine (Figure 2). Two sight glasses that indicate blockage of the fuel filters to maintenance staff form part of the assembly. After the fuel is filtered, it flows via the fuel rails to the injectors where it is metered into the combustion chamber. Once metered by the injectors all excess fuel is returned to the fuel tank.
