Collision with terrain involving Cessna 172, VH-WLF

10 km west of Wentworth Airport, NSW | 28 May 2012

ATSB Transport Safety Report

AO-2012-072

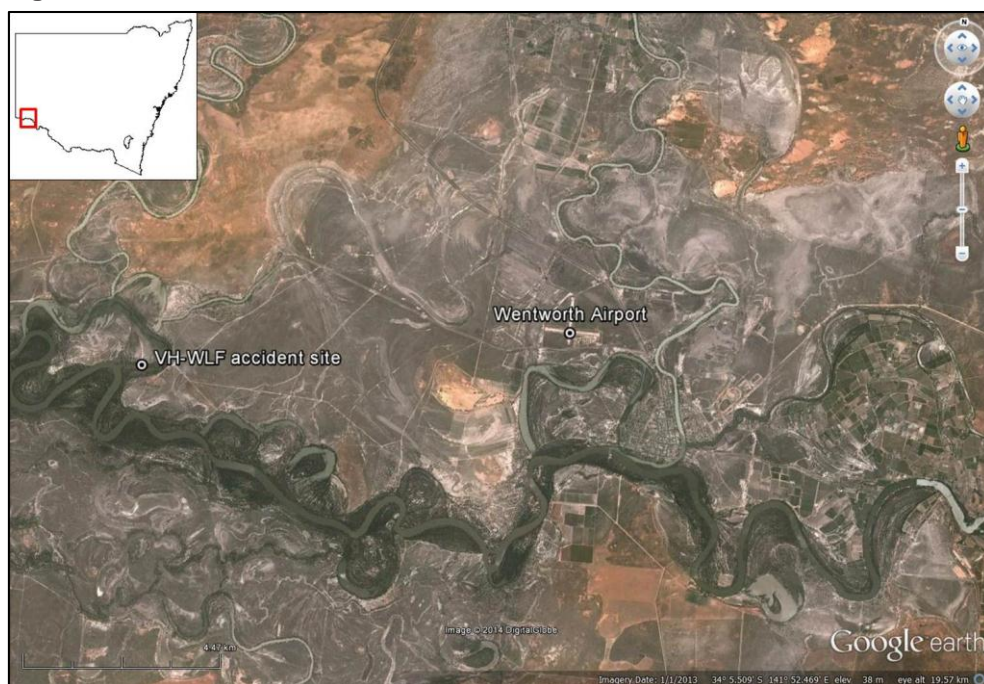
Figure 1: Accident location

No emergency satellite signals (see the section titled *Emergency locator transmitters*) were received from the aircraft. Following an extensive visual search involving multiple aircraft, the crew of one of the search helicopters sighted the aircraft wreckage on the evening of 30 May 2012 near the Murray River, about 10 km west of Wentworth Airport (Figure 1). On landing, the helicopter crew established that the pilot had received fatal injuries.
