Engine failure involving a Beech Aircraft Corporation Model 200, Super King Air, VH-ZMP

277 km NNW of Marshall Islands International Airport (Majuro Atoll) | 12 September 2013

ATSB Transport Safety Report Aviation Occurrence Investigation AO-2013-154 Final – 11 December 2014 Released in accordance with section 25 of the Transport Safety Investigation Act 2003

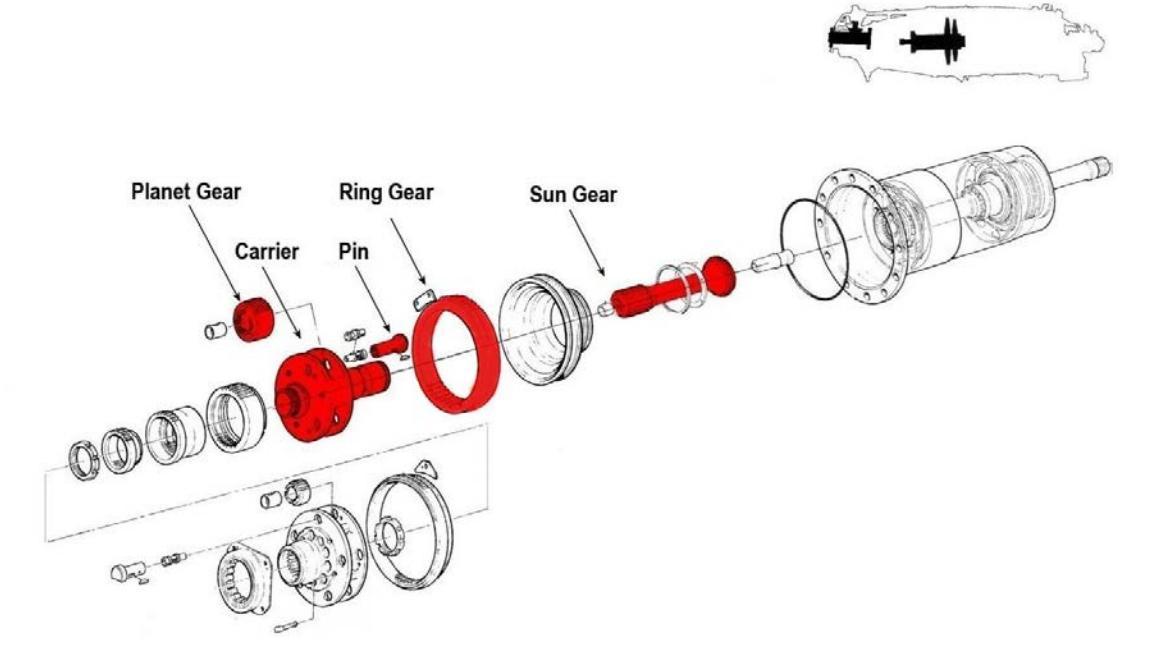
Figure 2: PT6A-41 engine diagram highlighting the general arrangement of the first-stage gears within the reduction gearbox

Torque from the power turbine is transmitted through the first-stage sun gear, which consists of a short, steel stub shaft with an integral spur gear. The sun gear drives three first-stage planet gears, assembled in a rotating carrier (Figure 2). The planet gears react against the non-rotating ring gear, which is radially fixed to the gearbox case. The reaction against the ring gear results in rotation of the gear carrier, which provides output to the second-stage reduction gears. The second-stage gears operate in a similar fashion to the first-stage and provide output to the propeller.
