# Rotor drive v-belt failure involving Robinson R22 helicopter, VH-HRX

100 km SW of Borroloola, Northern Territory | 27 March 2014

**ATSB Transport Safety Report**  
Aviation Occurrence Investigation  
AO-2014-058  
Final – 17 December 2014

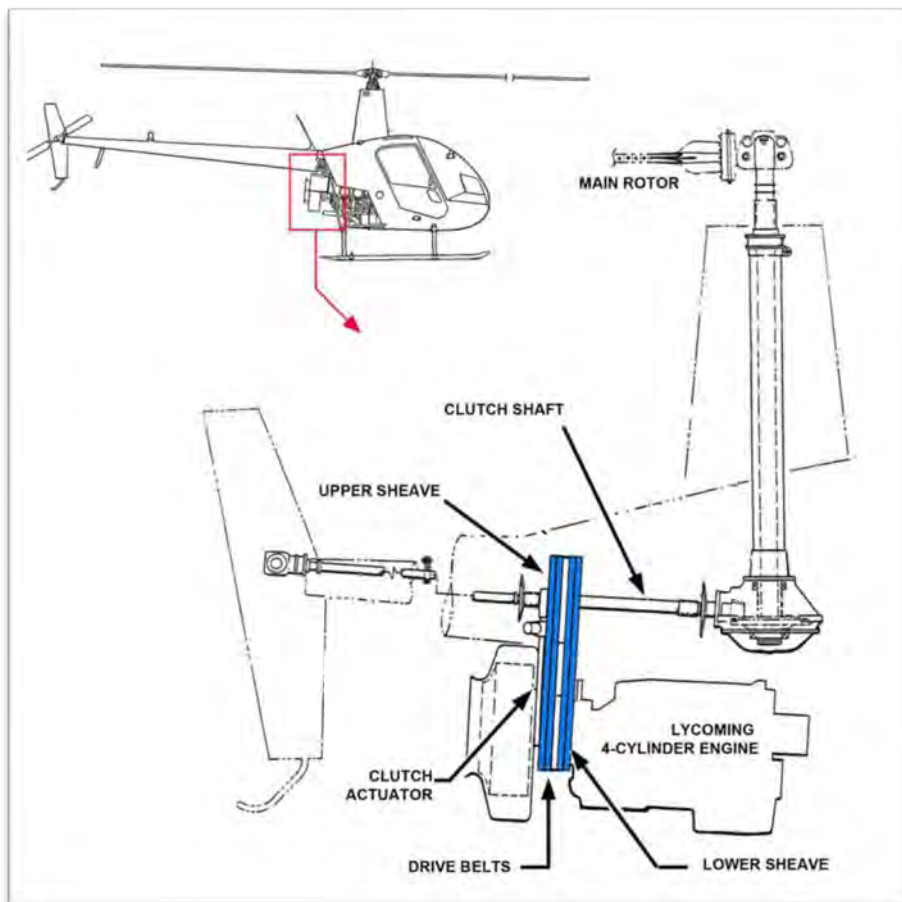
**Figure 3: Diagram of the Robinson R22 rotor drive system**

In the Robinson R22 the rotational energy produced by the horizontally-mounted piston engine is transmitted to the main and tail rotor systems by dual doubled-banded v-belts running on two sheaves (pulley assemblies) (Figures 3 and 4). The lower sheave is bolted to the output flange of the engine crankshaft and is mechanically connected to the upper sheave by an electrically-driven clutch actuator. The upper sheave incorporates a free-wheeling clutch which allows for free movement of the drive shafts and rotors when the engine is not operating or not otherwise driving the system.
